## Memorandum

Project John H. Stevens House

Regarding Fire Damage Condition Assessment

Re: Condition Assessment and Stabilization Recommendations  
John H. Stevens House, Minnehaha Park  
4901 Minnehaha Avenue So, Minneapolis, MN

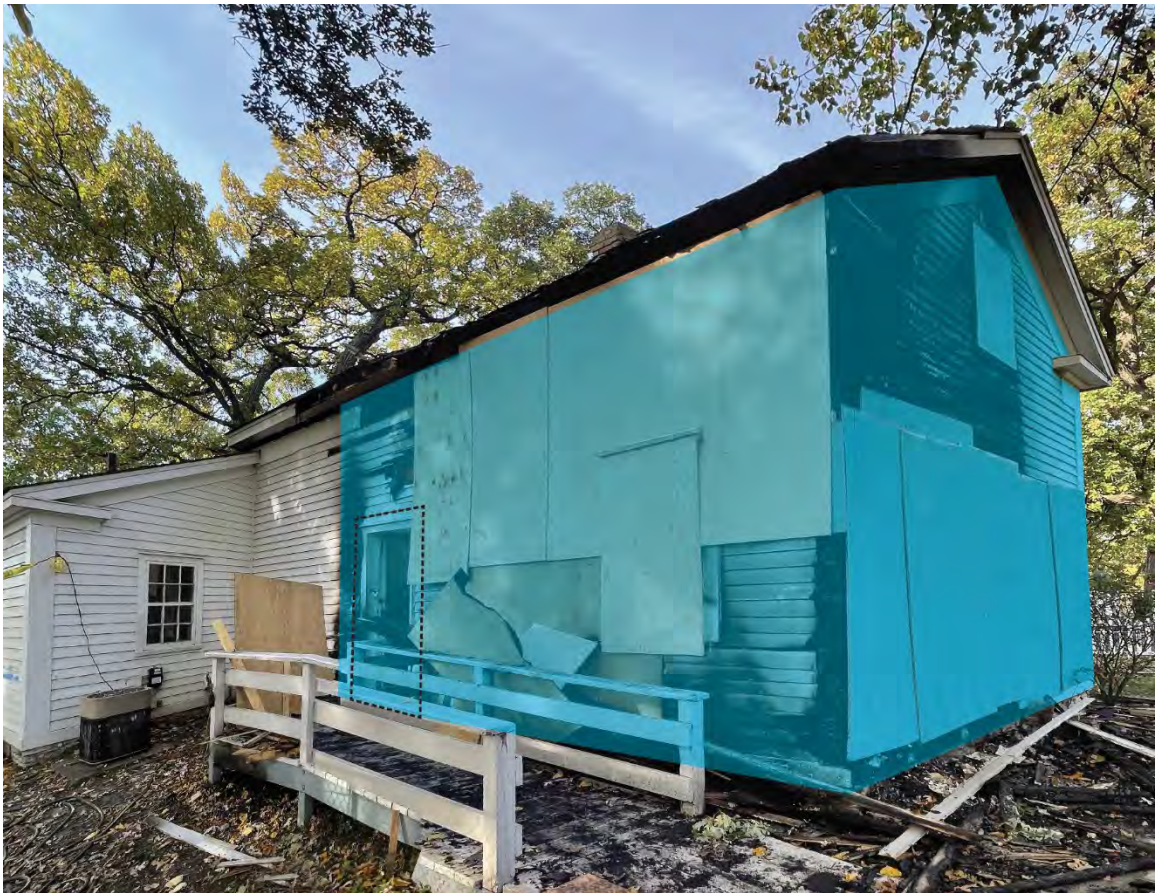
Photo 1 Eastern and northern facades.

- Remove debris along stone foundation which has built up from fire damage. Ensure ground surface is sloping away from foundation.
- Remove debris on walkway ramp.

- Remove burnt portions of siding and trim on portion of north and east façades.
- Install plywood at removed areas and intact areas, indicated in blue in diagrams below. If building is to be moderately heated over the winter it may be advantageous to install building wrap over areas of plywood, overlapping surrounding siding approximately 6". Provide a single plywood piece to cover the eastern facade door and trim for easy removal and access into the house.

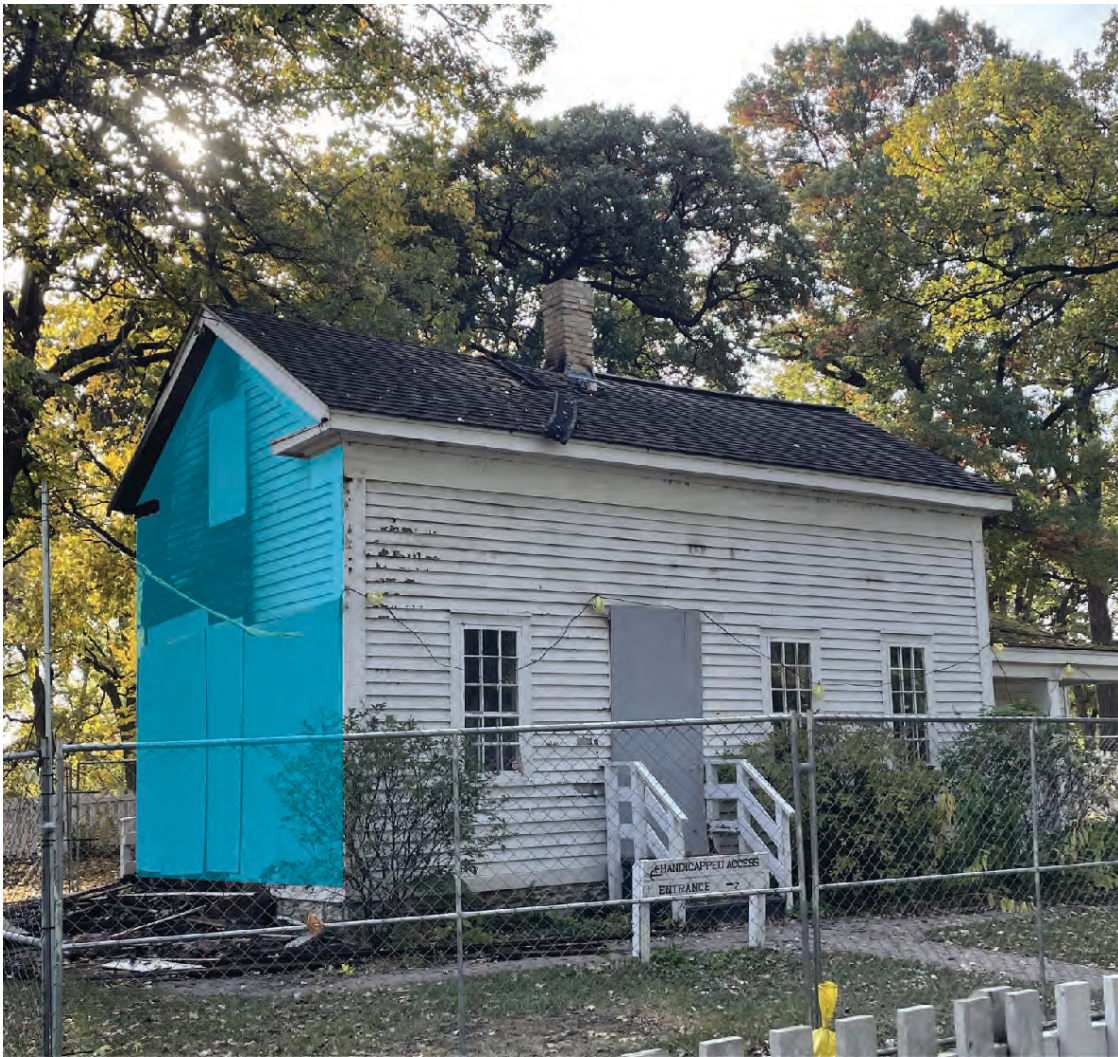
Photo 2 Northern and western facades.

- Windows on north and east facades and door on western façade will be covered with plywood as mentioned above.

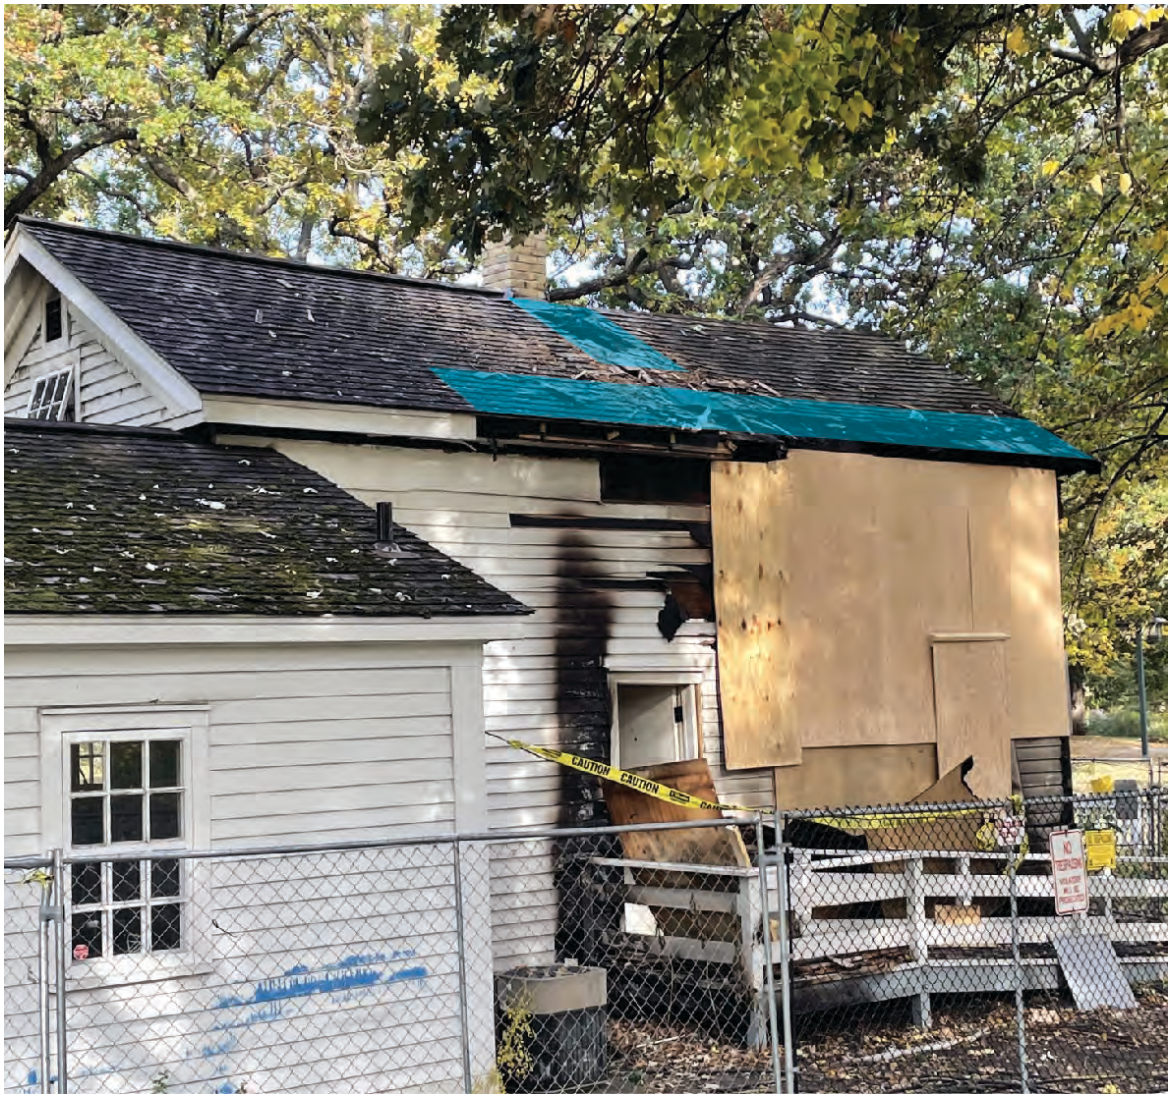
**Photo 3 Eastern facade with Kitchen addition to left.**

- Place plywood over roof openings and at roof eave (in blue in diagram below), see structural recommendations on S6.

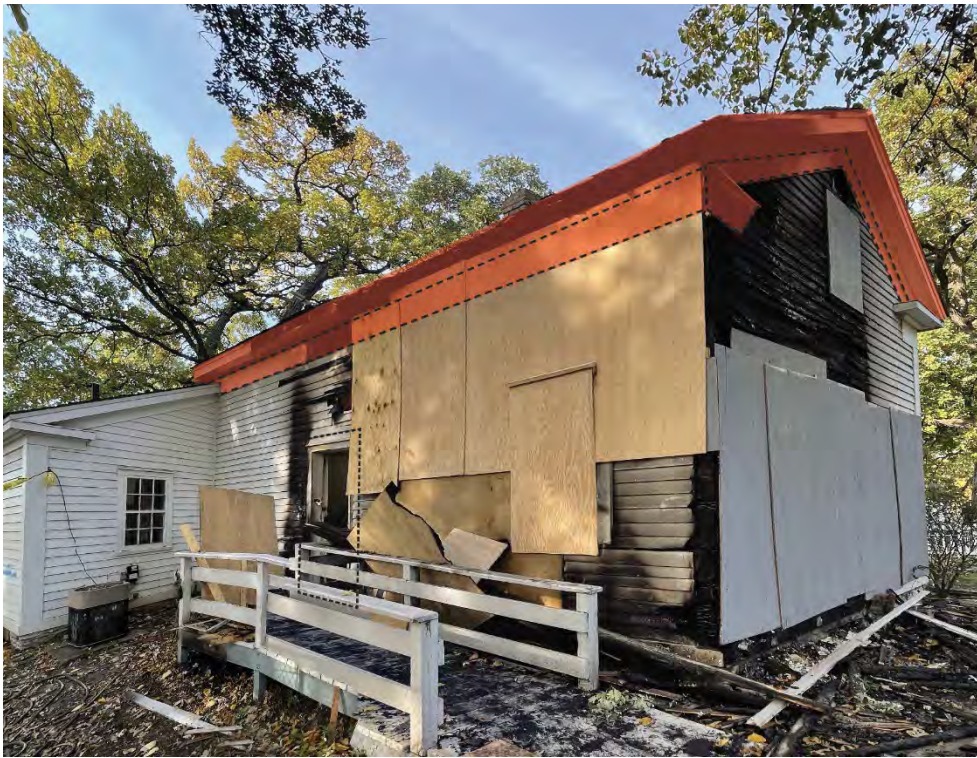
Photo 4 Eastern and northern facades.

- Affix tarp over entire roof, see structural recommendations on S6.
- The tarp should extend beyond the edge of the roof and wrap down face of the eave. The tarp should extend down the soffit to be affixed to the fascia (now plywood). See diagrams below, red indicates the tarp and dashed line indicates areas for attachment.

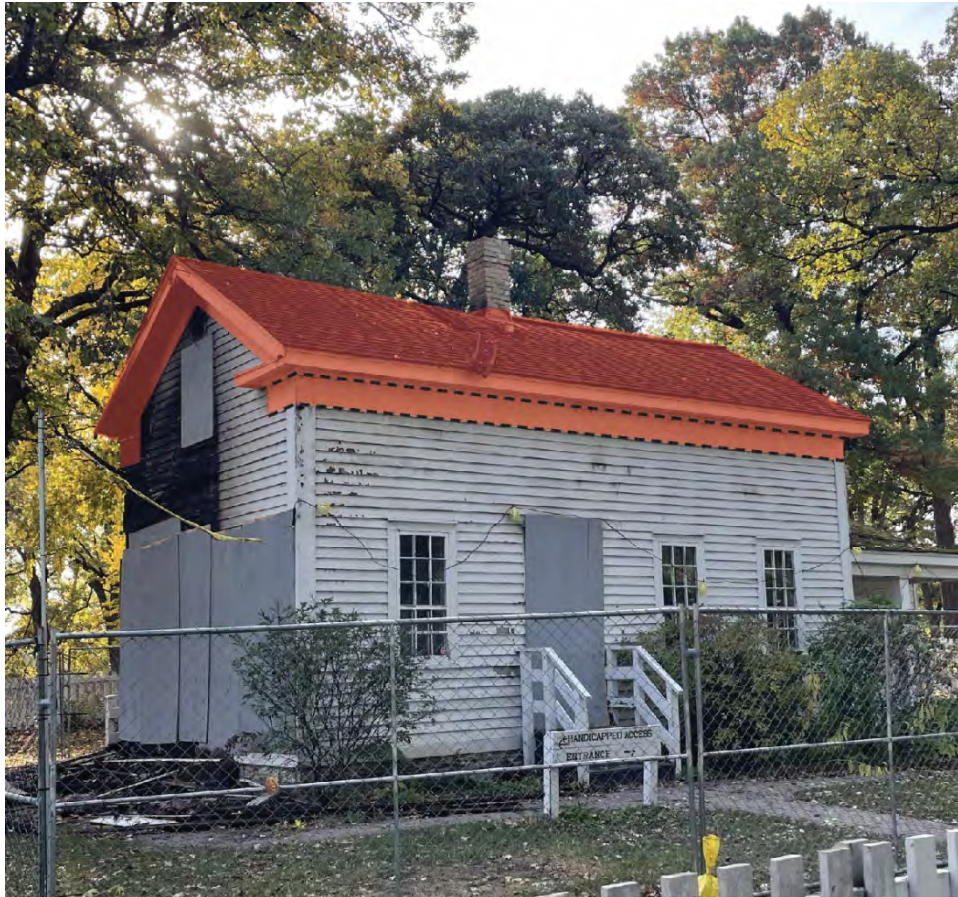
Photo 5 Northern and western facades.

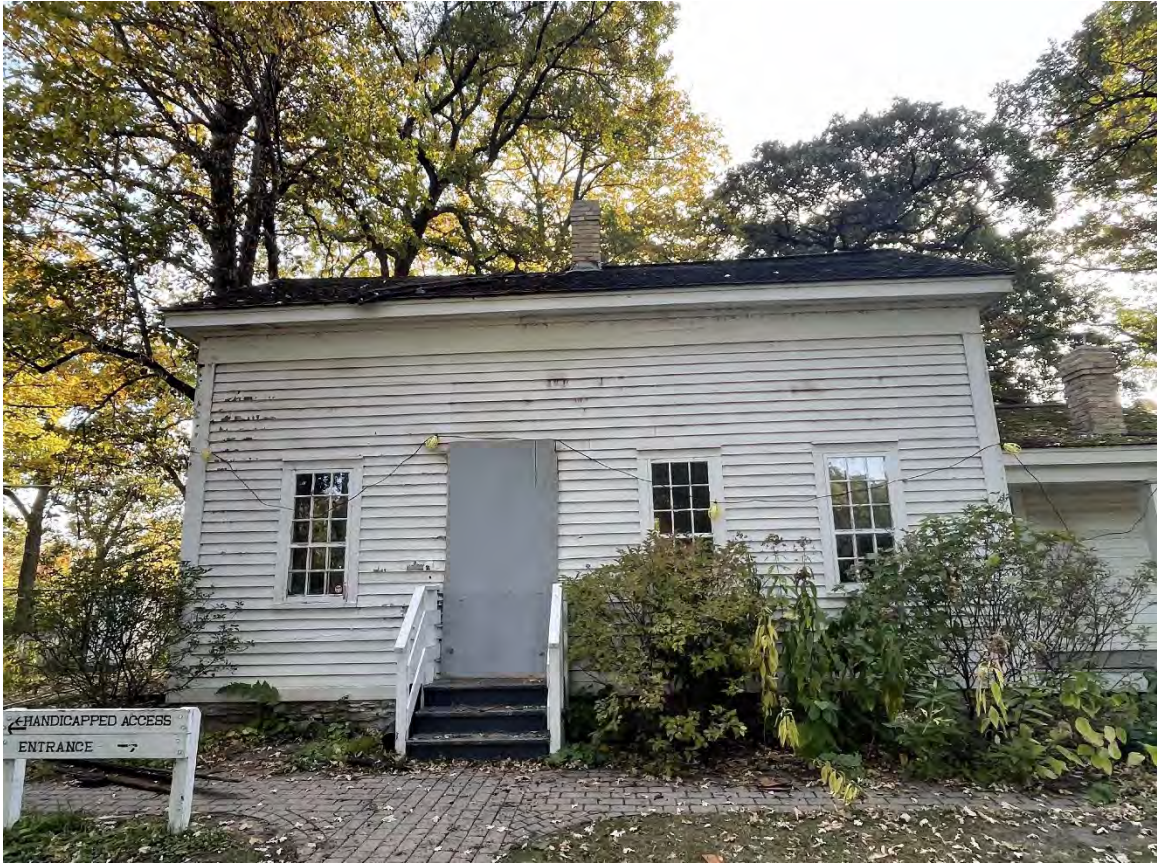
Photo 6 West facade.

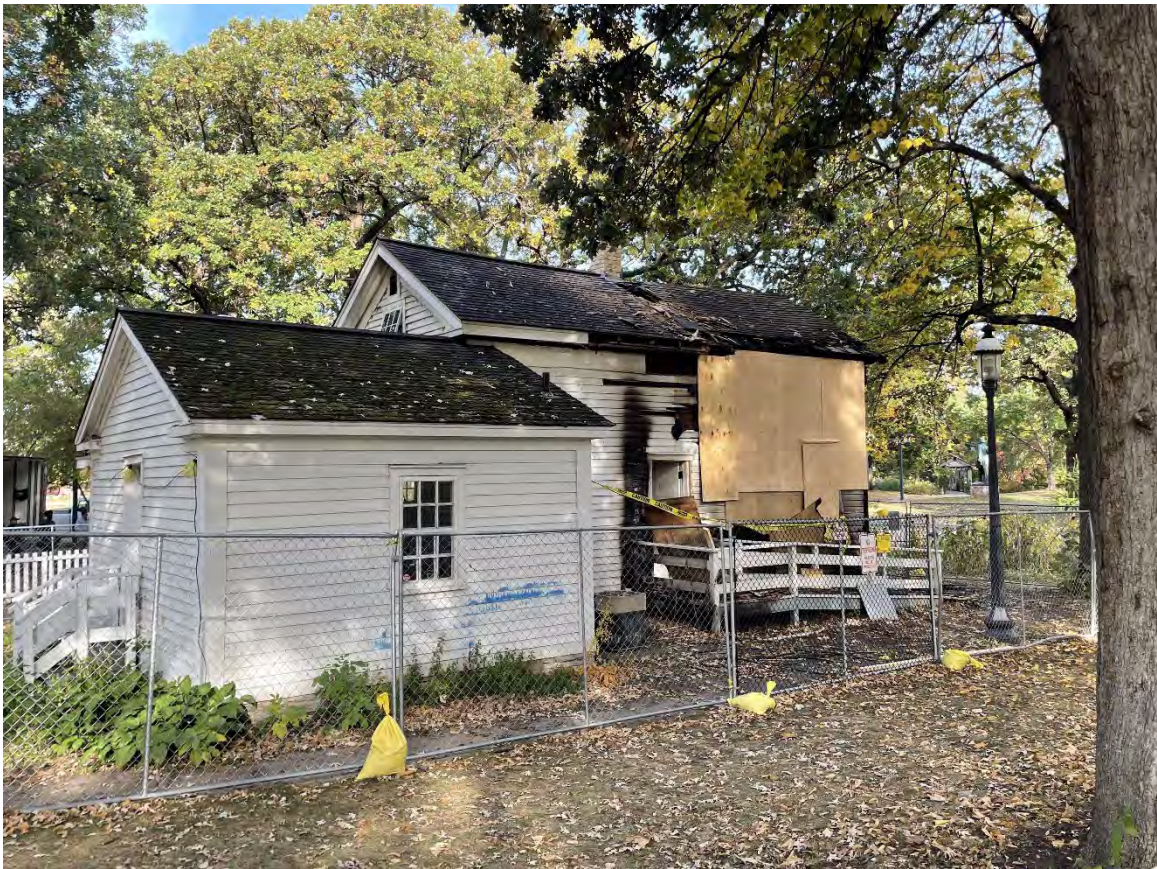
Photo 9 East facade.

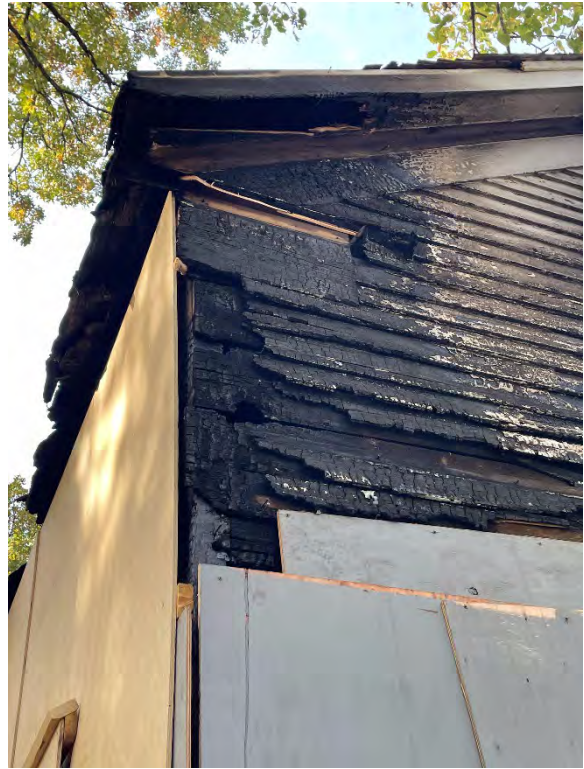
Photo 15 Closeup of damage on NE corner.

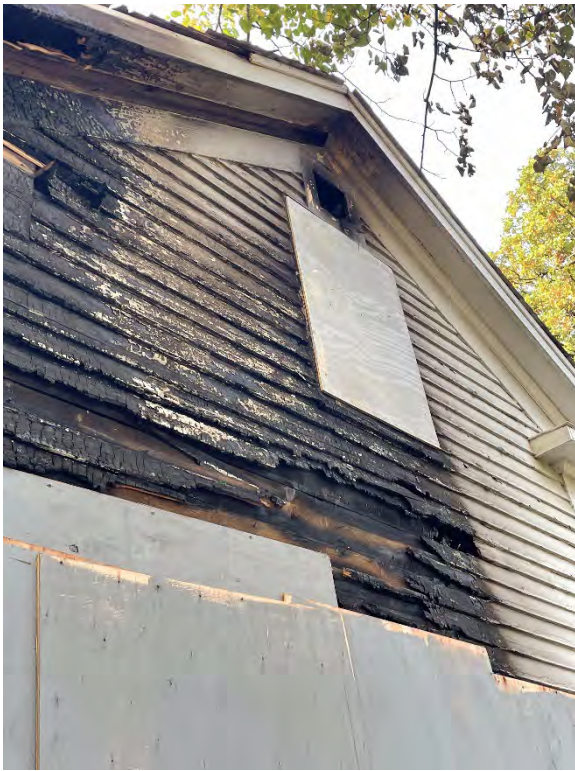
Photo 16 North 2nd floor window.

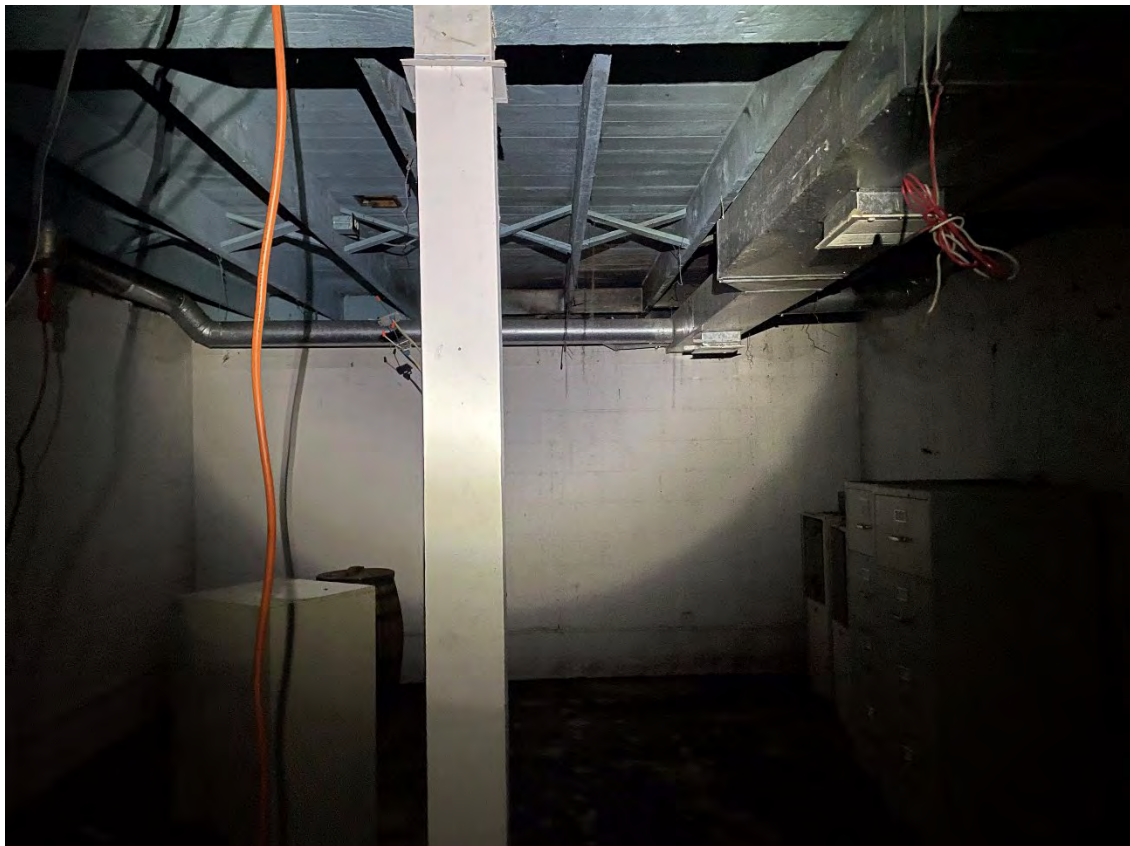
Photo 18 North elevation of basement meeting room.

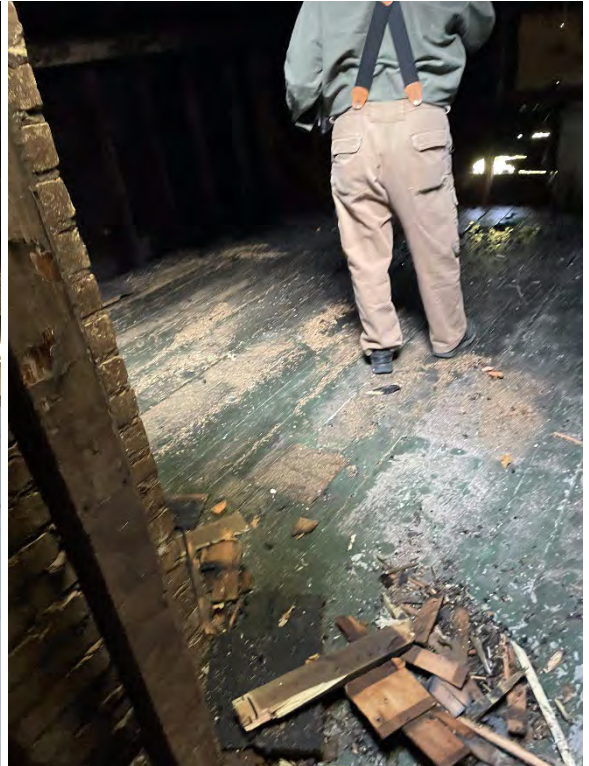
Photo 34 North chamber floor condition.

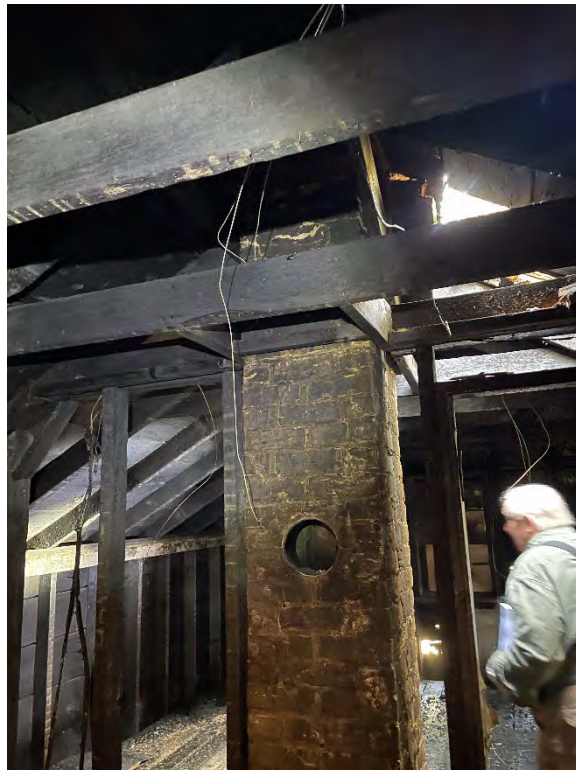
Photo 35 South chamber chimney condition.

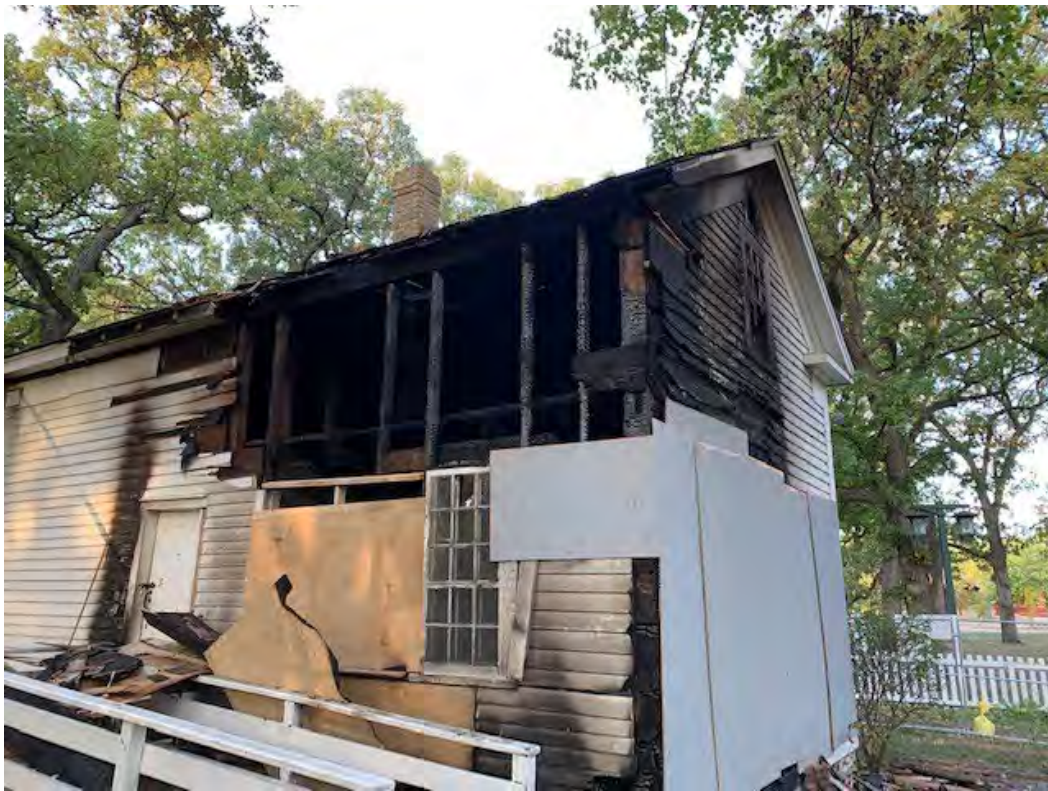
Photo 36 After third fire before plywood installation.

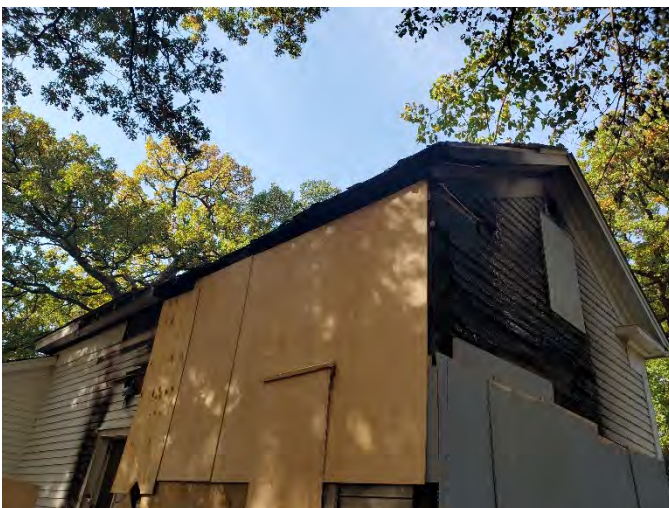
View from the northeast corner after the third fire. This fire has damaged a considerable portion of the north half of the two-story section.

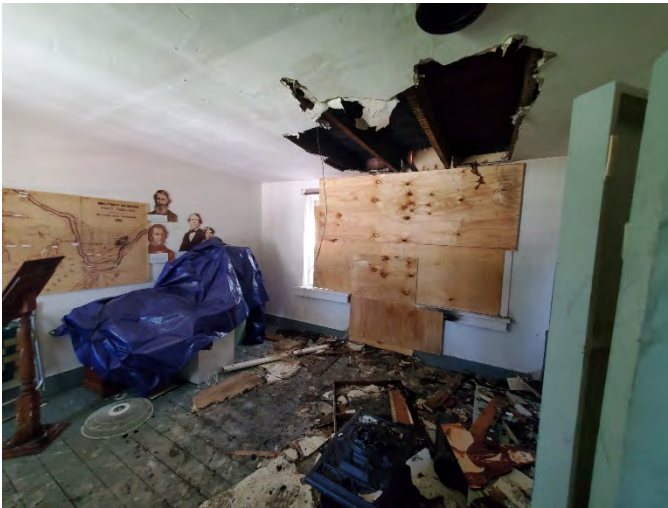
View at the first floor within the two-story section after the second fire. Damage was limited to several of the east wall studs and approximately three second floor joists.

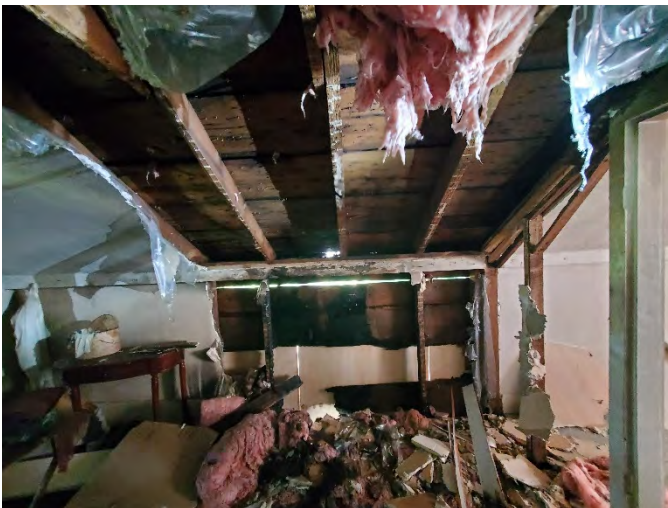
View of the second floor and roof framing within the two-story section after the second fire. Fire damage affected only the roof eave and east wall studs. The roof framing was relatively unharmed.

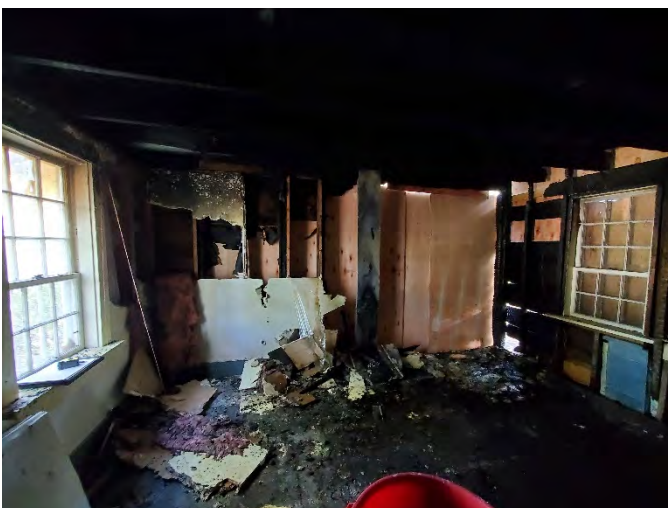
View at the first floor within the two-story section after the third fire. The east and north wall were severely damaged and most of the second-floor framing was affected.

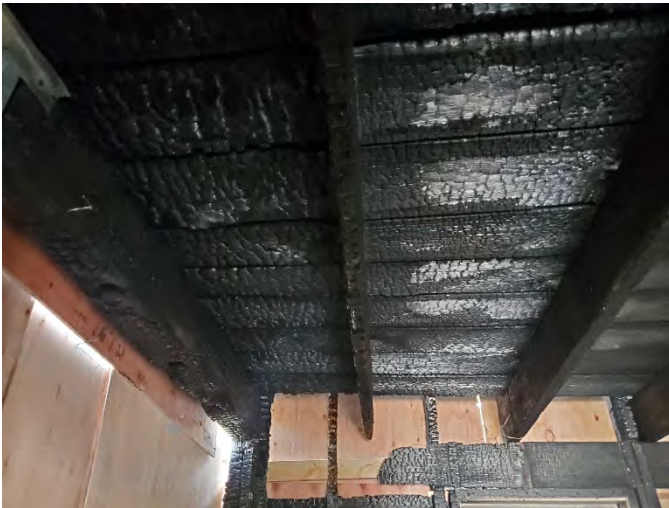
View within the first floor near the northeast corner illustrating the damage to the wall and second floor framing.

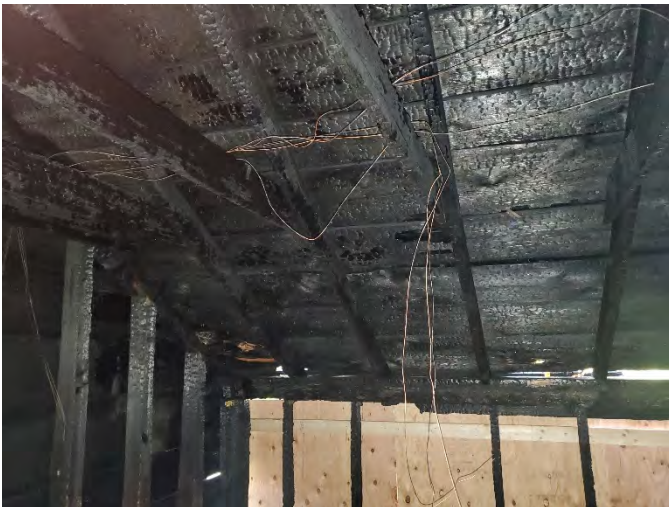
View within the second floor near the northeast corner illustrating the damage to the wall and roof framing. Nearly all of the roof framing and roof sheathing was affected. The wall studs at the east and north walls were also severely damaged.

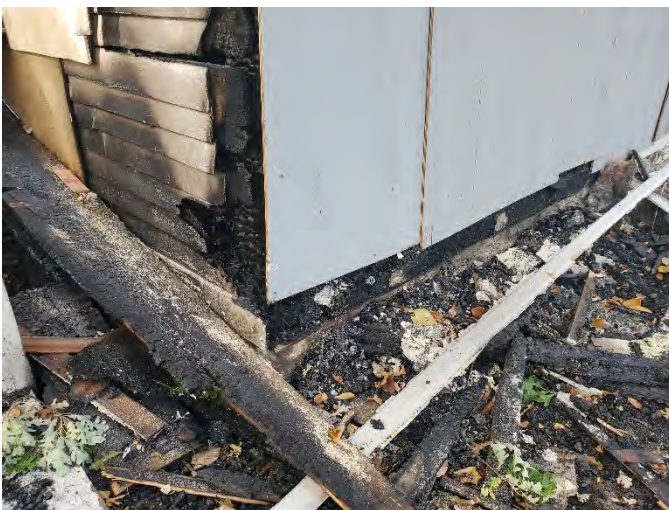
The fire has damaged the timber sill at the base of the walls but the first-floor framing, basement and foundations have been relatively unaffected.

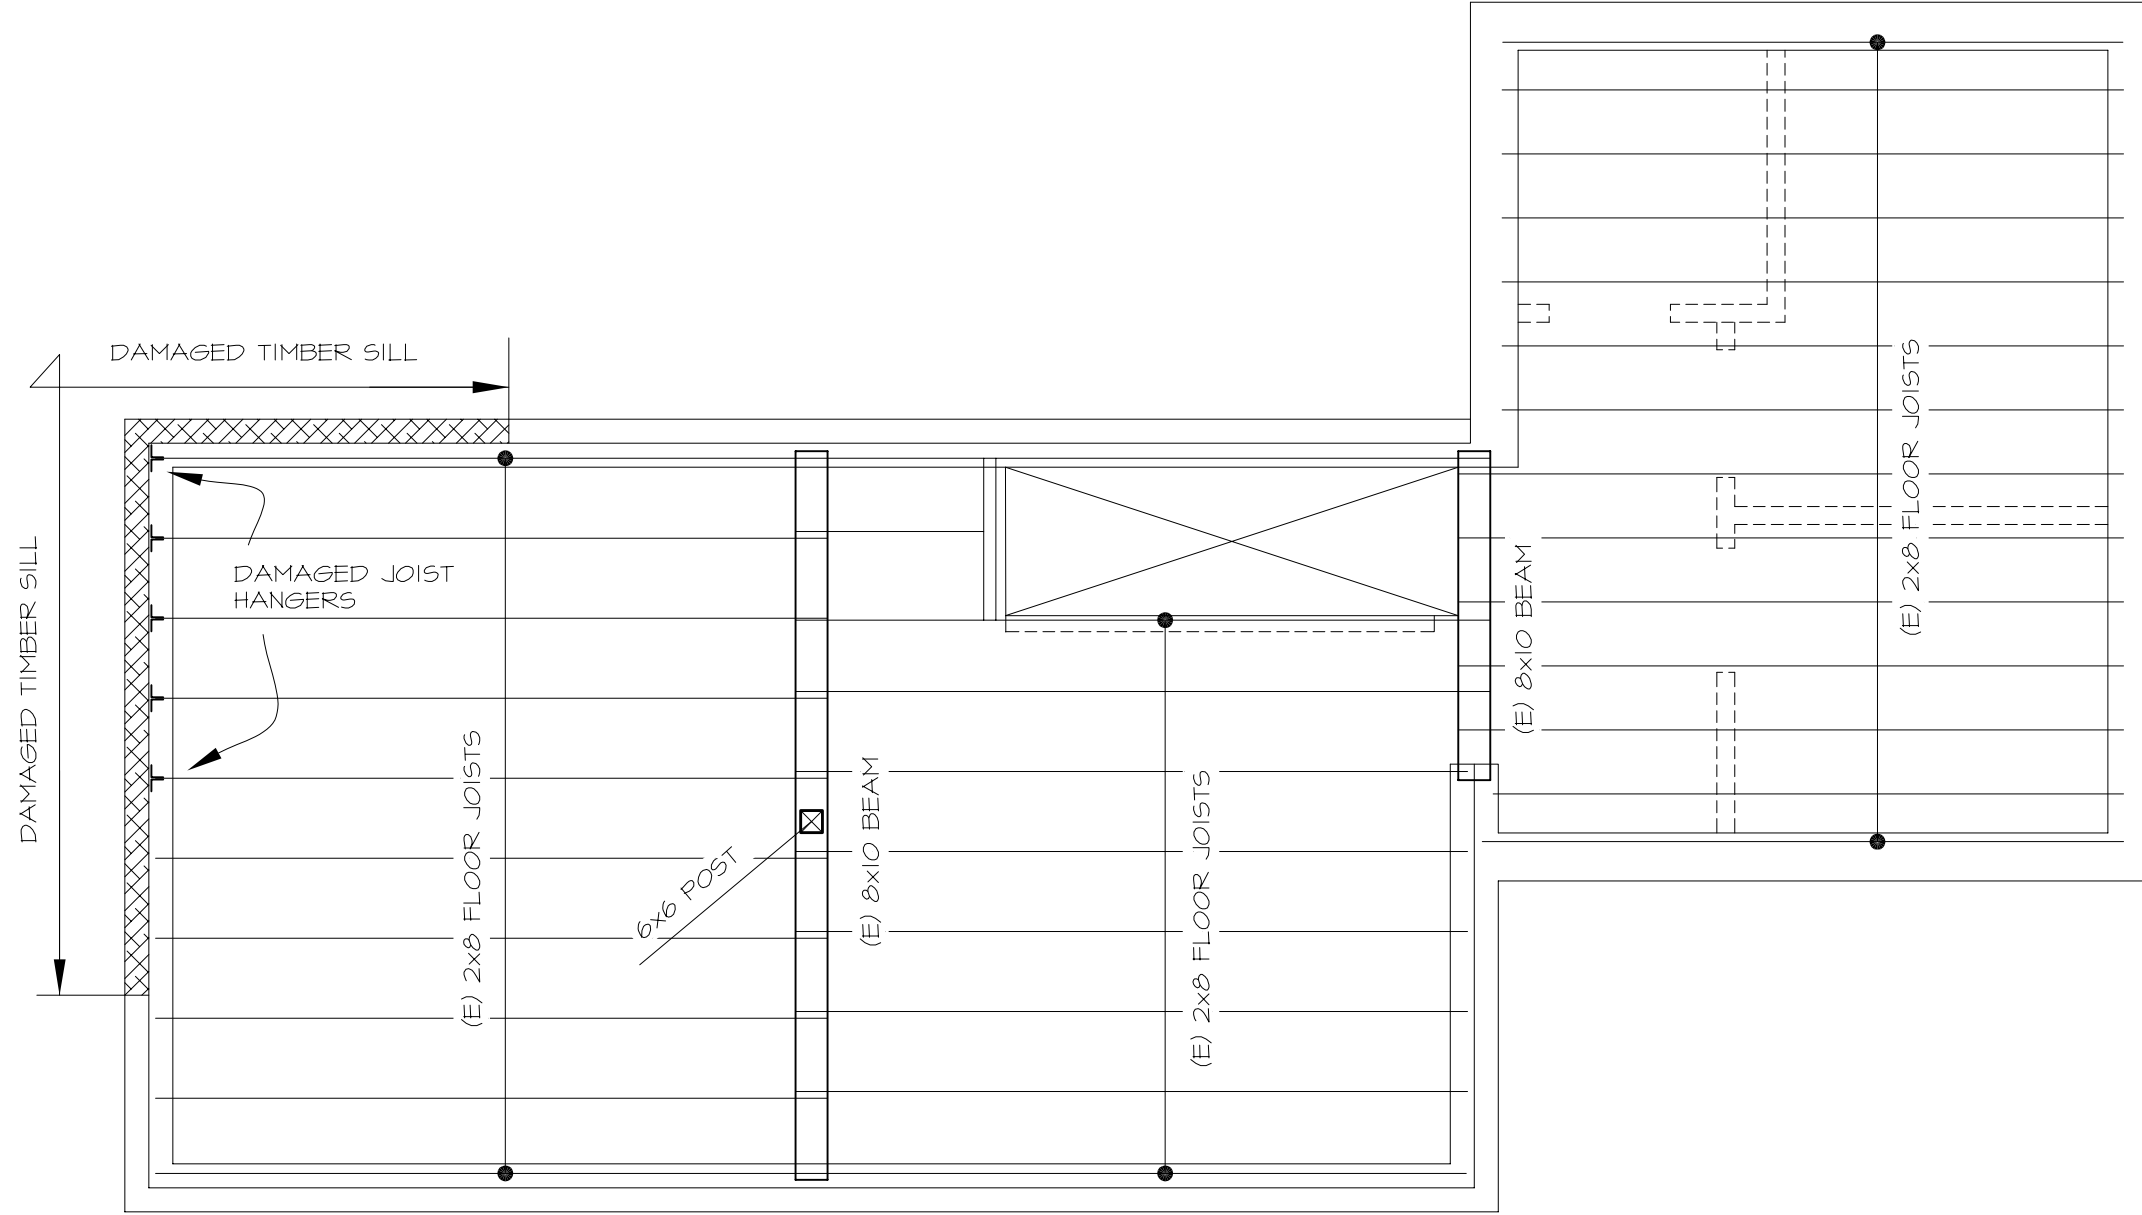
1st FLOOR FRAMING CONDITION AND OBSERVED DAMAGE

- The timber sill at the base of the east and north walls is damaged and will need to be replaced.
- The floor joists are unaffected, but it is likely that the joist hangers for several joists, connecting to the north wall timber sill have been compromised. Re-attachment of the joists to the sill or direct bearing on the foundation wall will need to be established.
- Drawing ES-1 illustrates the first-floor framing condition.

- FIRE DAMAGED TIMBER SILL AT NORTH AND EAST WALL.
- COMPROMISED JOIST HANGERS AT NORTH WALL.

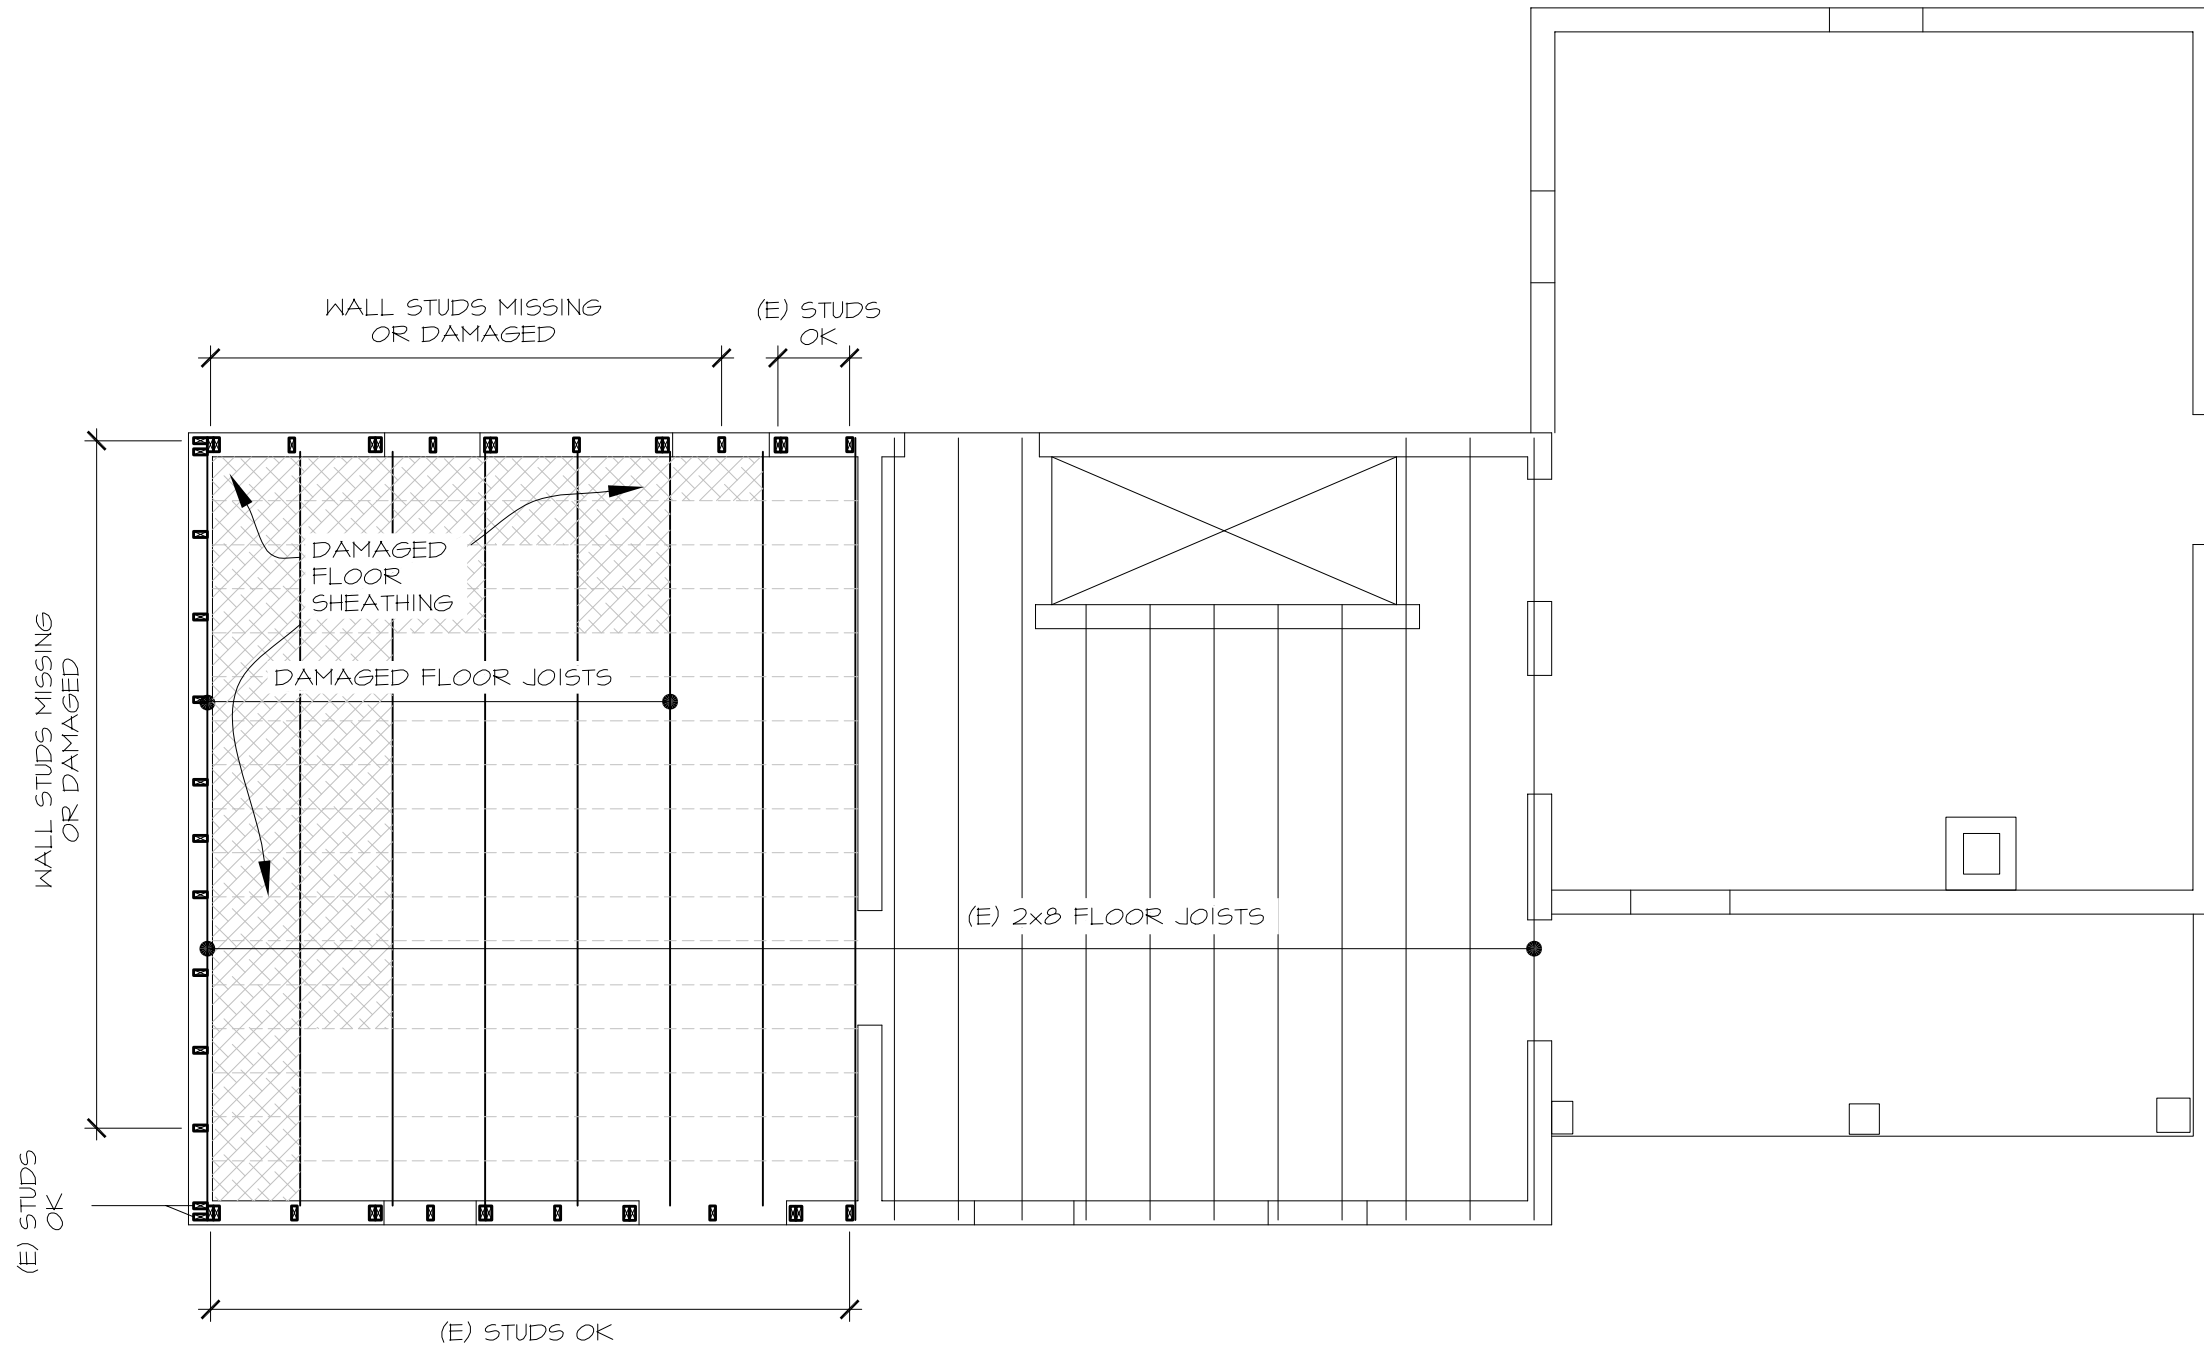
### 2nd FLOOR FRAMING CONDITION AND OBSERVED DAMAGE

- Six 2x8 floor joists are damaged and will need to be replaced or reinforced.
- Numerous wall studs at the east and north wall are damaged or completely missing. These will need to be replaced or reinforced.
- Approximately 30% of the floor sheathing is damaged. This sheathing will need to be replaced.
- Drawing ES-2 illustrates the second-floor framing condition.

- FIRE DAMAGED WALLS STUDS AT NORTH AND EAST WALL.
- FIRE DAMAGED FLOOR JOISTS.
- FIRE DAMAGED FLOOR SHEATHING

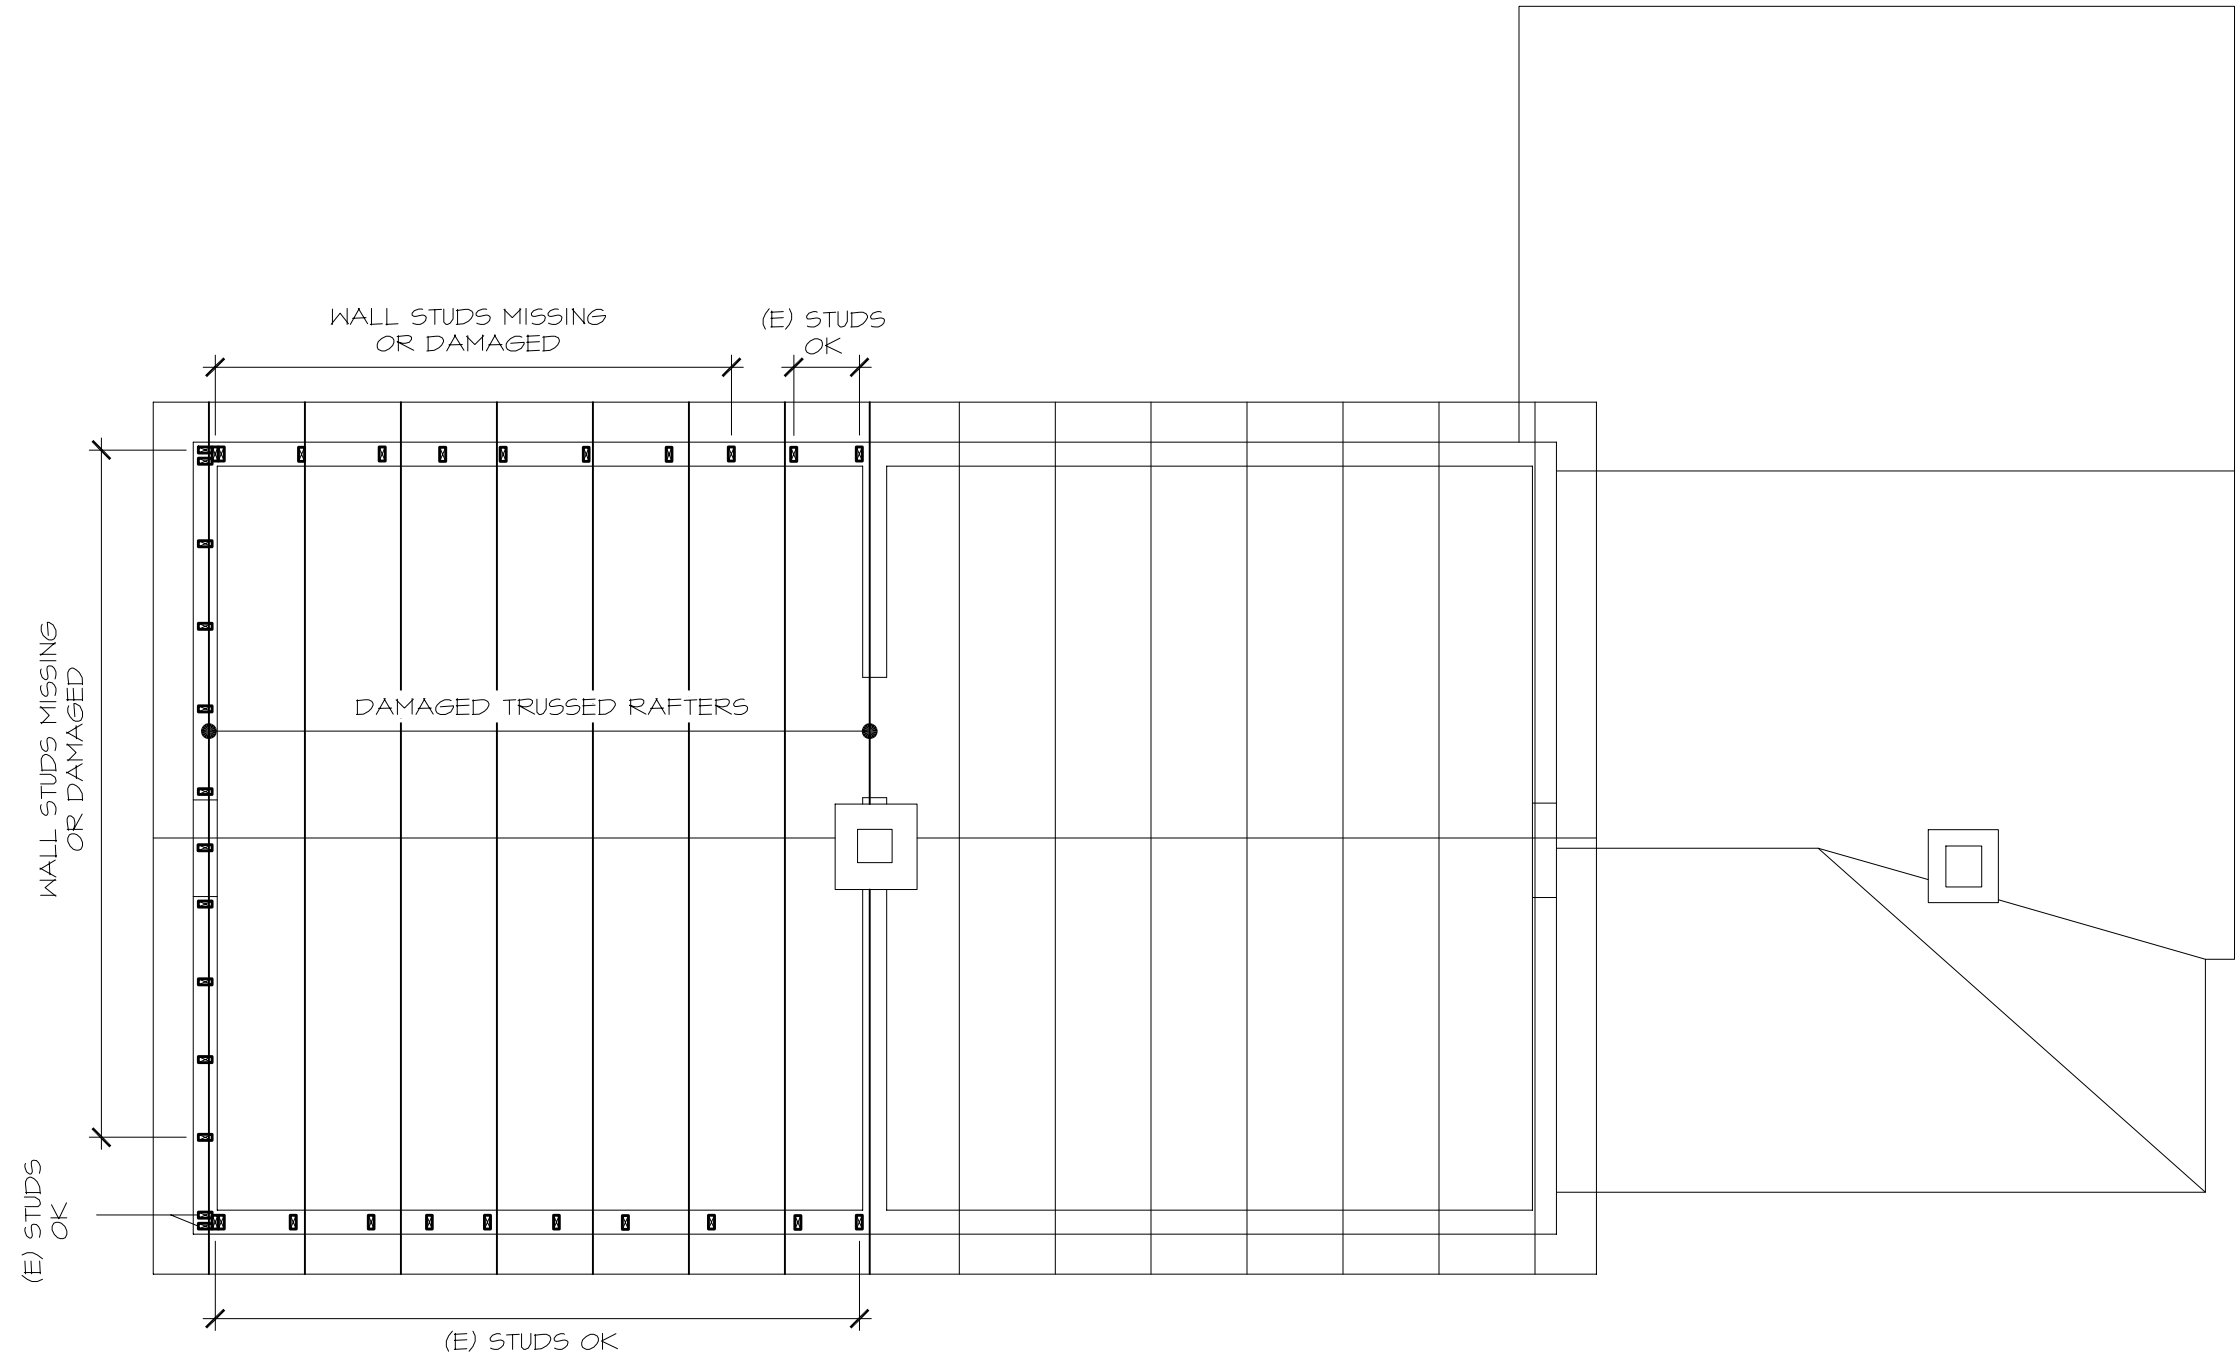
**ROOF FRAMING CONDITION AND OBSERVED DAMAGE**

- Nearly all of the trussed rafters at the north half of the two-story building section are damaged. These will need to be replaced or reinforced.
- Numerous wall studs at the east and north wall are damaged or completely missing. These will need to be replaced or reinforced.
- Drawing ES-3 illustrates the roof framing condition.

- DAMAGE OBSERVED:
- FIRE DAMAGED WALLS STUDS AT NORTH AND EAST WALL.
  - FIRE DAMAGED TRUSSED RAFTERS
  - REFER TO ES-4 FOR ROOF SHEATHING
