## Memorandum

Project John H. Stevens House

Regarding Fire Damage Condition Assessment

Re: Condition Assessment and Stabilization Recommendations  
John H. Stevens House, Minnehaha Park  
4901 Minnehaha Avenue So, Minneapolis, MN

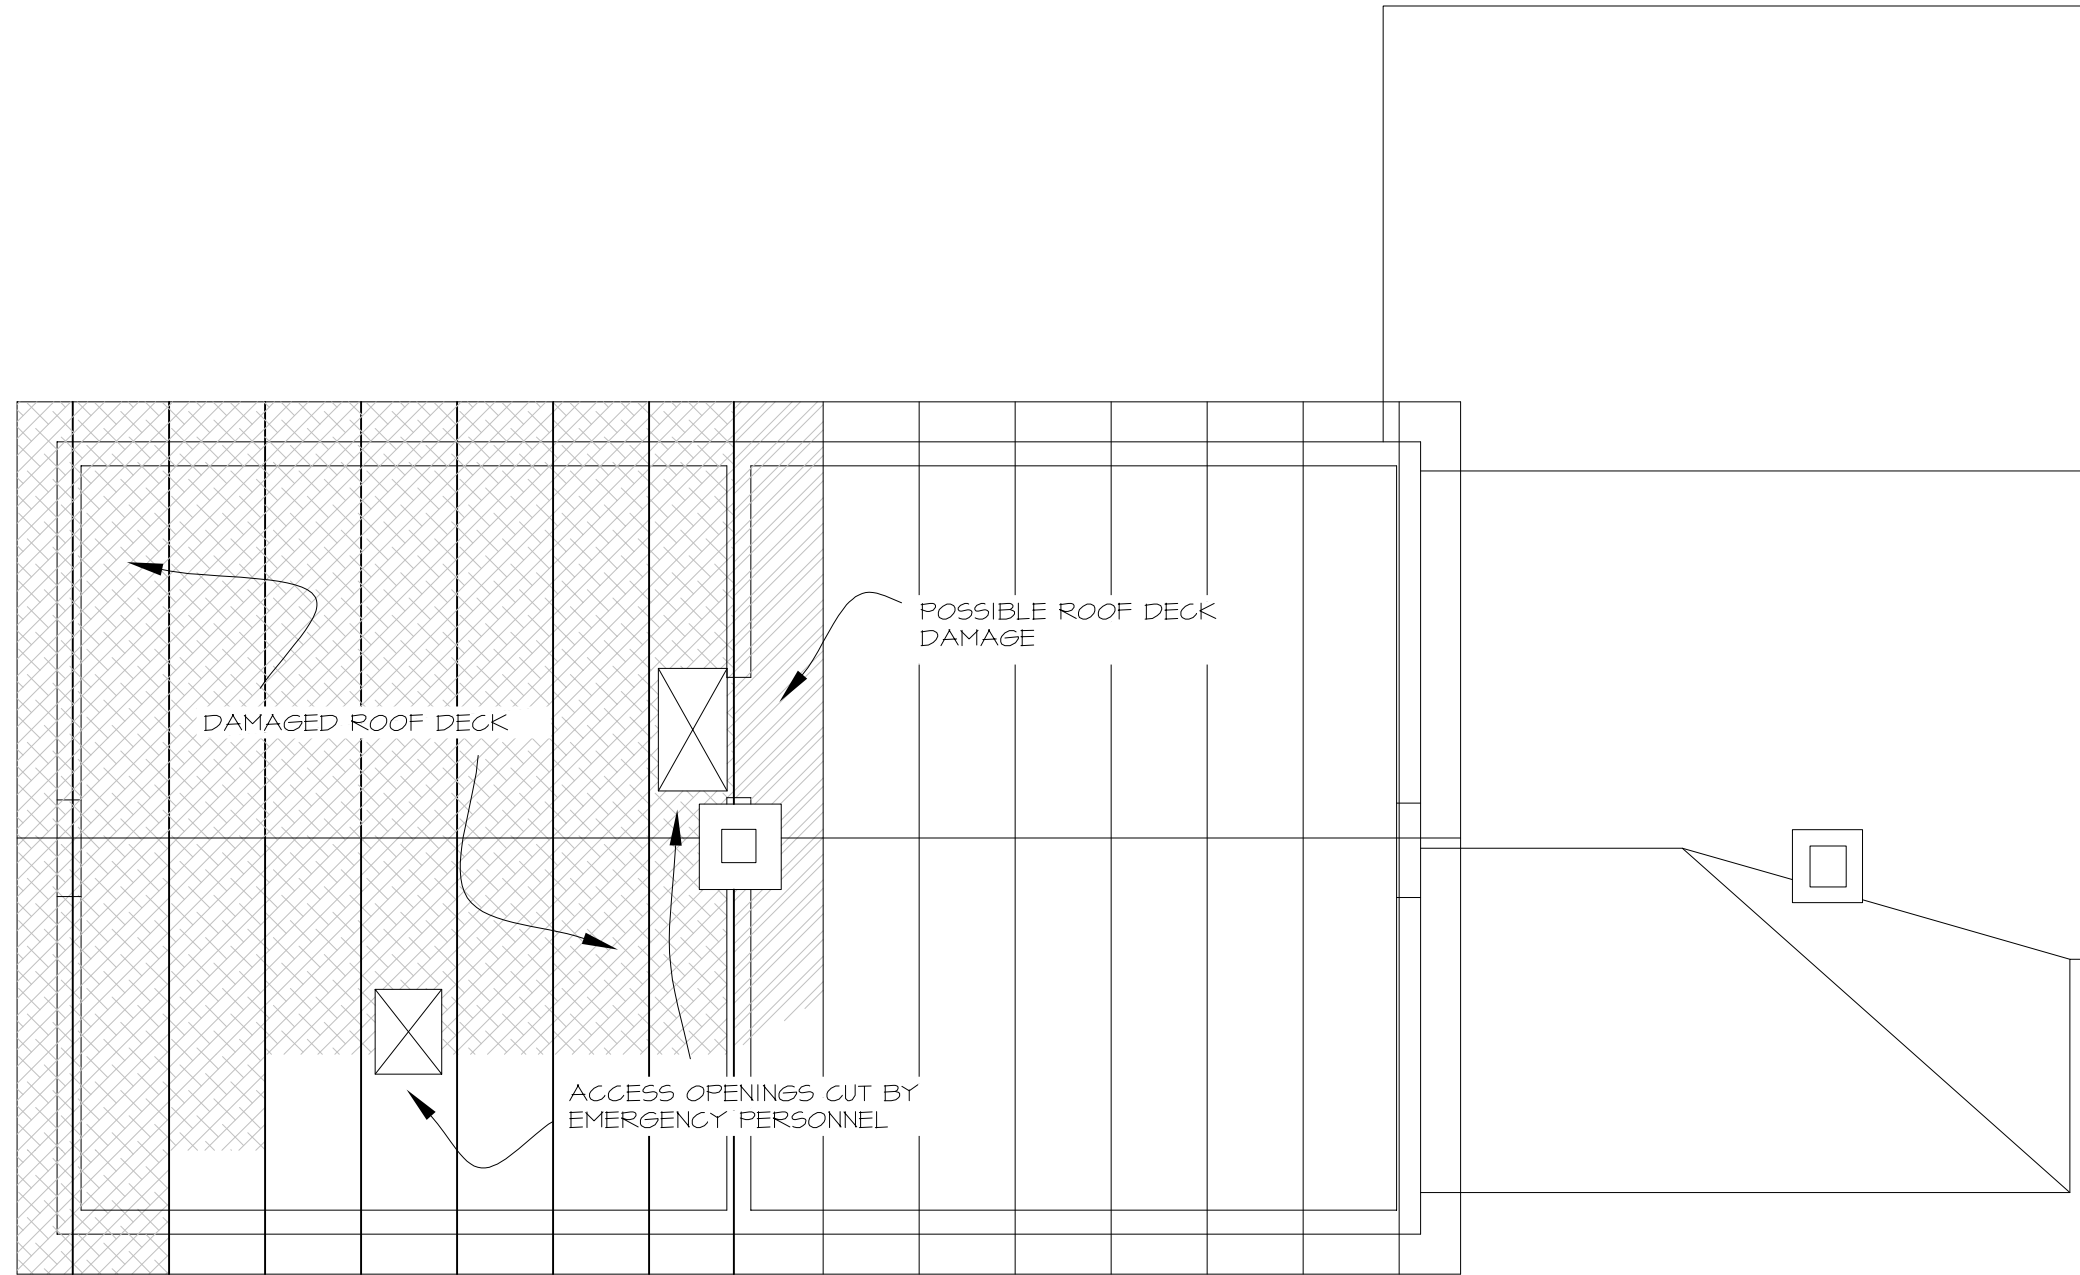
1
ES-4
**ROOF DECK CONDITION AND OBSERVED DAMAGE**
1/4" = 1'-0"

- Approximately 80% of the roof deck sheathing is damaged.
- Emergency personnel have cut two rough openings through the roof.
- All of the roof sheathing at the north half of the building and a small section in the south half will need to be replaced.
- Drawing ES-4 illustrates the roof deck condition.

- FIRE DAMAGED ROOF SHEATHING.
- OPENINGS CUT IN ROOF.
- REFER TO ES-3 FOR ROOF FRAMING.
