# BDE MAKA SKA REFECTORY REBUILD

## EXISTING CONDITIONS ASSESSMENT

JANUARY 2021

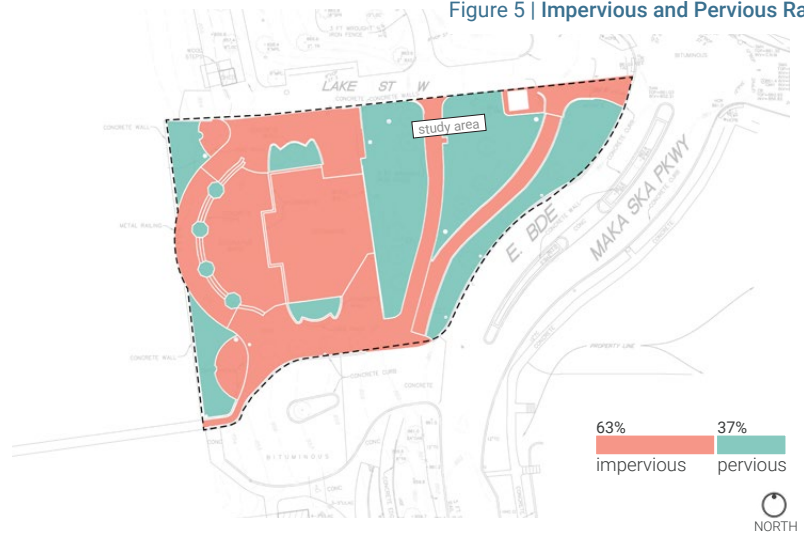
Figure 5 | Impervious and Pervious Ratio

The 24965 sq ft site is composed of 37% pervious and 63% impervious surfacing. This is above the DNR *recommendation* of 25% impervious cover for sites adjacent to lakes and streams and the maximum Impervious Surface Coverage threshold of 45% for sites located within the Shoreland Overlay District (SH) *required* by the City of Minneapolis.

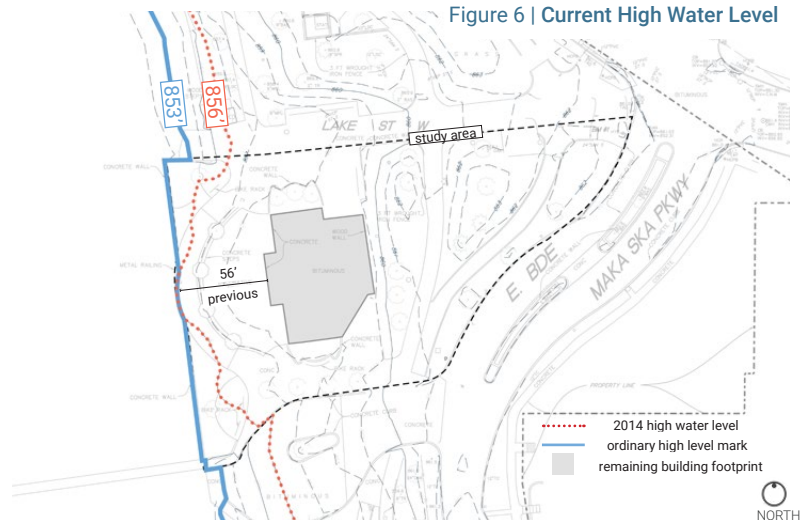
Figure 6 | Current High Water Level

Per the MN DNR, the ordinary high water level of Bde Maka Ska stands at 853'. However, the Minneapolis Chain of Lakes Regional Park - reflecting larger regional patterns - has recorded a pattern of increased high water levels over the last decade. The MN DNR recorded a peak high water level of 855.8' during the 2014 season. According to the Metropolitan Council's Potential Localized Flood Risk data set (2018), the flooding levels could reach 858' on the site (Figure 4). To support the resiliency of the site in coming years, the potential high water levels should be reviewed and planned for in the site design.

The development area currently abuts the water edge. The the previous building footprint was set back 60' from water edge and 5' above the ordinary high water level. This is compliant with the required setback for the shoreline over-lay district for the City of Minneapolis.

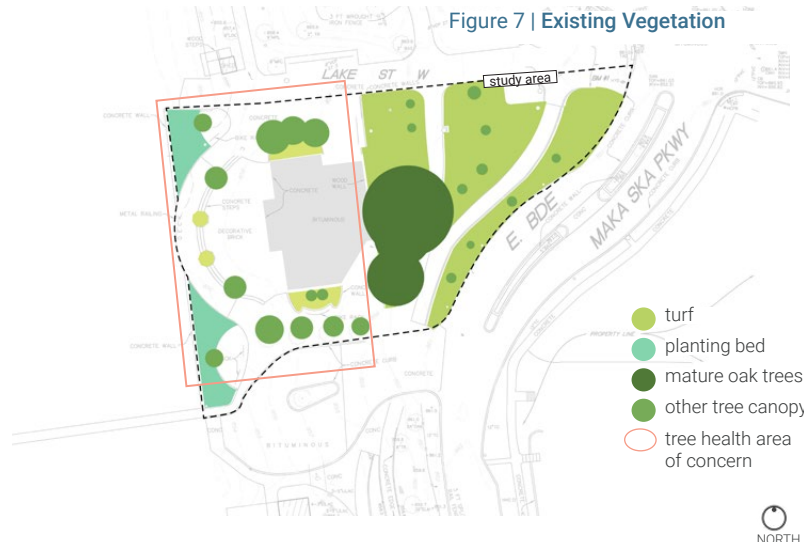
Figure 7 | Existing Vegetation

While the site is currently dominated with impervious surfaces, there is highly valuable vegetation located on the site. Three mature oaks located east of the previous building footprint are estimated to be over 100-years old and provide cooling, character, habitat, and other ecological values to the site. The trees located on western half of the site including the crab apple trees adjacent to the previous building footprint, the maple trees on the southern edge of the site, and the ash trees located in planters along the shoreline show signs of stress attributed to an insufficient growing area. Other trees on site include Ash, Maple, and Basswood. Many are immature and < 4" caliper, having been planted in 2018 during the construction for the trail realignment.

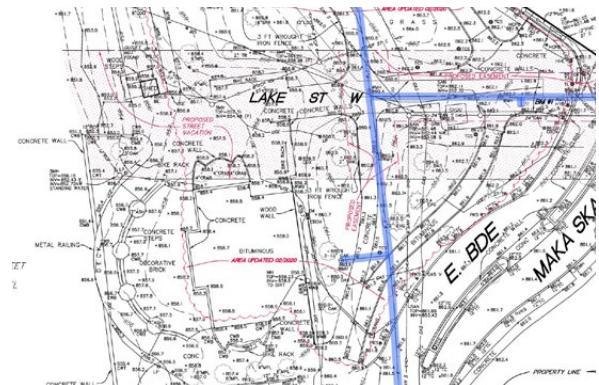
Figure 8 | Watermain Location

There is a 6" city watermain located to the east of the proposed site. To the north this waterline connects to a 12" city watermain that connects to West Lake Street. There is a drinking water fountain located at the southeast intersection of the walking path and the promenade. An existing water service to the old refractory extends from the 6" main to the west. The existing water service was not installed below the frost depth, was not intended for winter use and was shut down after the fall season.

A new domestic and fire water service will be required for the refractory building and will be buried with 7.5-8 feet of cover which will allow for year round use.

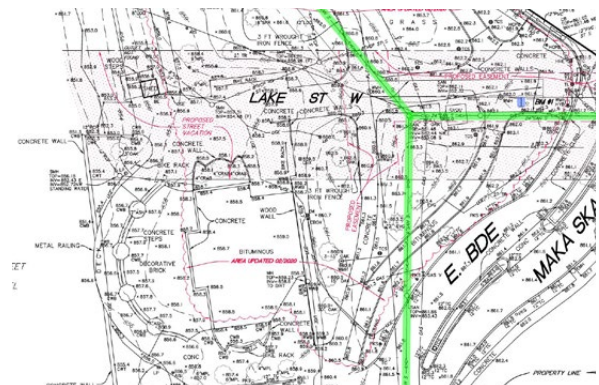
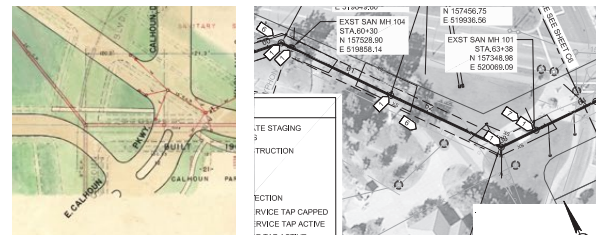
Figure 9 | Sanitary Sewer Location

There is 9" city sanitary sewer located on the east side of the site. There is a manhole located in the green space on the southeast corner of the pedestrian path and promenade. There is a second manhole located in the green space behind the roadway curb located to the east of the site. The existing sewer is approximately 8-10 feet deep. The 9" sewer connects to a Met Council 24" VCP sewer line that serves sewer from the northwest and flows to the east to sewer main located in West Lake Street.

A new service will be required for the Refectory building. This service line will be buried with 6' of cover and connect to the existing manhole to the east of the site.

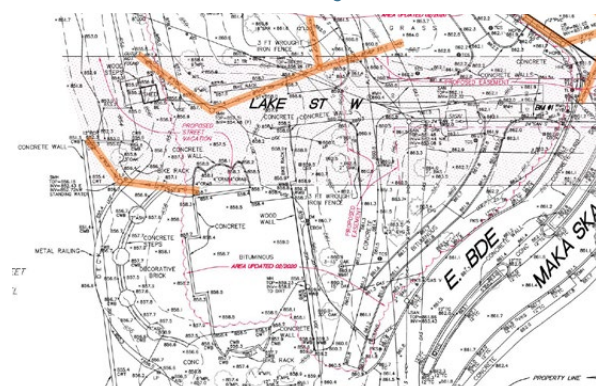
Figure 10 | Storm Sewer Location

There's a 12" RCP storm sewer located at the northeast corner of the site. A manhole is located in the landscape area off the deck connection that is approximately 4' deep. The survey lists this manhole as holding water. This 12" pipe discharges to Bde Maka Ska at the access point.

There's an 8" VCP city storm sewer located on the north side of the site near the shed. A manhole is located in the paved access area that is approximately 3' deep. This pipe discharges to Bde Maka Ska at the access point.

There is an 18" RCP city storm sewer located in West Lake Street. There are curb inlet catchbasins within the intersections of Bde Maka Ska Parkway, Knox Avenue and West Lake Street. These sewers flow to the east to an 18" pipe which connects to a 30" storm sewer located in Knox Avenue S.

New storm sewer services from the Refectory will be required for the roof drainage. This storm sewer will discharge to a stormwater treatment system on the site which will discharge to the lake.

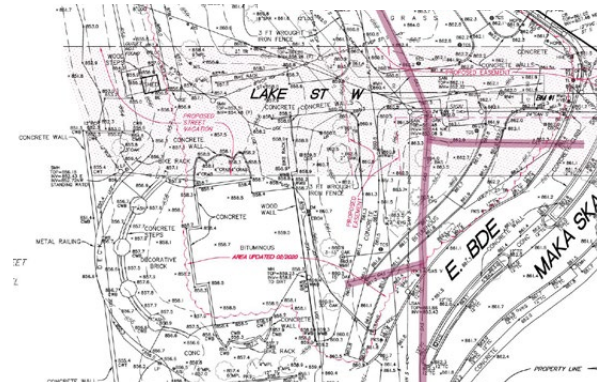
Figure 11 | Gas Line Location

There is a 12" steel Class 2 Centerpoint Energy gas line located on the east side of the site that runs from the north to West Lake Street. There's a connection to this 12" line that runs south and there is a service connection on the south side of the site.

A new gas service will be required for the refractory.

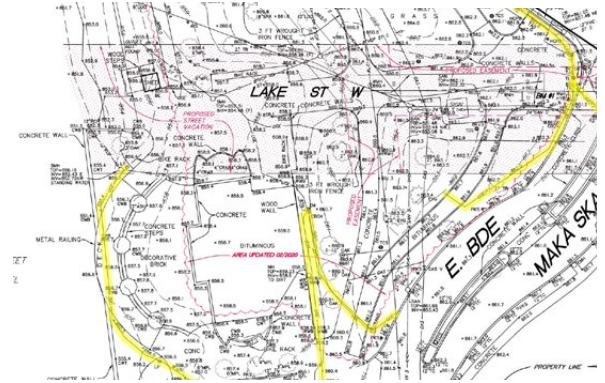
Figure 12 | Electrical Line Location

There are underground electrical lines, conduits, light poles, transformers, electrical boxes and other electrical equipment on the east and west sides of the site. The primary electrical service is located to the east.

A new electrical service will be required for the refractory.
