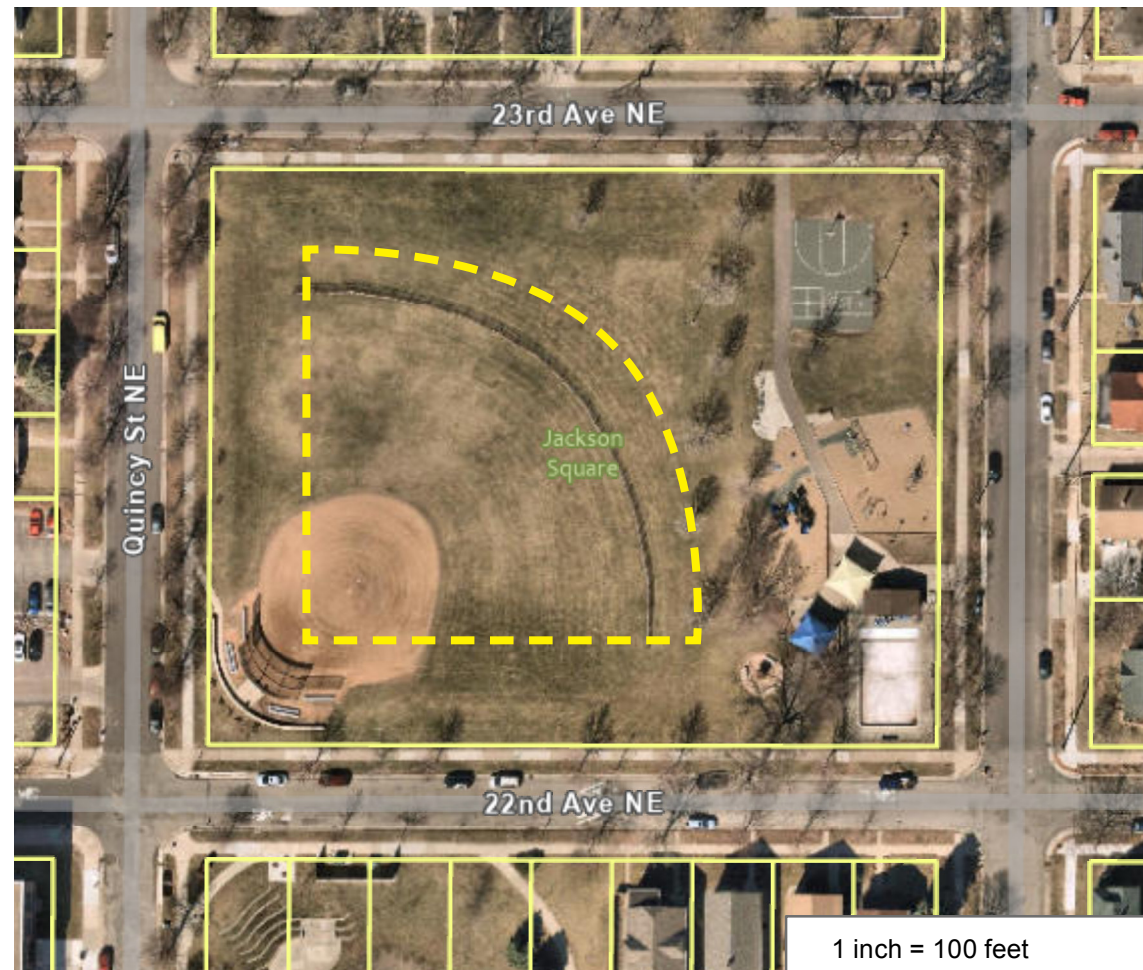
Field layout

Player safety	fencing present at team benches but not at bull pen ground condition is good
Field characteristics	outfield at 200 would require adjustment to 225' no foul poles no field lighting
Play features	full backstop present field set for softball no scoreboard no covered dugouts drinking fountain present no electricity batting cage not present team equipment shed not present
Maintenance features	equipment shed not present irrigated
Spectator features	seating present no concessions

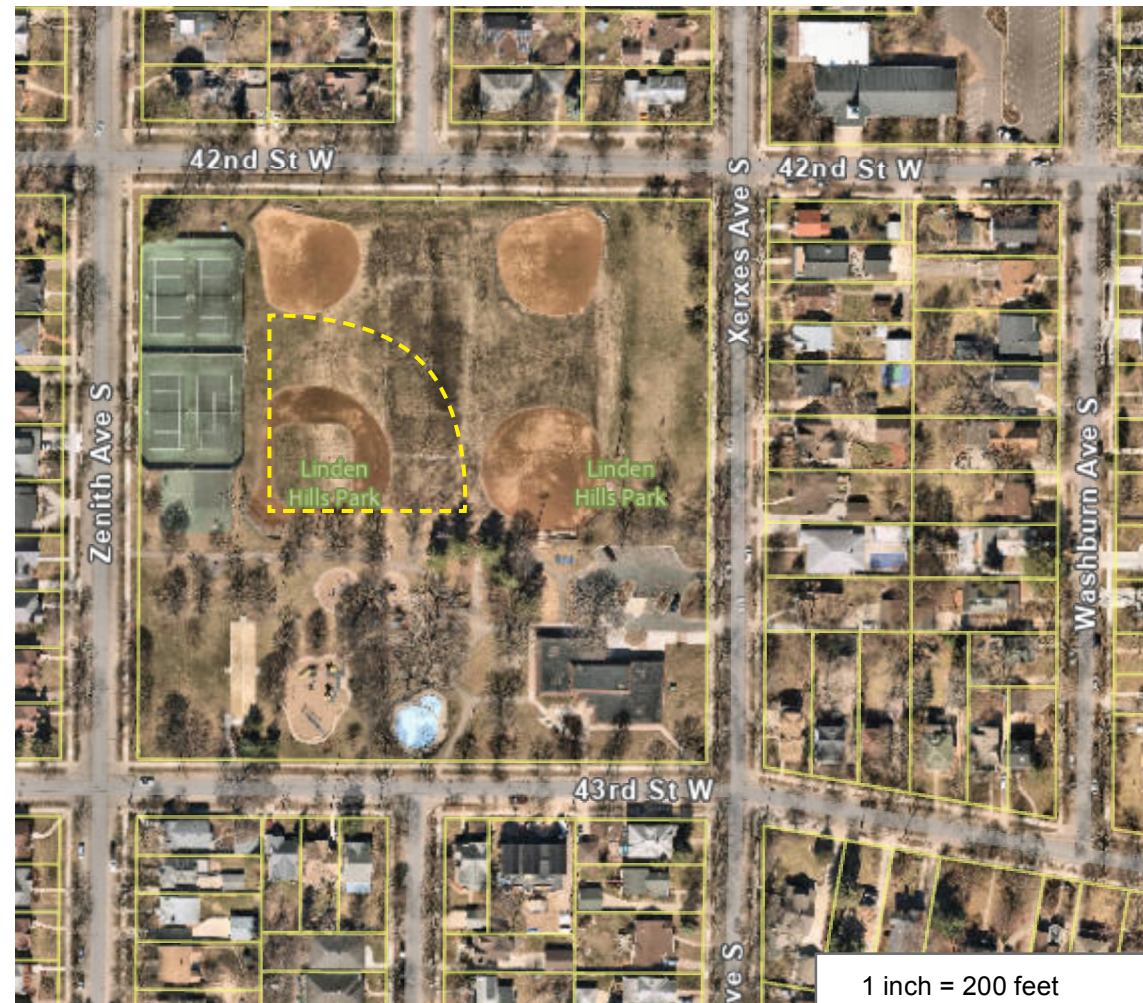
Field layout

Player safety	fencing present at team benches but not at bull pen ground condition is bad
Field characteristics	outfield at 200; would require adjustment to 225' no foul poles field lighting
Play features	full backstop present field set for baseball; would require infield removal no scoreboard no covered dugouts drinking fountain present electricity source present batting cage not present team equipment shed not present
Maintenance features	equipment shed not present no irrigation
Spectator features	no seating no concessions

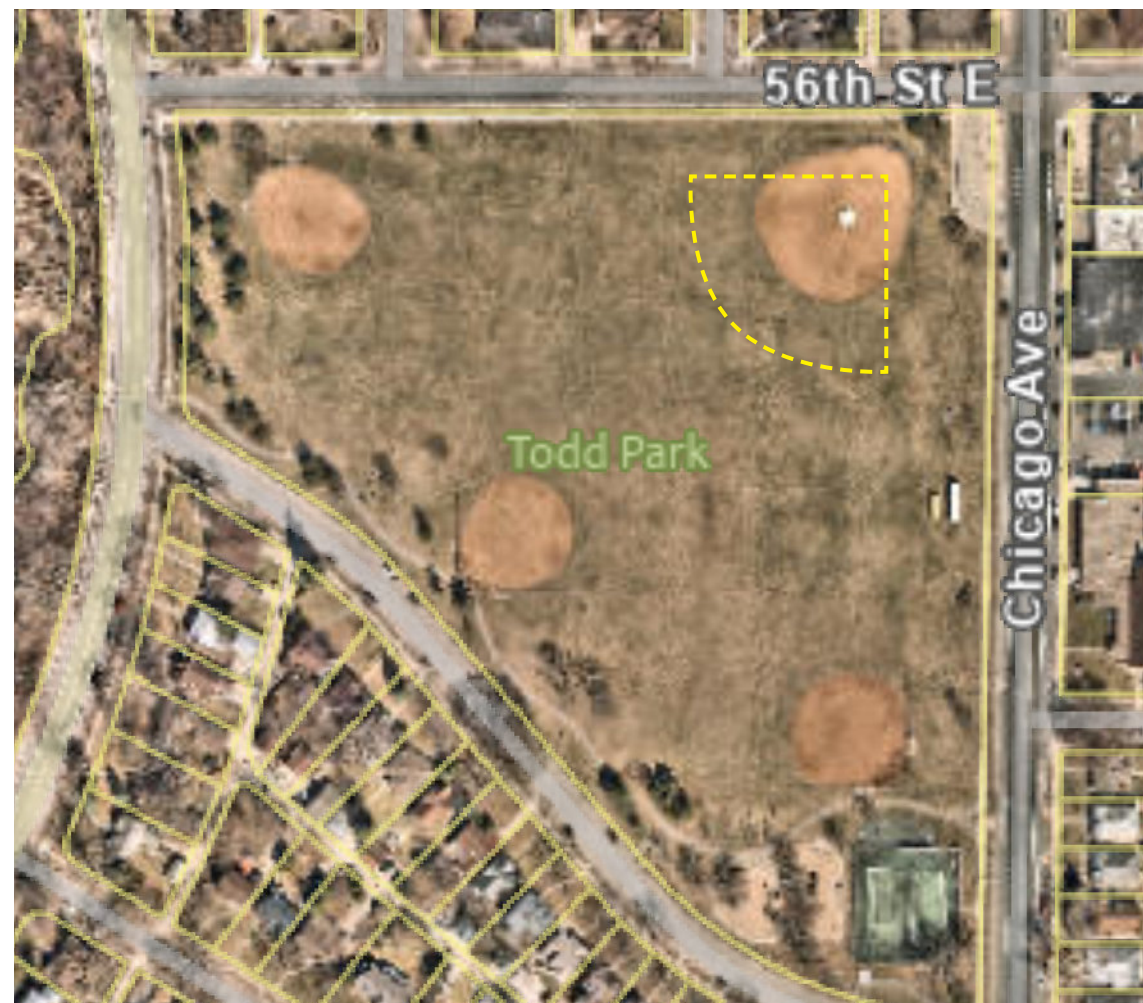
Field layout

Player safety	fencing present at team benches but not at bull pen ground condition is poor
Field characteristics	outfield at 200 would require adjustment to 225' no foul poles no field lighting
Play features	full backstop present field set for softball no scoreboard no covered dugouts no drinking fountain no electricity batting cage not present team equipment shed not present
Maintenance features	equipment shed not present no irrigation
Spectator features	no seating no concessions

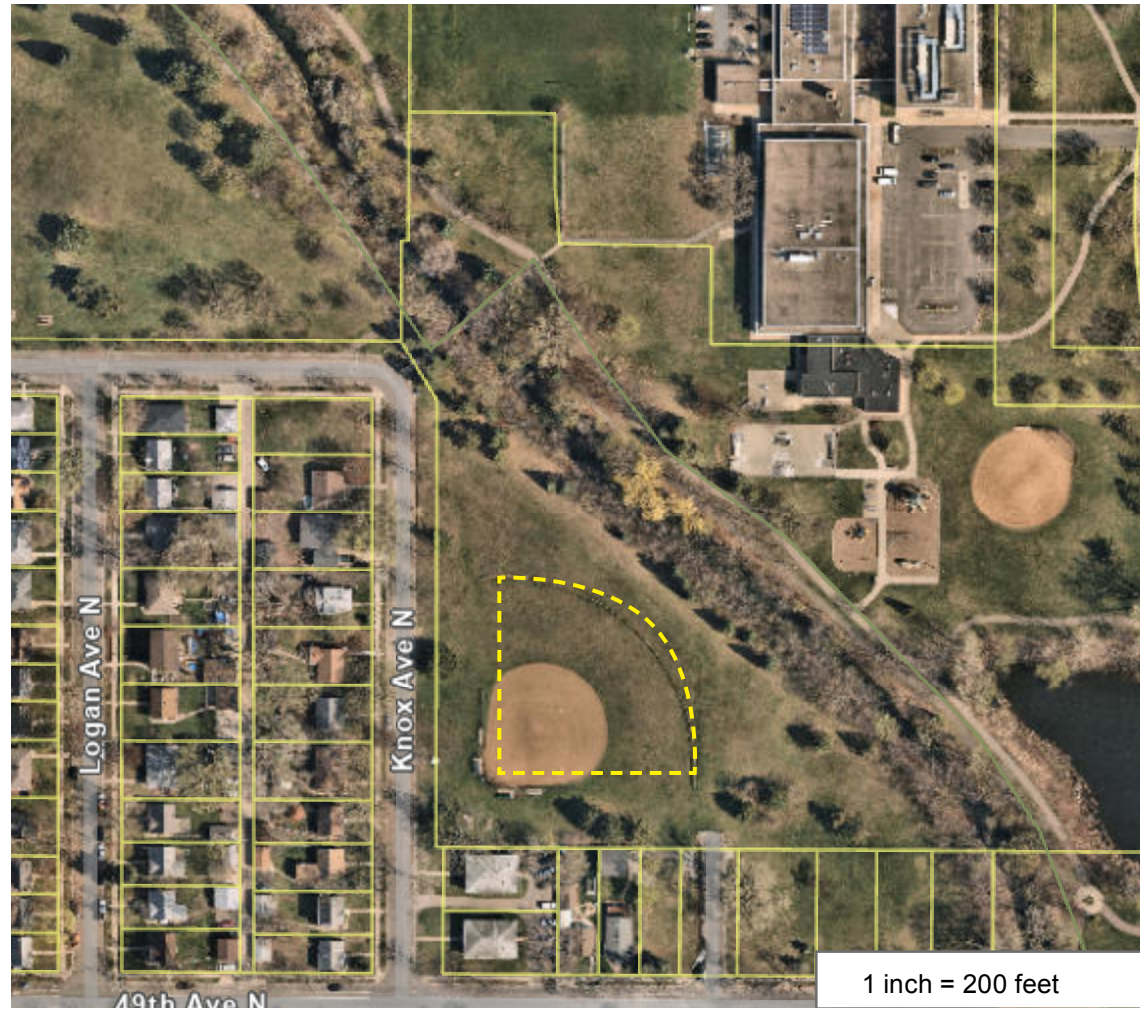
Field layout

Player safety	fencing present at team benches no bull pen ground condition is good
Field characteristics	outfield at 200 would require adjustment to 225' foul poles no field lighting
Play features	full backstop present field set for softball no scoreboard no covered dugouts no drinking fountain no electricity batting cage not present team equipment shed not present
Maintenance features	equipment shed not present no irrigation
Spectator features	seating no concessions

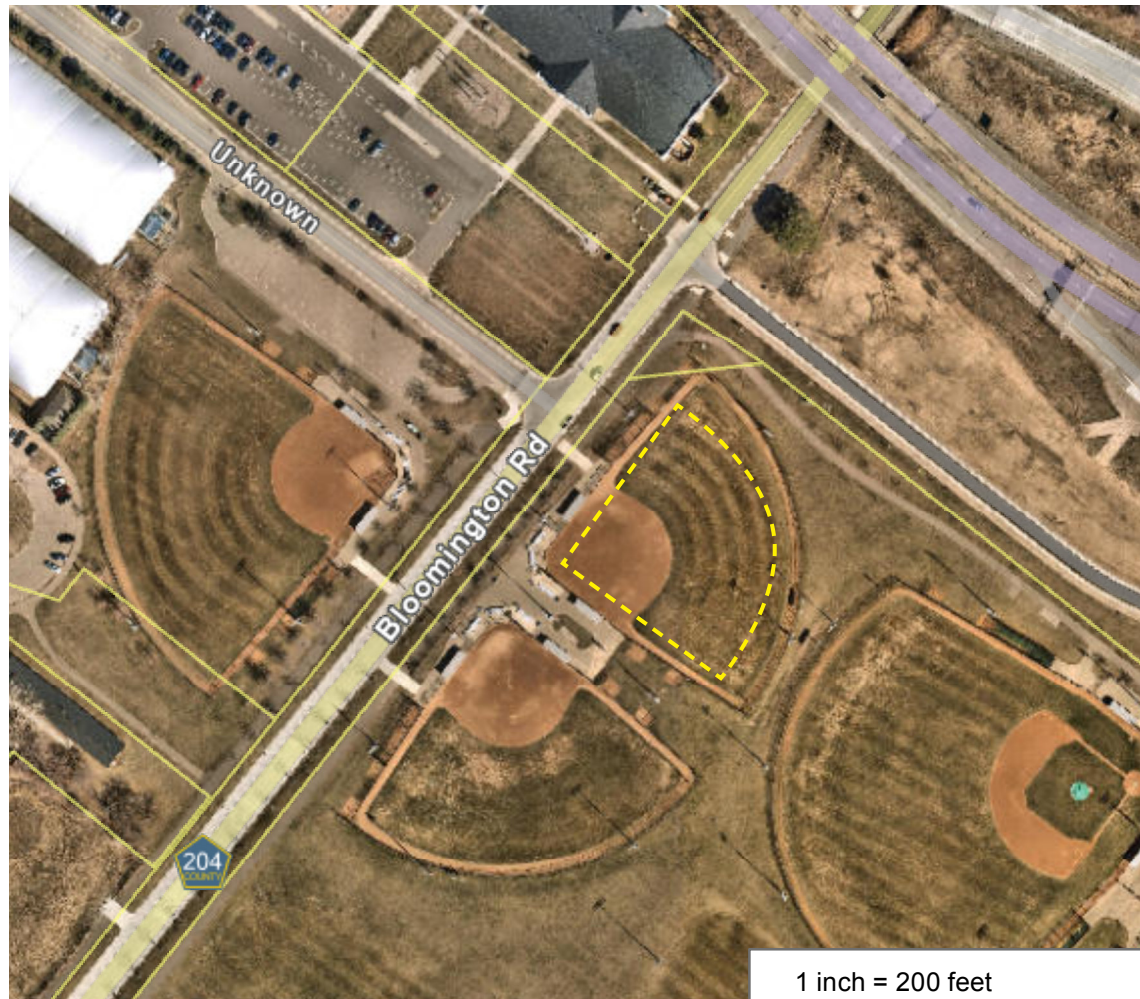
Field layout

- Player safety: fencing present at team benches, bull pen fencing, ground condition is very good
- Field characteristics: outfield fencing requires adjustment to 225', foul poles, field lighting
- Play features: full backstop, field set for softball, scoreboard, covered dugouts, drinking fountain?, electricity source?, batting cage not present, team equipment shed not present

Maintenance features: equipment shed not present, irrigation?

Spectator features: no concessions

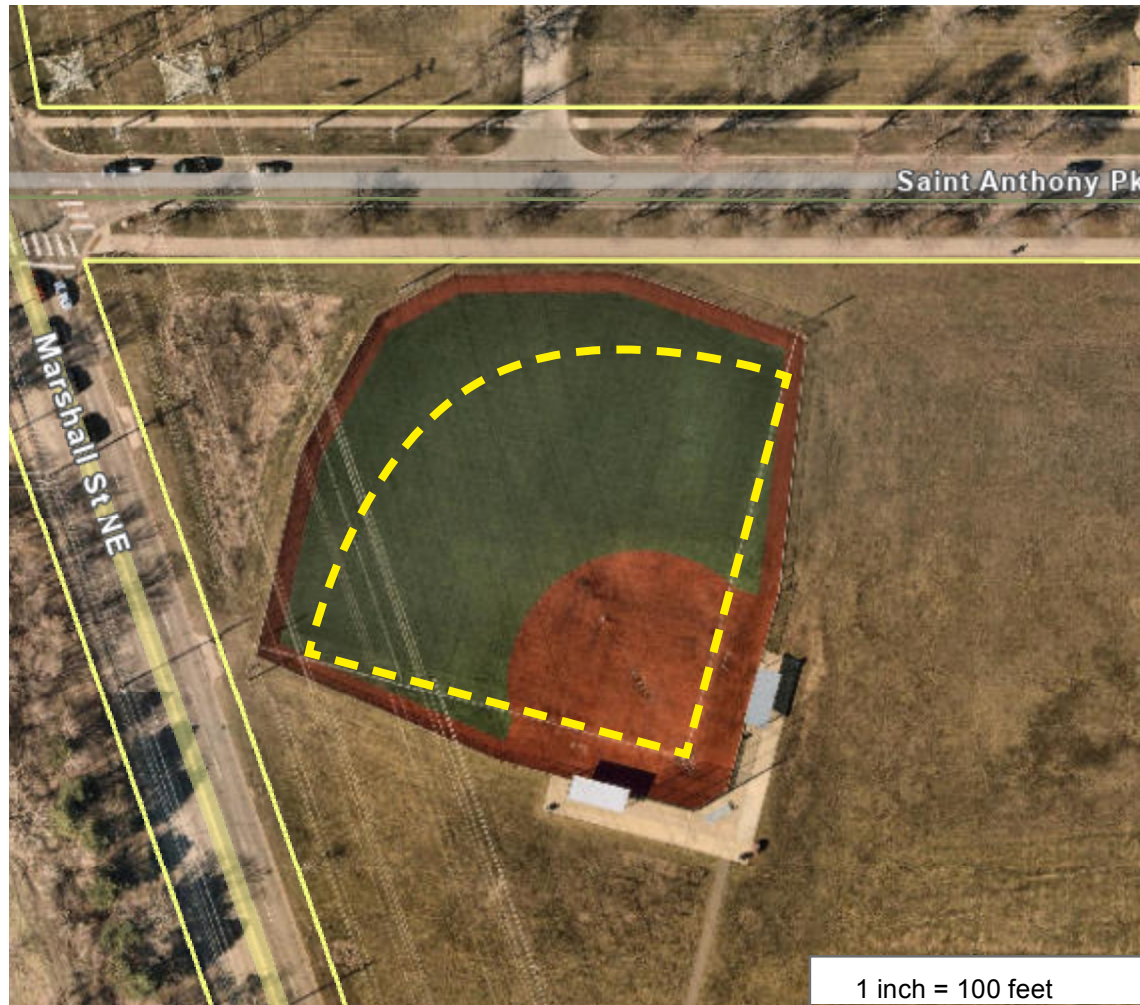
Field layout

Player safety	fencing present at team benches no bull pen fencing ground condition is artificial in good condition
Field characteristics	outfield requires adjustment to 225' foul poles no field lighting
Play features	full backstop present field set for softball scoreboard covered dugouts drinking fountain no electricity batting cage not present team equipment shed not present
Maintenance features	equipment shed not present
Spectator features	seating no concessions

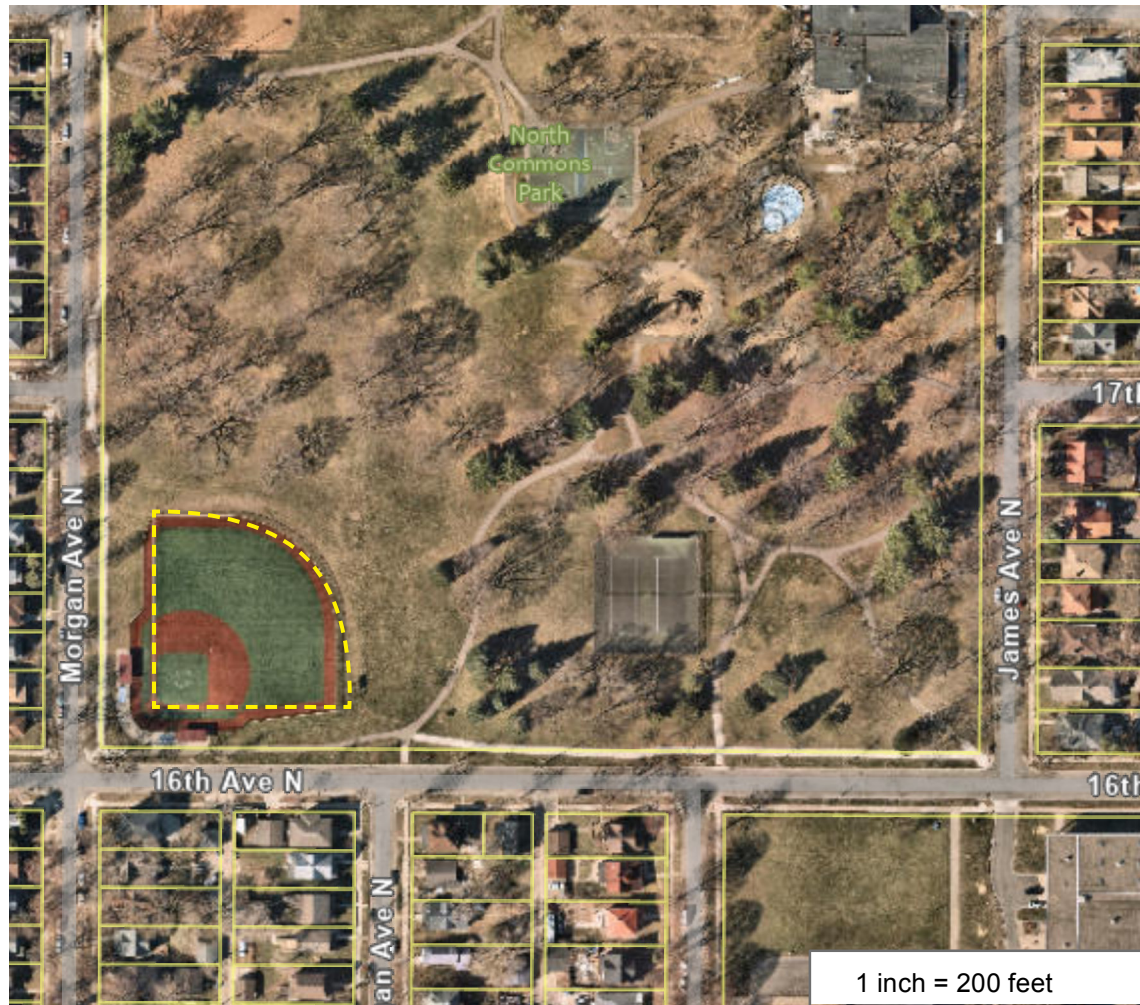
Field layout

- Player safety fencing present at team benches
no bull pen fencing
ground condition is artificial turf in good condition
- Field characteristics outfield at 225'
foul poles
no field lighting
- Play features full backstop present
field set for softball
scoreboard
covered dugouts
drinking fountain?
electricity source?
batting cage not present
team equipment shed not present

- Maintenance features equipment shed not present
- Spectator features seating
no concessions
