HERITAGE PRESERVATION APPLICATION SUMMARY

Project Name: Boom Island-Nicollet Island Bridge Rehabilitation

Request: To allow rehabilitation of and alterations to the existing Boom Island-Nicollet Island Bridge (Bridge No. 93835).

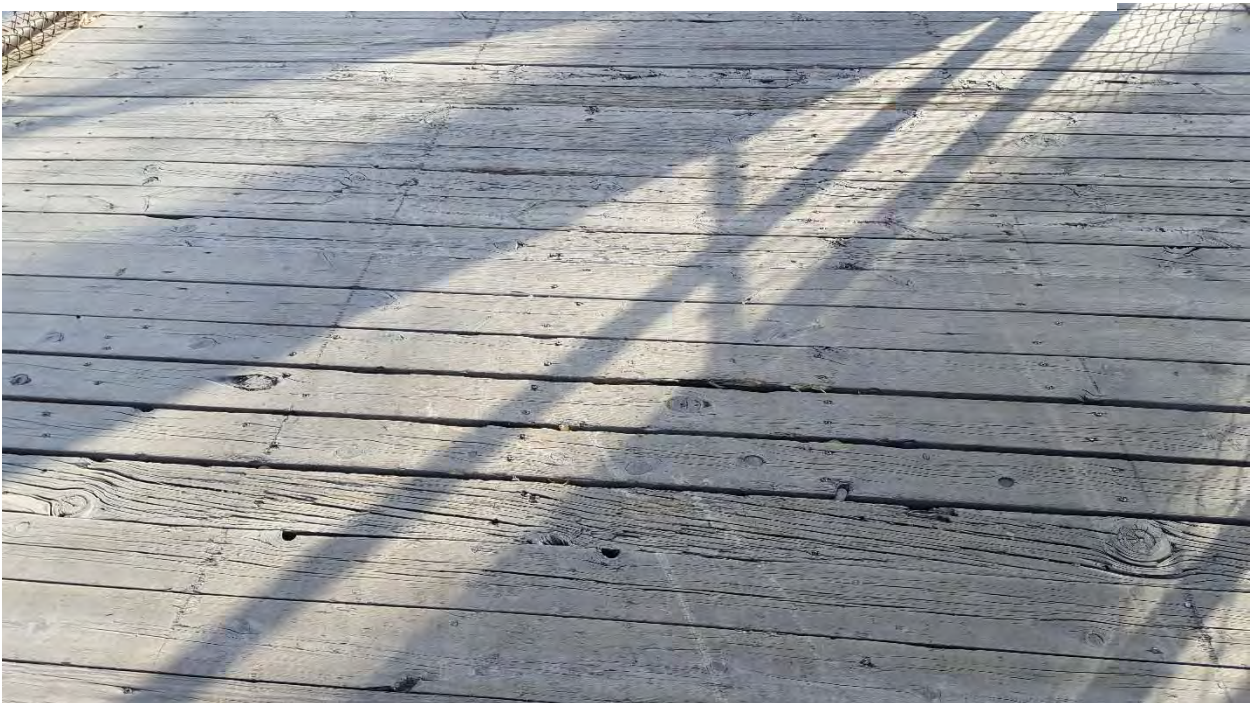
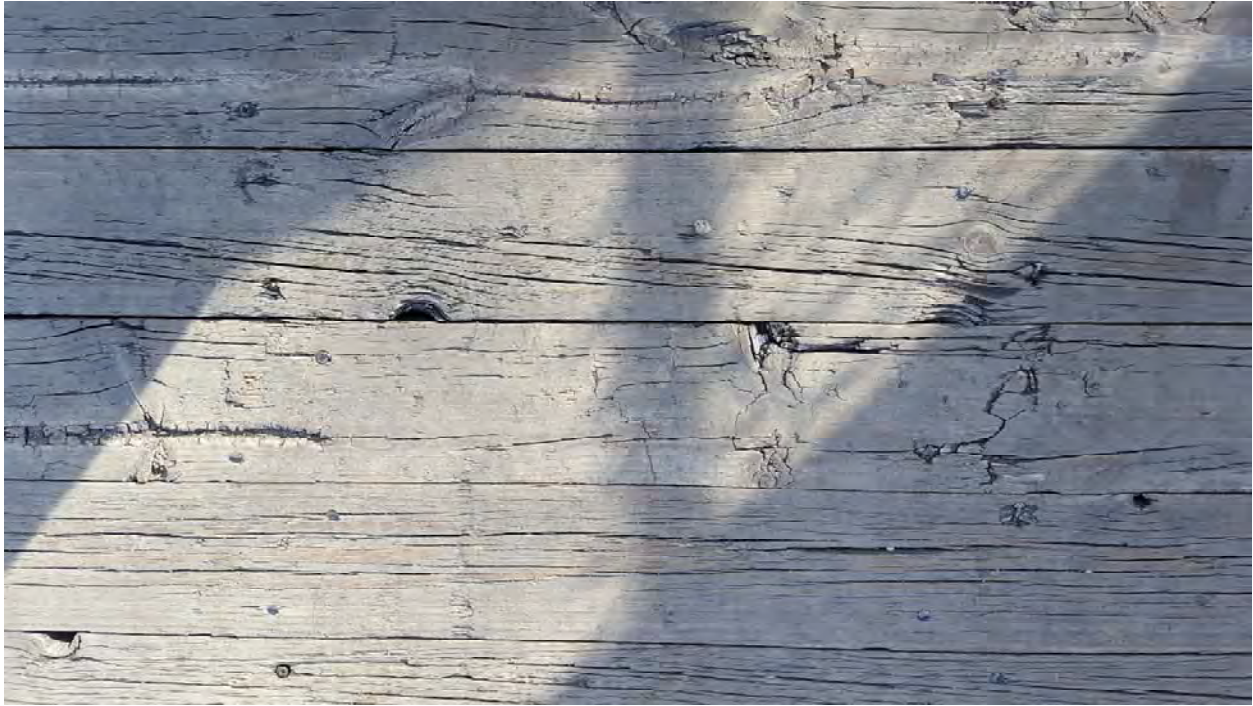
Condition of Existing Timber Deck

Timber Ties: The timber ties need to be removed due to their condition but will be replaced in-kind. The proposed timber ties will have similar size and spacing, but the lengths will be longer to carry the loads from the deck to the stringers.

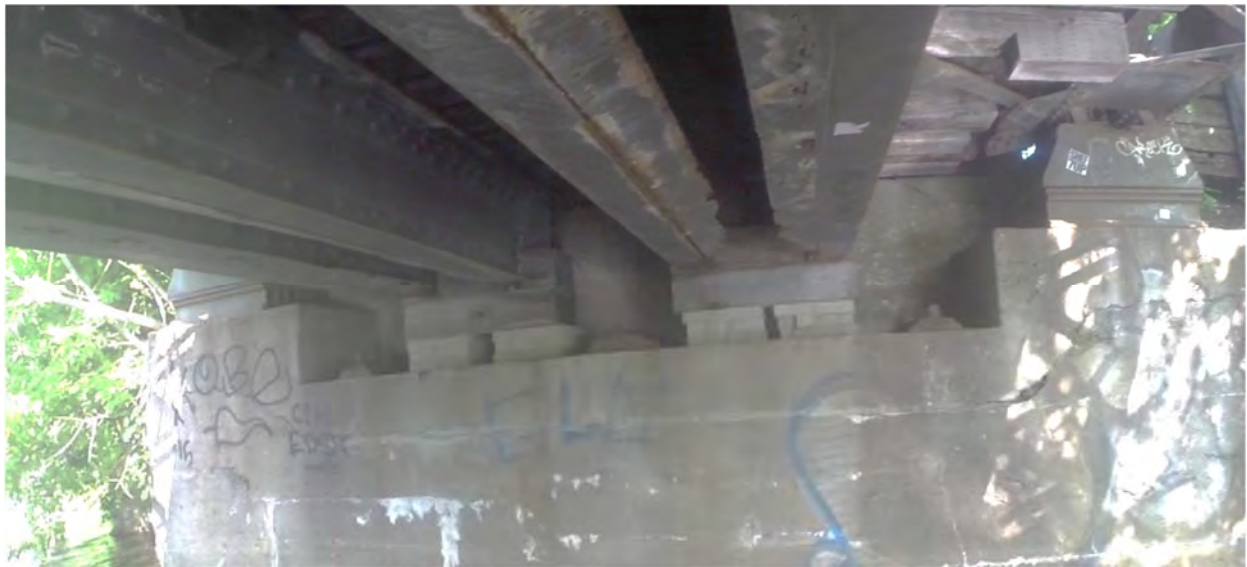
The abutments are cracked and spalled. The spalls will be repaired and the cracks will be sealed. In addition, the top of the abutment backwall will be removed and replaced in-kind to provide support for the proposed deck system. The proposed abutment concrete will match the color and texture of the existing concrete.

Cracks and Spalls on North Abutment; temporary repairs to the stringer supports are also visible; corrosion visible on bottom angles of interior and exterior stringers; limited space can be seen between exterior and interior stringers – spacing is the same along the entire length of the bridge

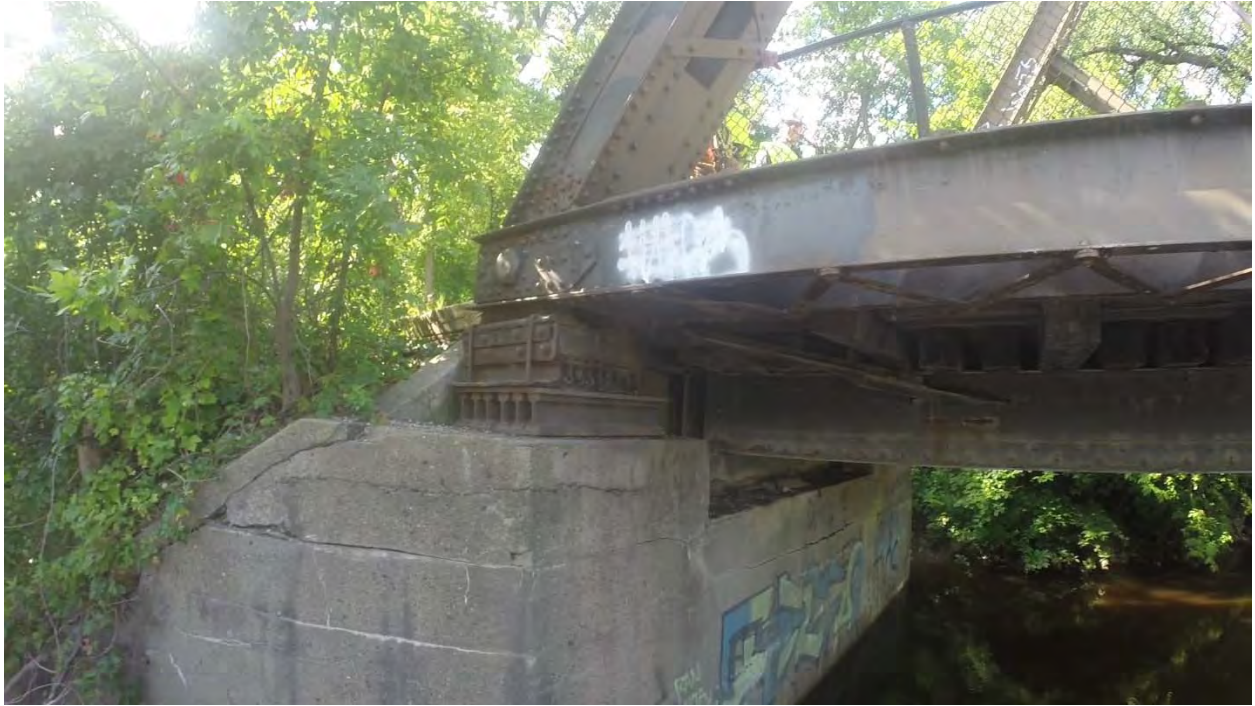
Cracks and Spalls on South Abutment

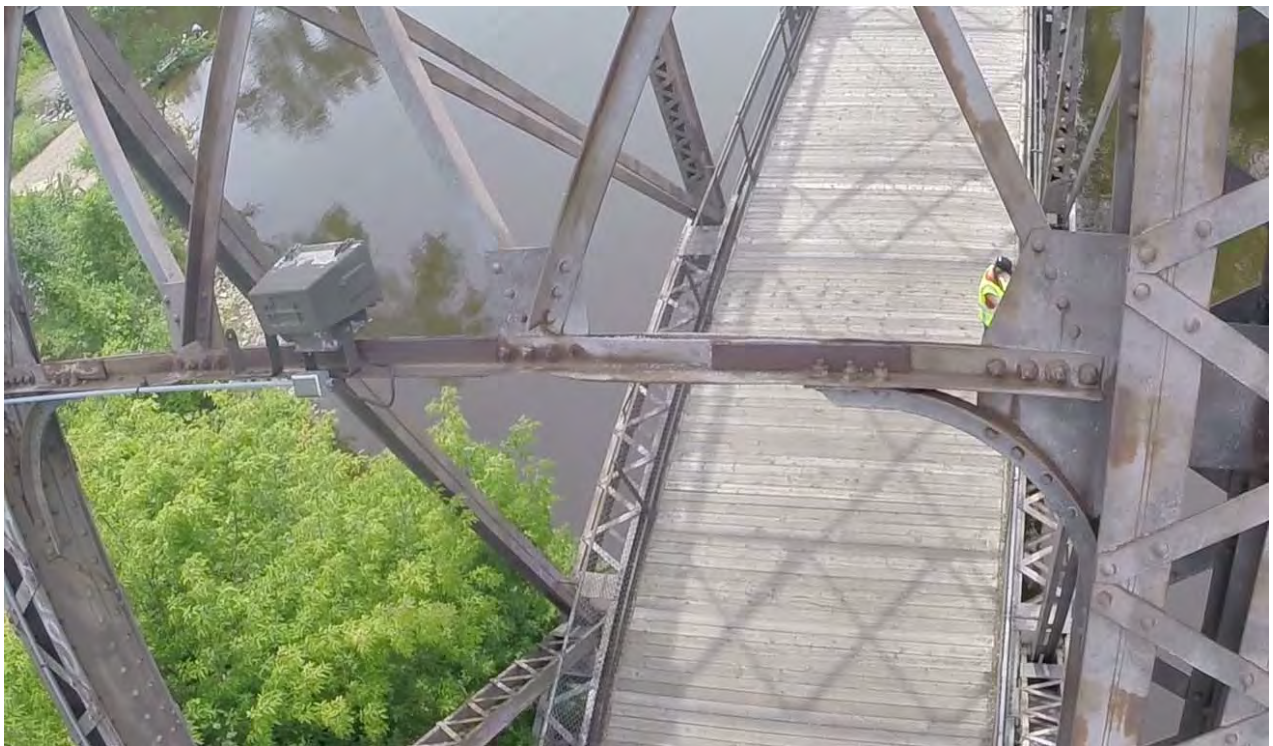
The existing lower horizontal angle of the portals is deteriorated. This angle will be removed and replaced in-kind.

**North Portal Lower Horizontal; can see additional plates and missing parts of angle;
South Portal similar**

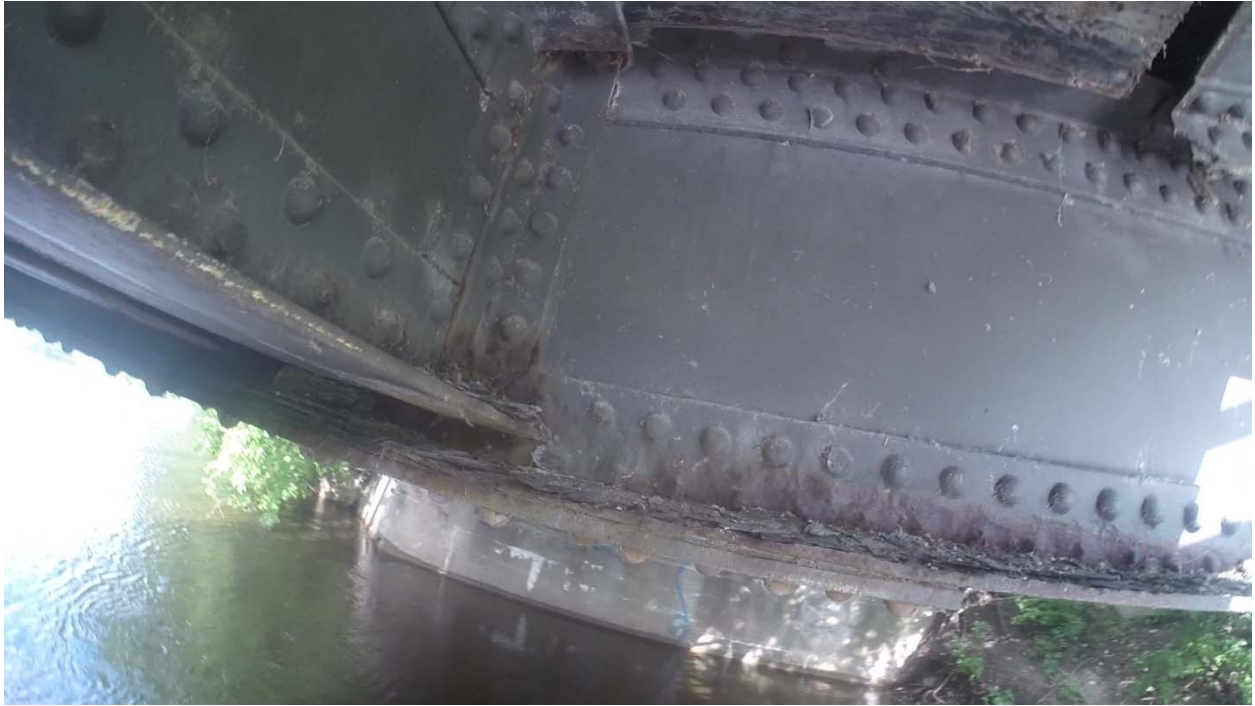
Typical Floor Beam - deterioration outside of stringers; propose to remove bottom angles to end of cover plate seen above.

The bottom angles are beyond the condition where a repair plate and a good coat of paint can repair the floor beam. The bottom cover plate, angles, and 3" of the bottom of the vertical web plate will be removed. A new vertical web plate will be added to compensate for the section

loss in the existing vertical plate. A new horizontal plate will be welded to the bottom of the new vertical plate. This detail retains the historic “I” shape of the floor beams. The repair does not replace the bottom angles in kind because built-up members are more likely to accumulate pack rust.

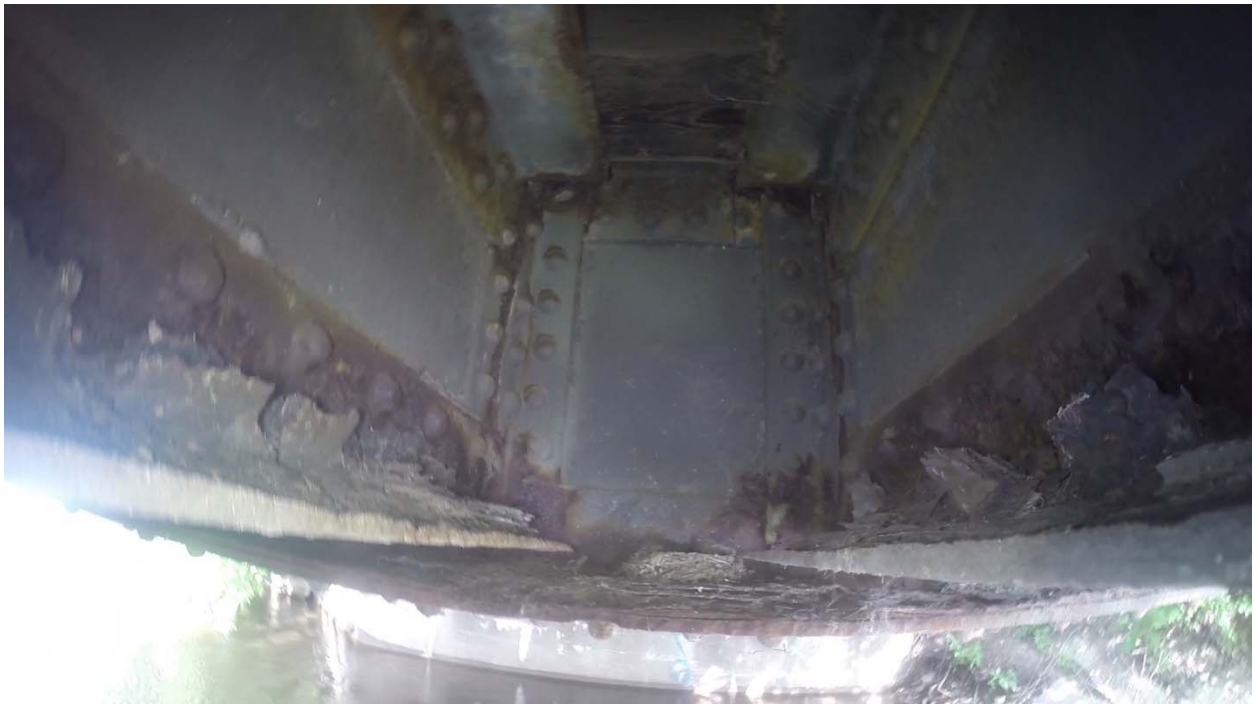
The floor beams are a built-up member consisting of back-to-back 6"x6" angles on the top and bottom with a vertical web plate between the angles. A horizontal cover plate is above and below the angles. The bottom legs of the bottom two angles have significant corrosion between the exterior stringers. The web plate has high levels of corrosion; at least 2 web plates have holes.

Typical Floor Beam and Interior Stringers; the bottom leg of the angle for the floor beam is completely deteriorated

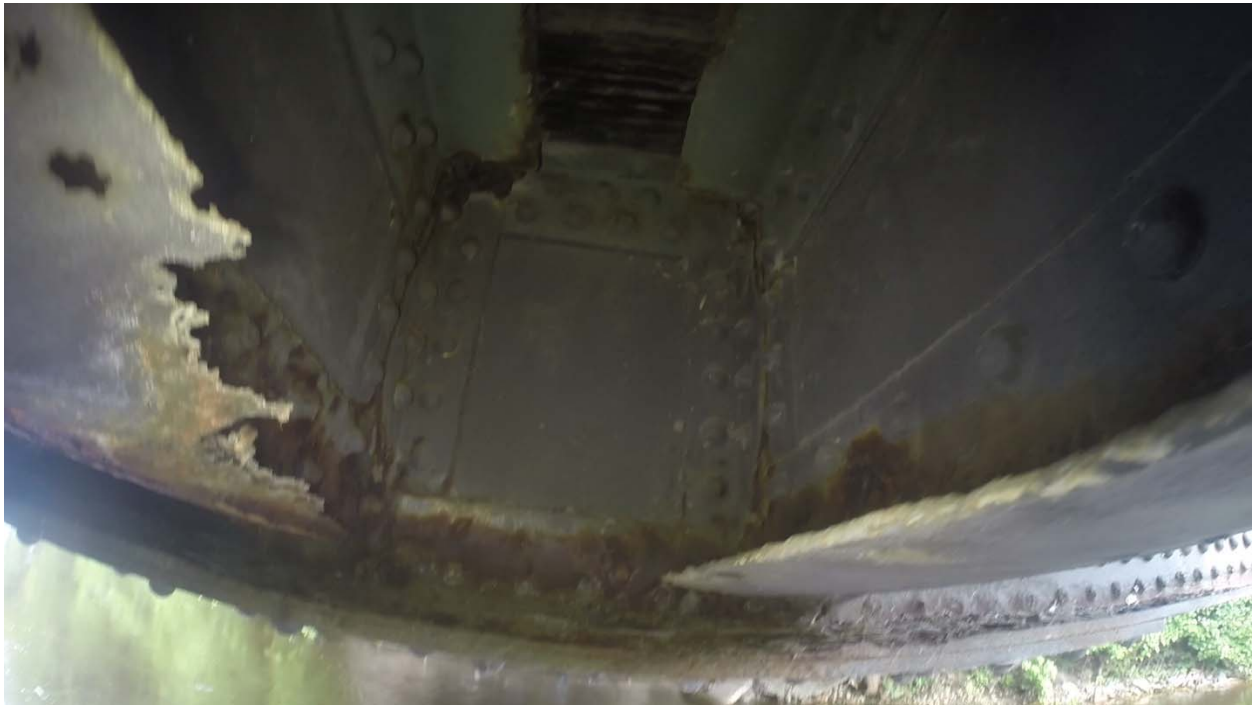
Typical Floor Beam and Stringers; Interior stringer is to the left and exterior stringer is to the right.

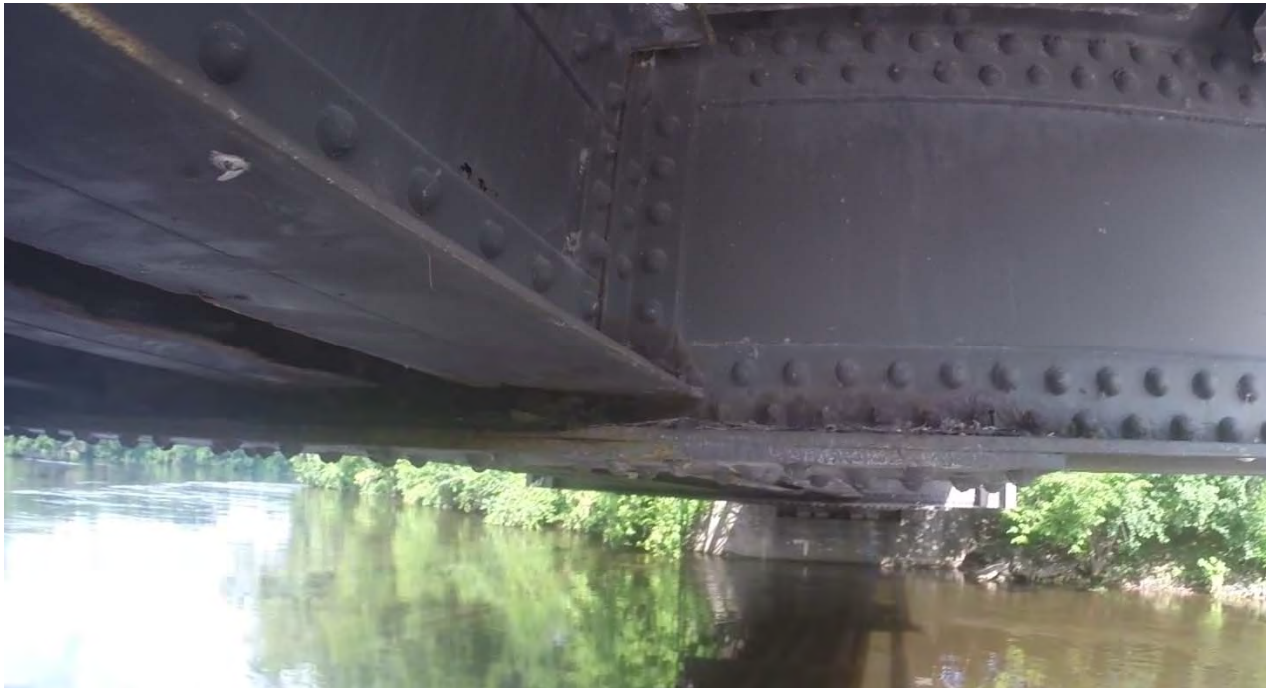
Typical Floor Beam – bottom leg of angles; severe deterioration begins under stringer; mainly only cover plate

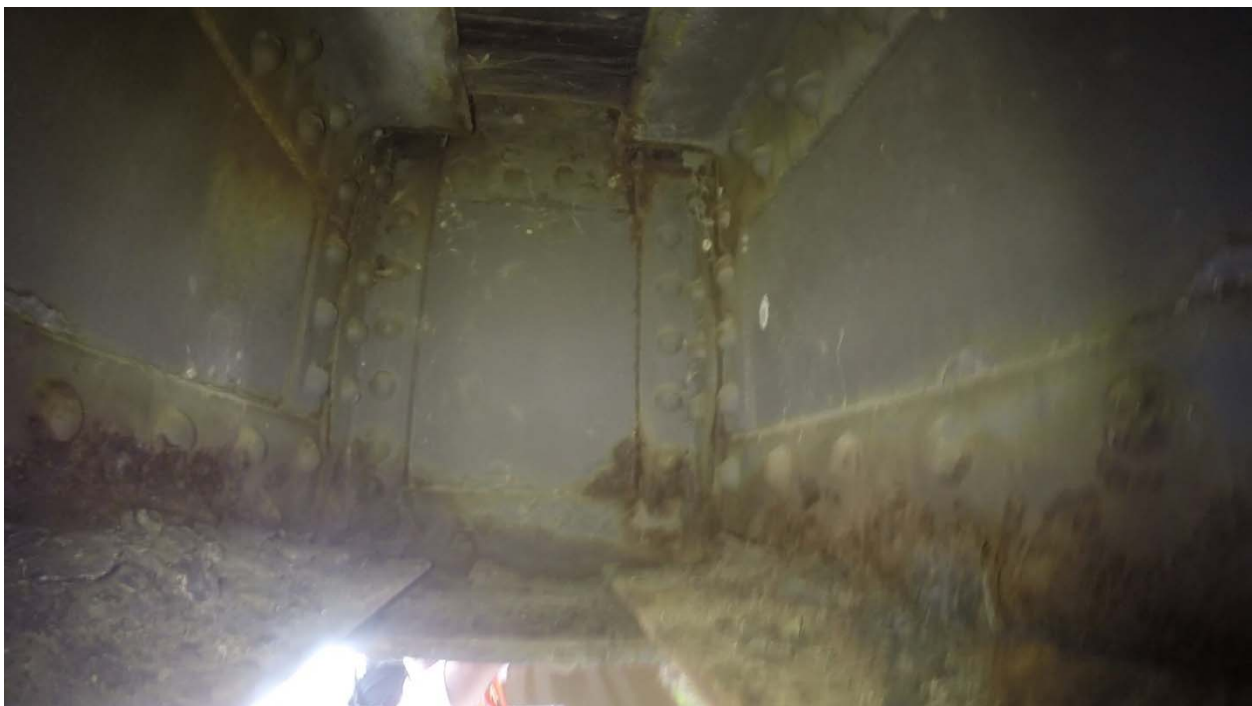
Typical Floor Beam and Interior Stringers

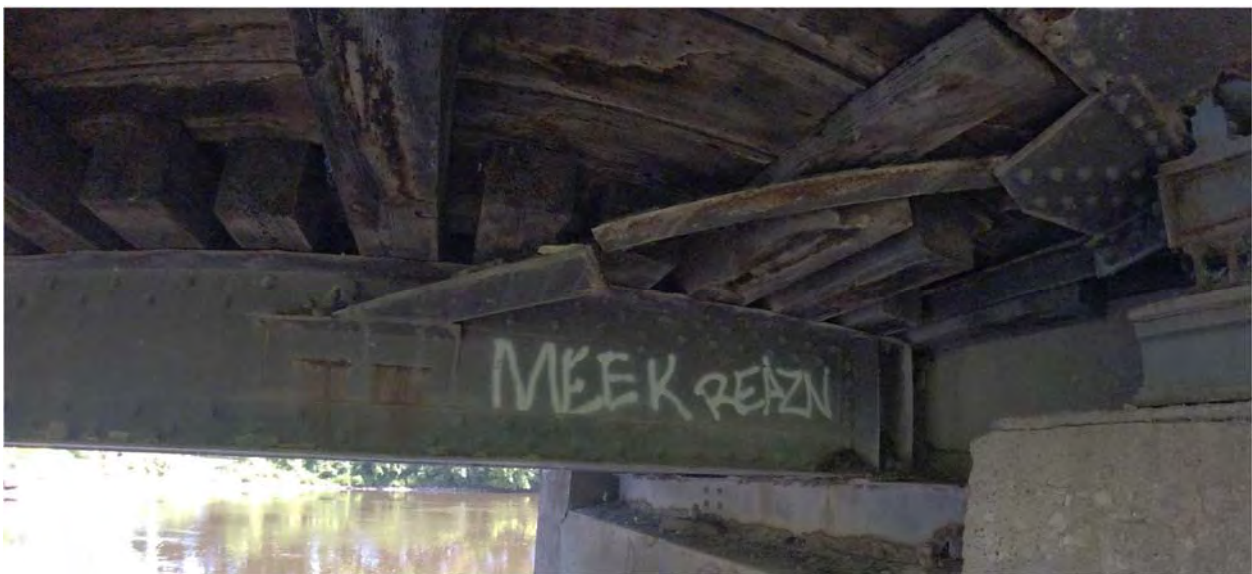
Bottom Lateral Bracing – severed from non-original plate. There is where new lateral bracing will be added to historic angle. Welds to attach the angle to the exterior stringer shows this was added later.

Bottom Lateral Bracing: The in-place bottom lateral bracing is mostly not original construction. The original elements will be retained, and the non-historic members will be replaced in-kind with new plates and shelf angles.

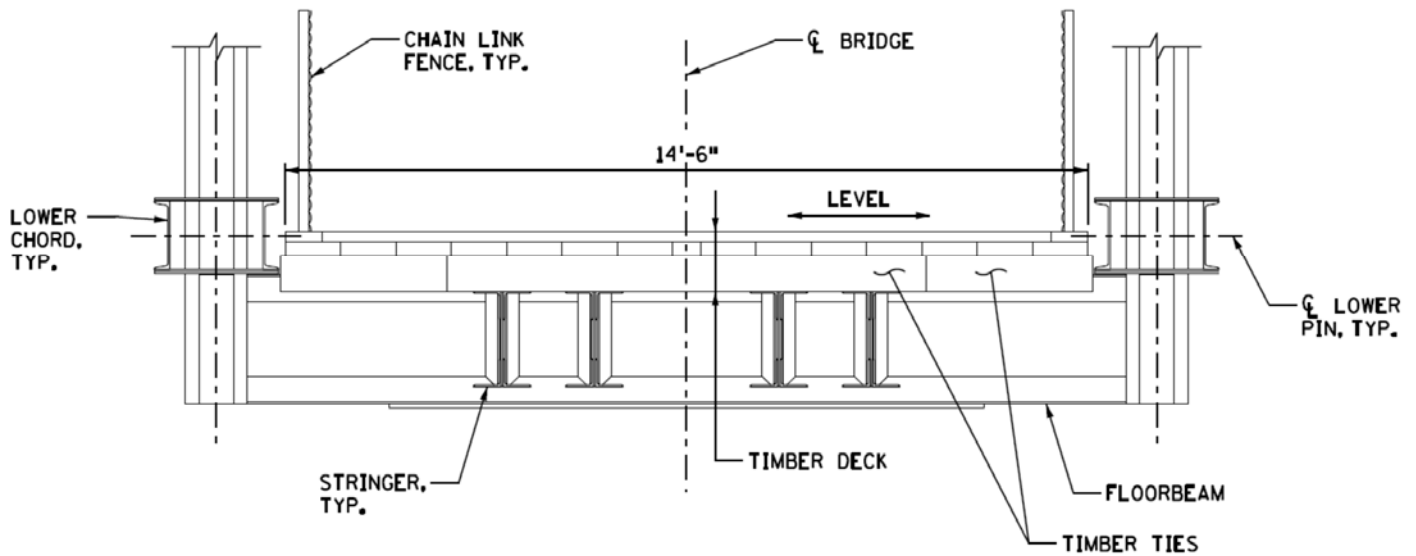
Existing Transverse Section

In addition to the floor beams, the existing stringers are deteriorated, and the timber ties and non-original deck are decayed. The timber deck, timber ties, and non-original chain link fence will be removed. The interior stringers possess the worst deterioration and need to be removed.

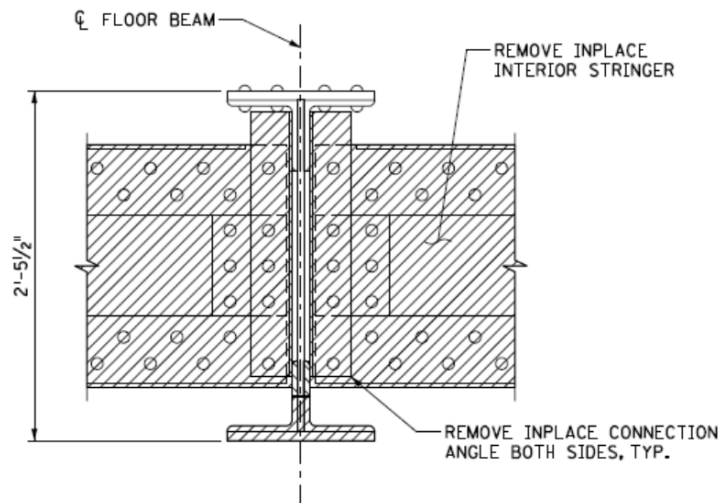
Existing Section of Floor Beam

The existing floor beam is a built-up member consisting of back-to-back 6"x6" angles on the top and bottom with a vertical plate between the angles and horizontal cover plates below and above the angles. The bottom two angles have significant deterioration. We are removing the two deteriorated bottom angles and 3" off the bottom of the vertical plate which is also deteriorated.

The two interior strings have the worst deterioration and will be removed. If they were to remain, their close spacing would inhibit access to adequately repair the floor beams to support the stringers and deck system.
