# 13 POWDERHORN LAKE

## HISTORY

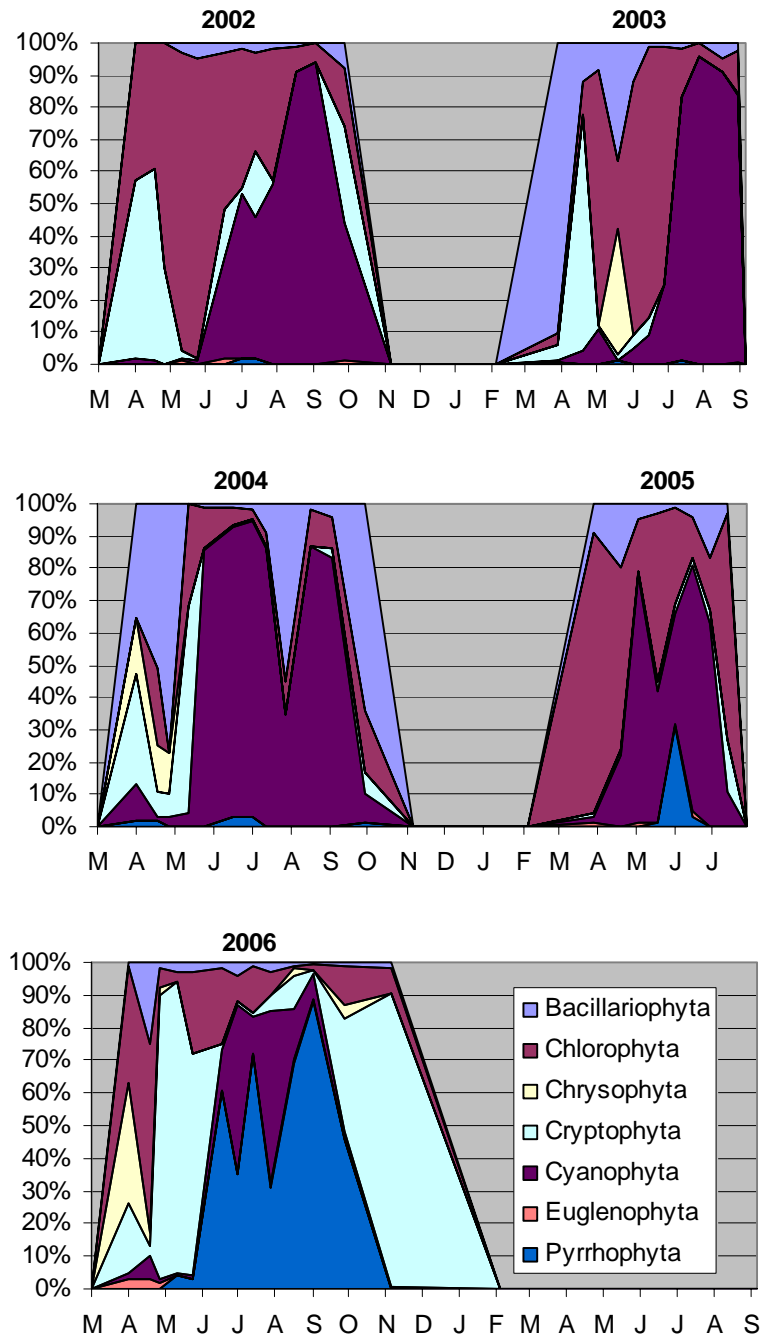
**Figure 13I. Distribution of phytoplankton in Powderhorn Lake from 2002-2006.**

The phytoplankton community structure in Powderhorn Lake has changed over time (Figure 13I). Between 2002 and 2004, chlorophyta and cyanobacteria were dominant during open-water season, bacillariophyta made up a significant percent of the species present in spring and fall, and cryptophyta had several spring blooms. Unusually, in 2006 pyrrhophyta made up

the majority of the individuals in the summer samples, and cryptophyta had larger blooms in spring and fall. (In comparison, several of MPRB's monitored lakes have small mid-summer pyrrhophyte blooms amounting to 5-10% of the individuals sampled.) Cyanophyta was only significantly present during June and July of 2006, and chlorophyta was also a smaller presence in 2006 than in several of the previous years.

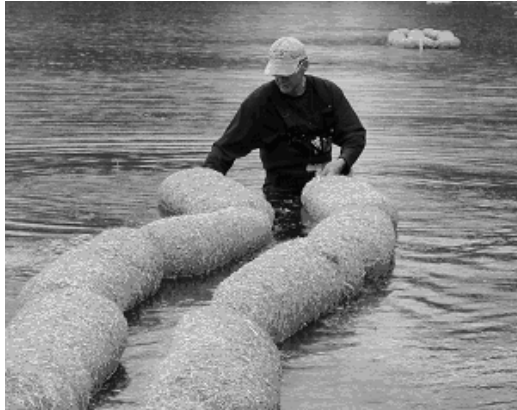
**Figure 13K. Barley straw treatment at Powderhorn Lake.**

Figure 13K shows installation of barley straw logs in Powderhorn Lake. Barley straw was first used at Powderhorn Lake on 5/5/04 when 250 pounds/acre were added. The first treatment appeared to have little if any effect. A second application at a higher dose was applied on

5/11/05 where 360 pounds/acre were added. A third barley straw application was applied 5/11/06 where 364 pounds/acre were added. The barley straw is staked below the surface of the water where it slowly decomposes over the year. The Secchi transparencies from Powderhorn Lake in 2005 and 2006 did reflect improvements in surface water clarity. The dramatic 2005-06 Powderhorn TSI improvements are likely the combined result of the multitude of restoration efforts (CDS units, alum, summer aeration, fish manipulation, barley straw, etc). An encouraging sign was the observation of aquatic plant growth in 2006.
