Minnehaha Falls Background Info and Full History

Minnehaha Falls WPA Work and Current Condition

CONCEPT A - Replicate WPA Stone Veneer Infrastructure

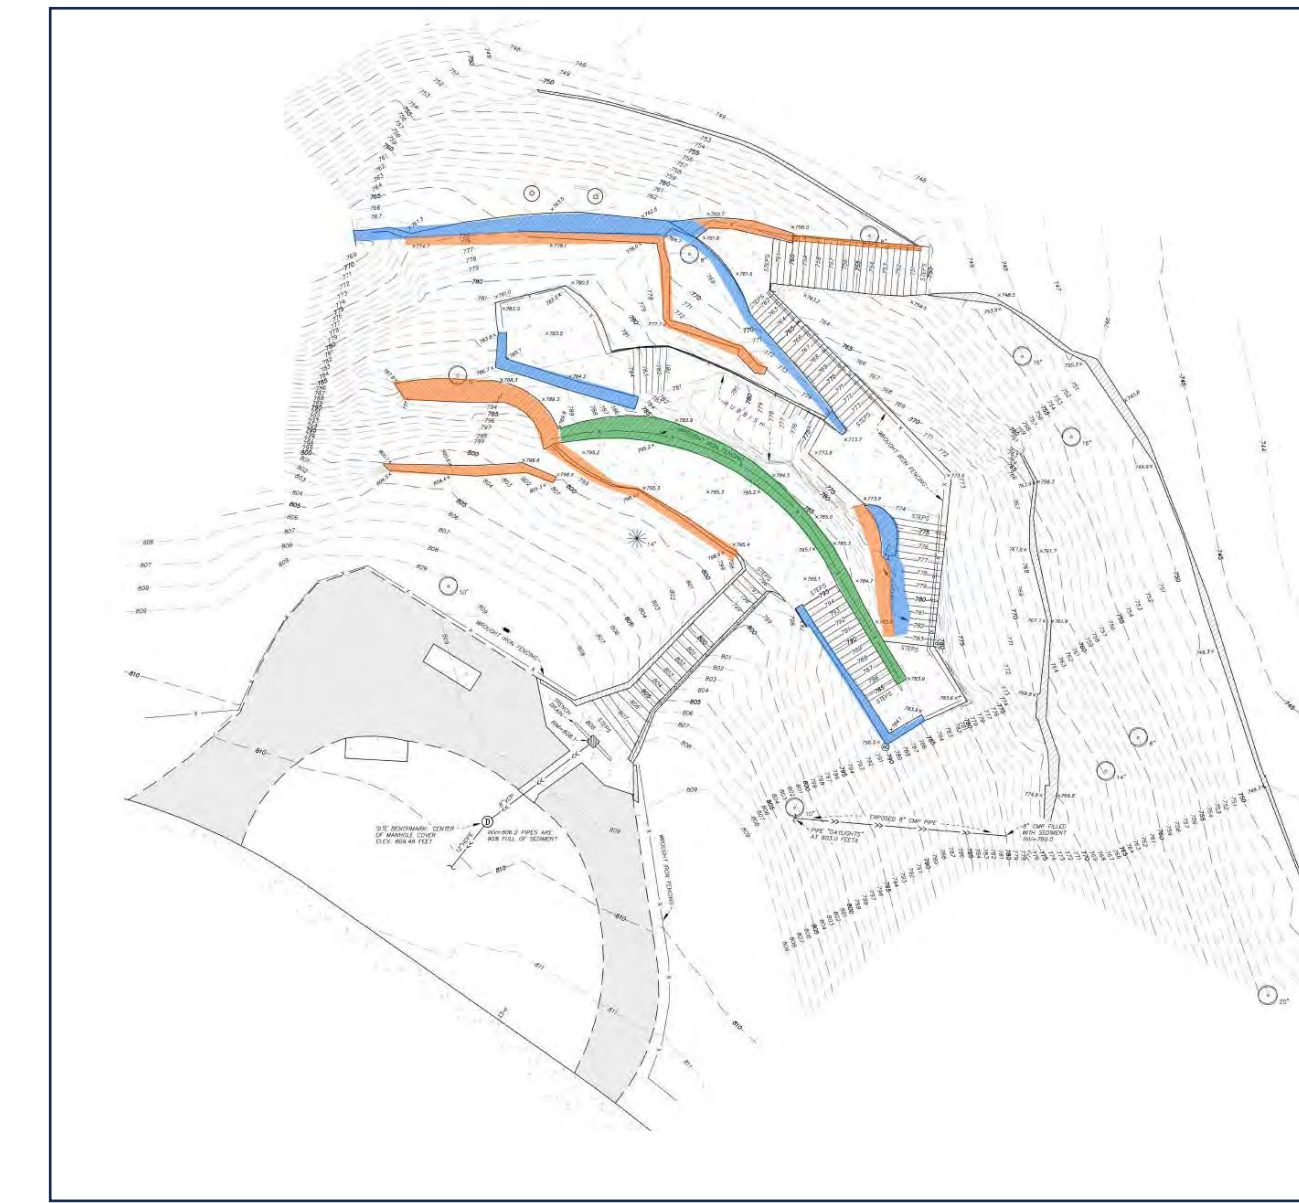
Historic Walls
 c. 1900 Stone Walls
 c. 1900 Concrete Wall
 c. 1942 Stone Walls

The infrastructure alignment, materials, and construction methods have changed many times through history. Currently there is a mix of infrastructure present on the site.

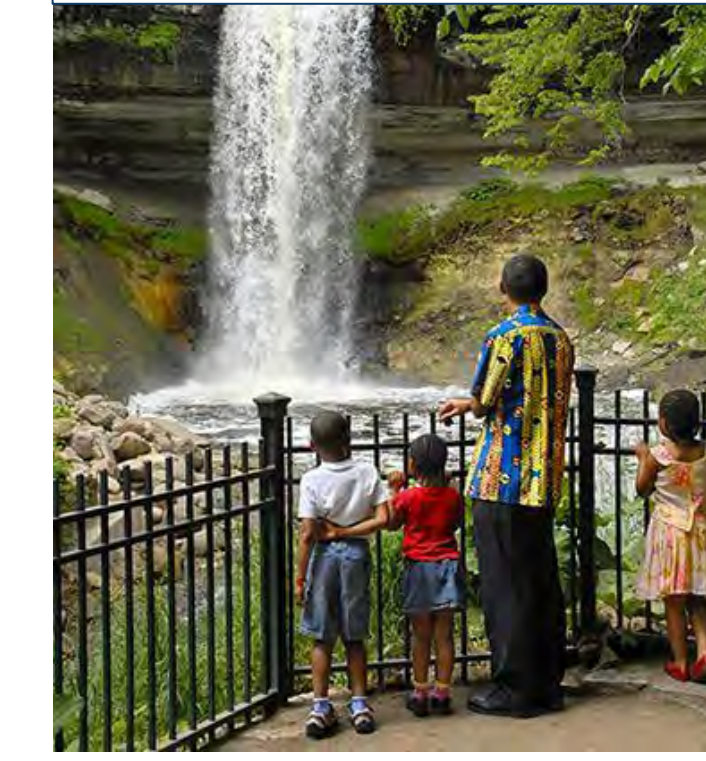
3: Example replicated overlook

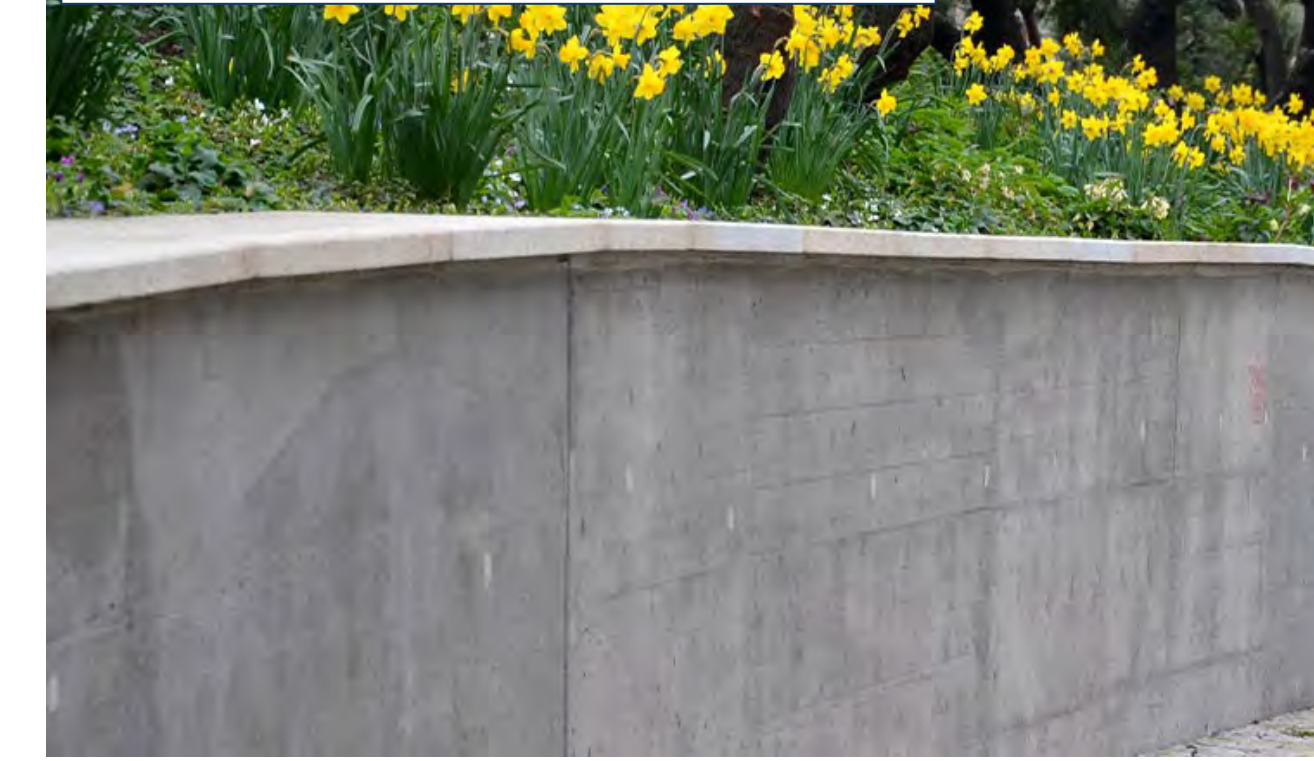
5: Example replicated concrete walls

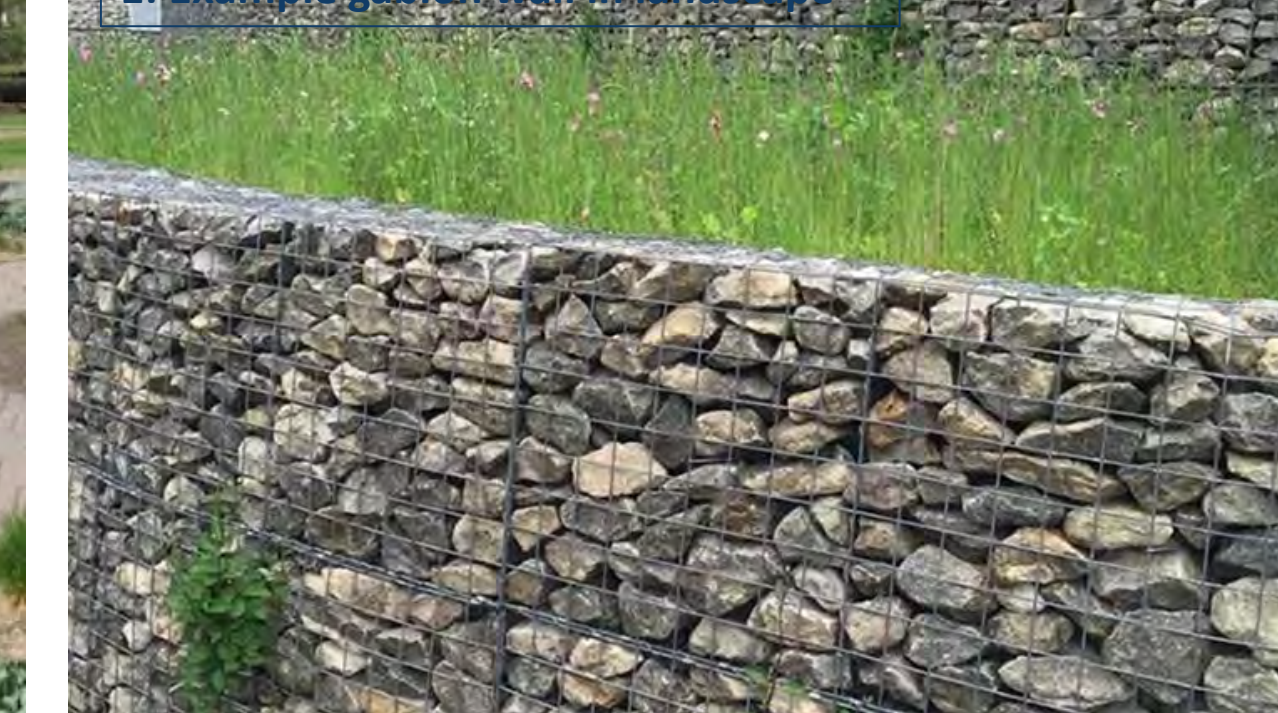
1: Example gabion wall in landscape

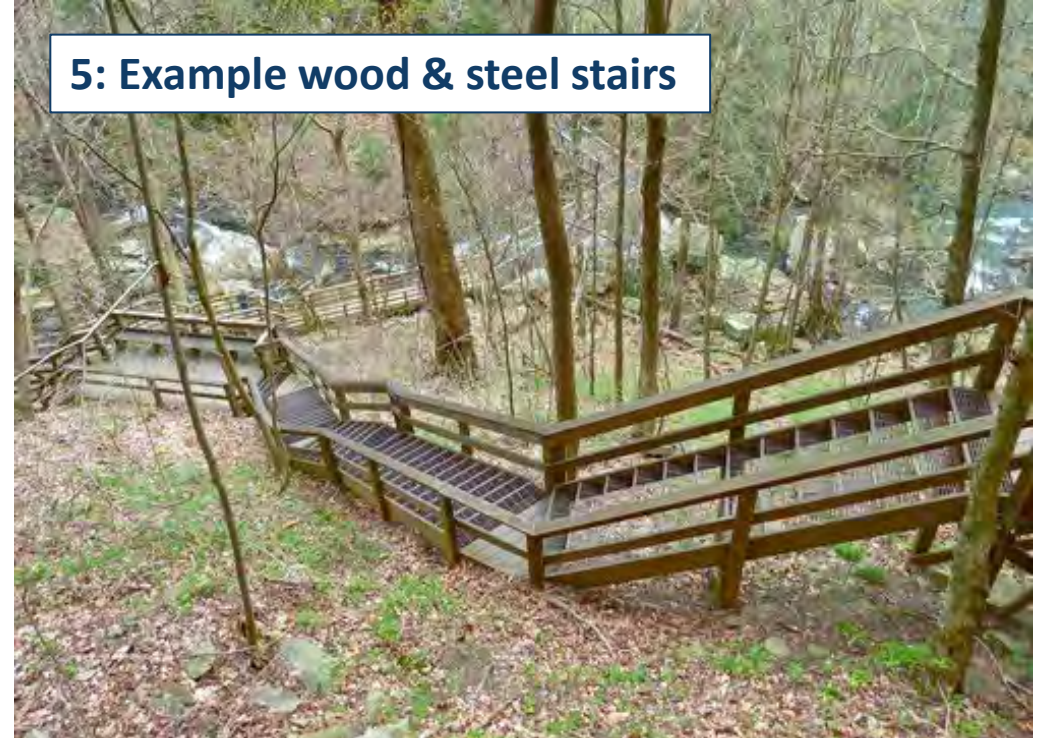
5: Example wood & steel stairs

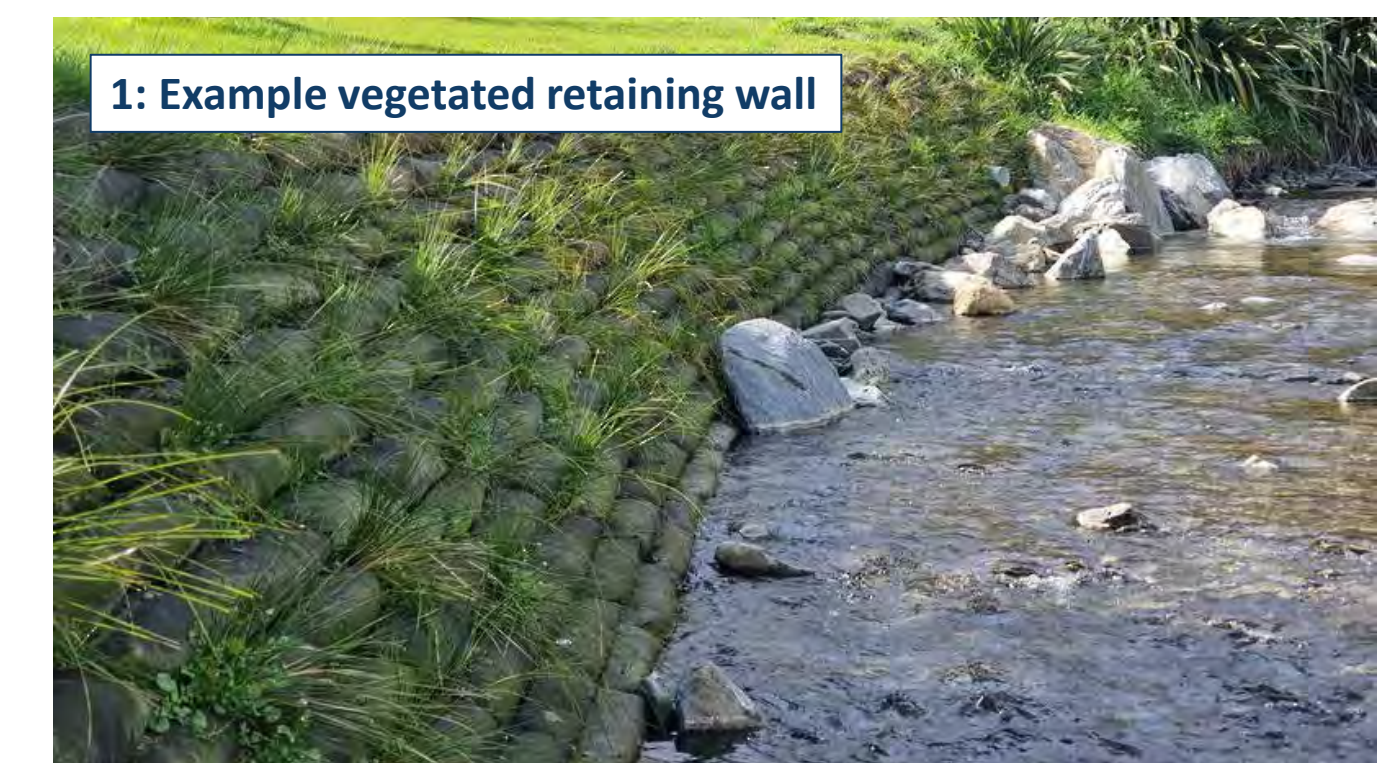
1: Example vegetated retaining wall
