# Lake Nokomis Shoreline Enhancement Project

## Community Meeting 2

February 13, 2018

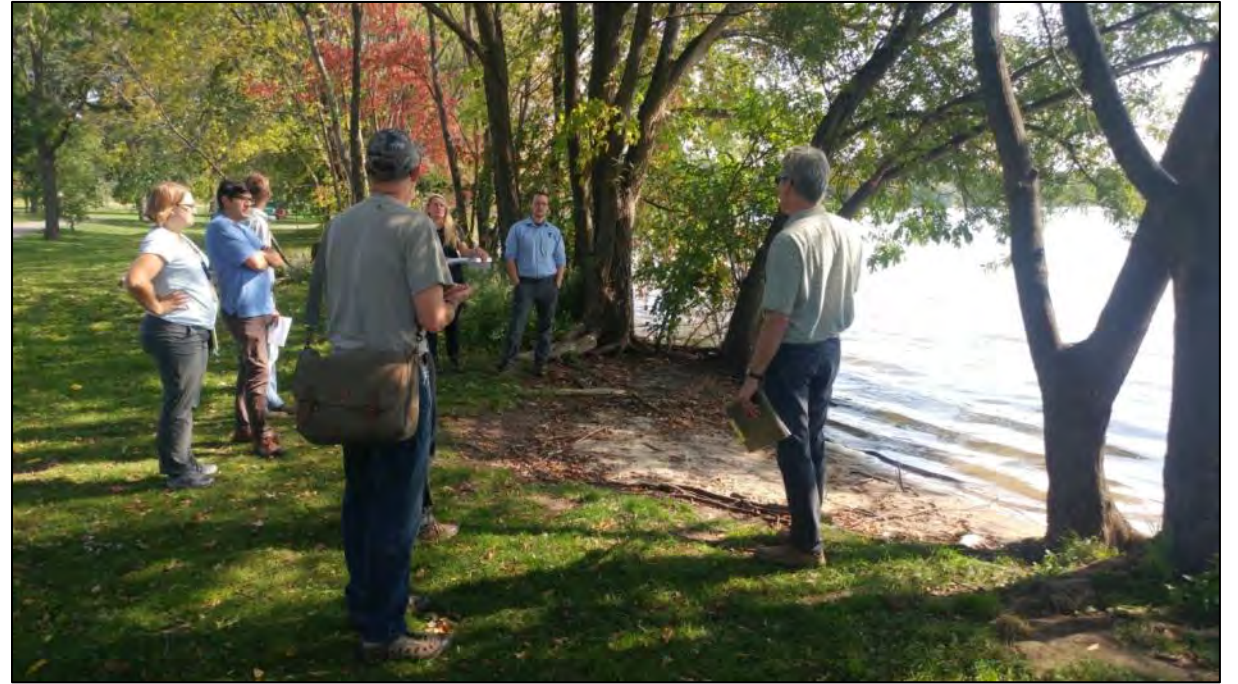
# Existing Conditions – Primary Issues

- Upland areas dominated by turf with woody vegetation along much of shoreline
- Majority of shoreline stable, but exceptions exist – often (but not always) associated with access
- No littoral emergent vegetation
- Water levels fluctuate, and have been high in recent years

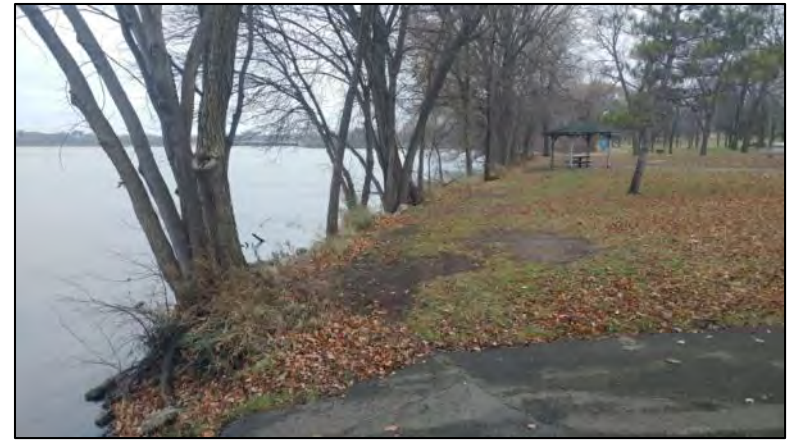
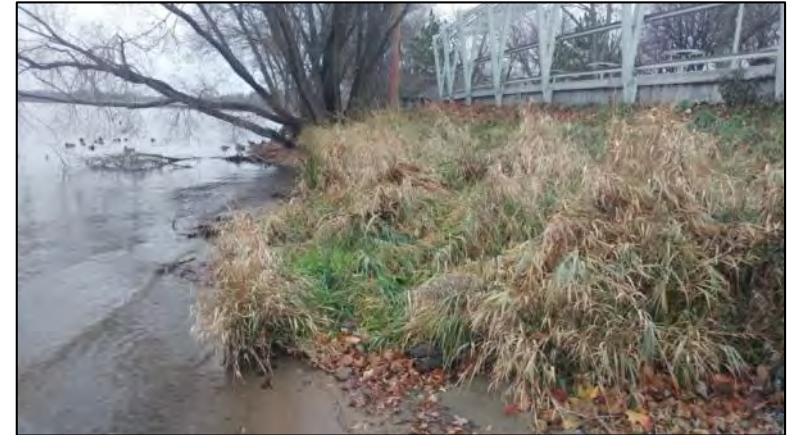
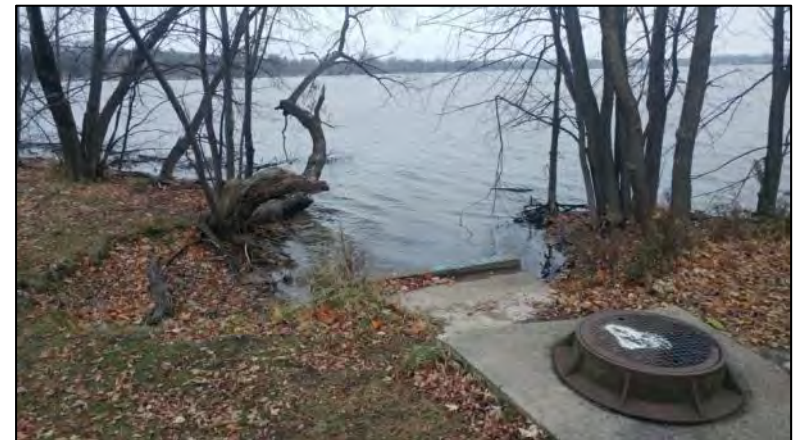
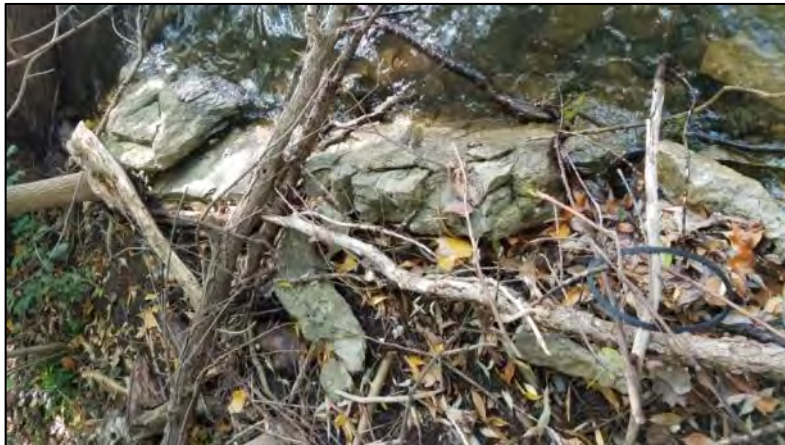
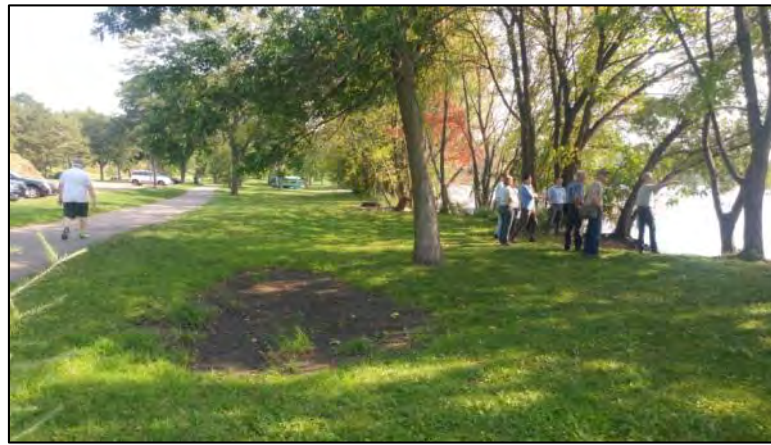
# Existing Conditions – Other Issues

- Concentrated runoff
- Invasive vegetation
- Erosion near stormwater infrastructure
- Wet depressions in turf
- Historical WPA walls

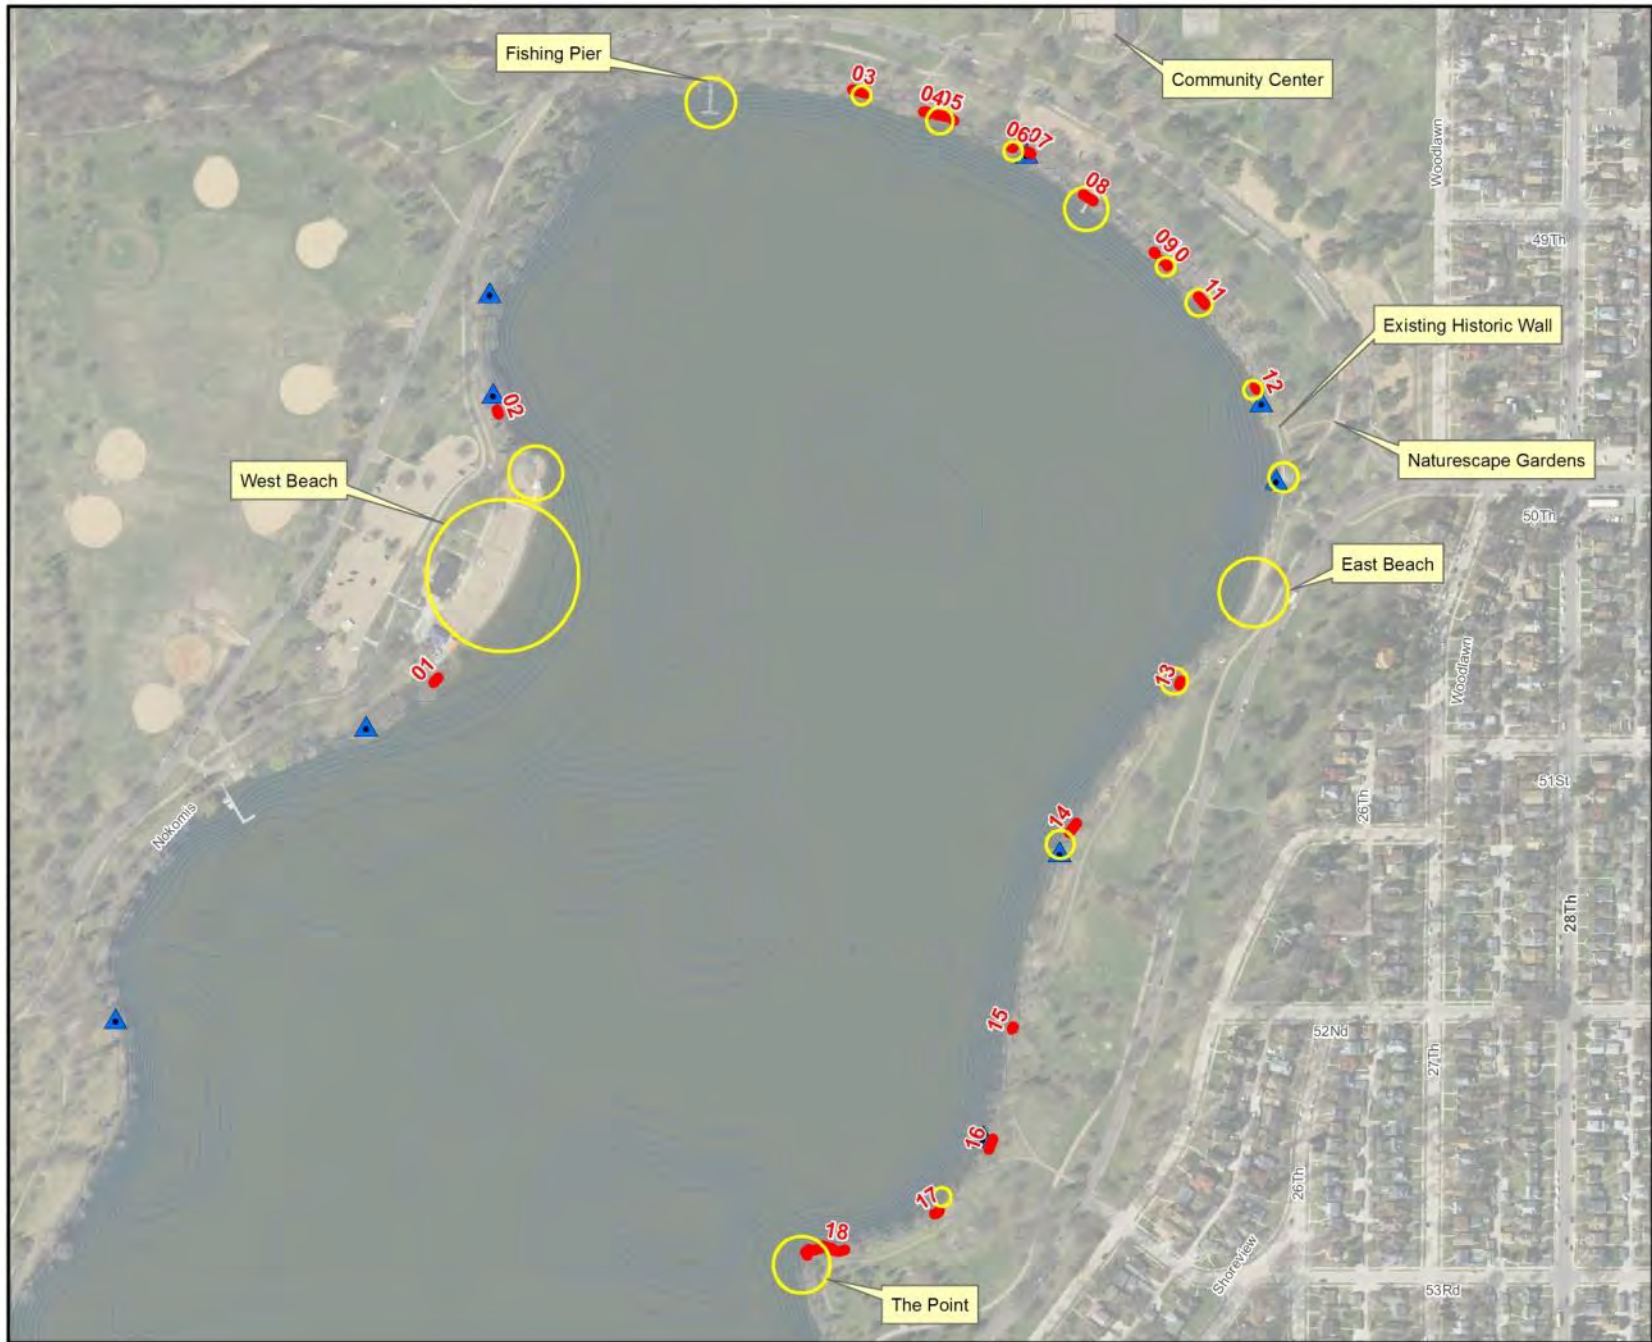
# Lake Nokomis Shoreline Enhancement

- Shoreline Activity Area
- Shoreline Erosion (449 lf)
- ▲ Stormwater Outfall
- Bathymetry (water depth, 2-ft interval)

Data Sources:  
 - MCWD bathymetry data  
 - LMIC WMS server (2016 aerial photo)

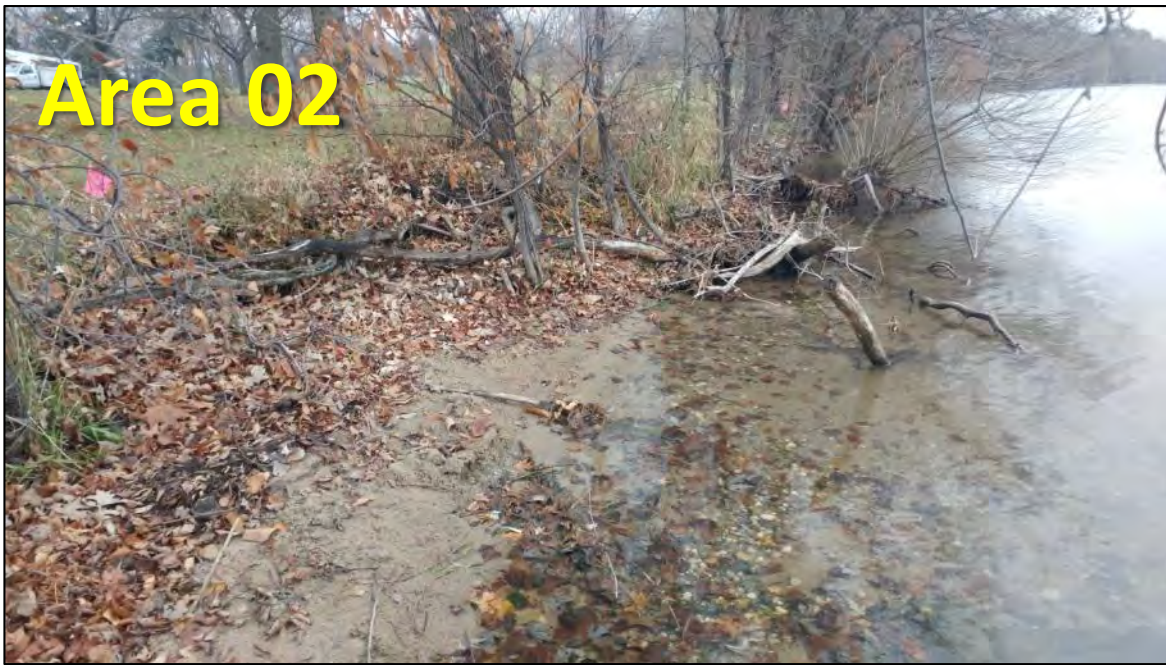
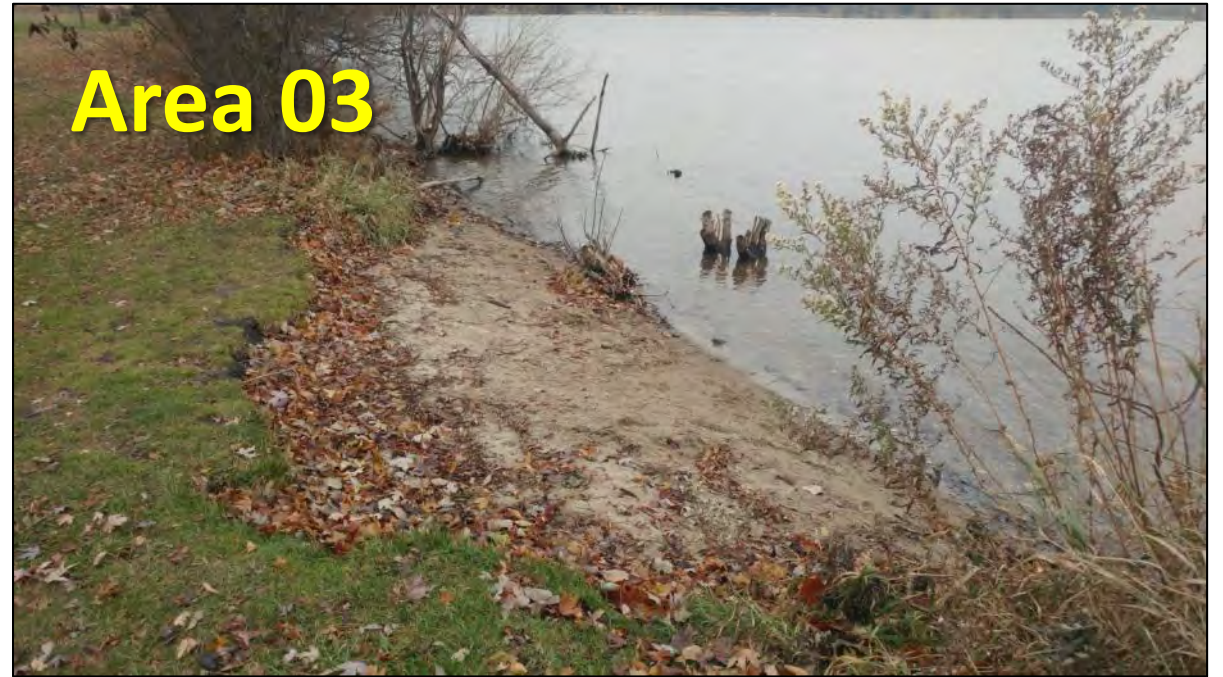
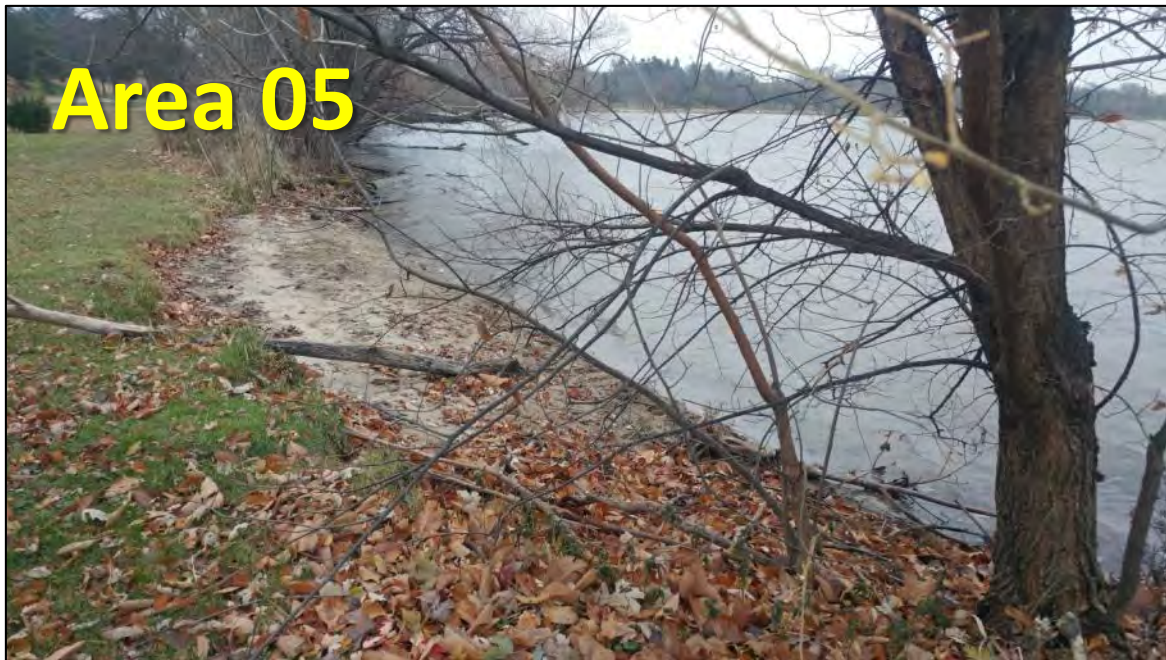
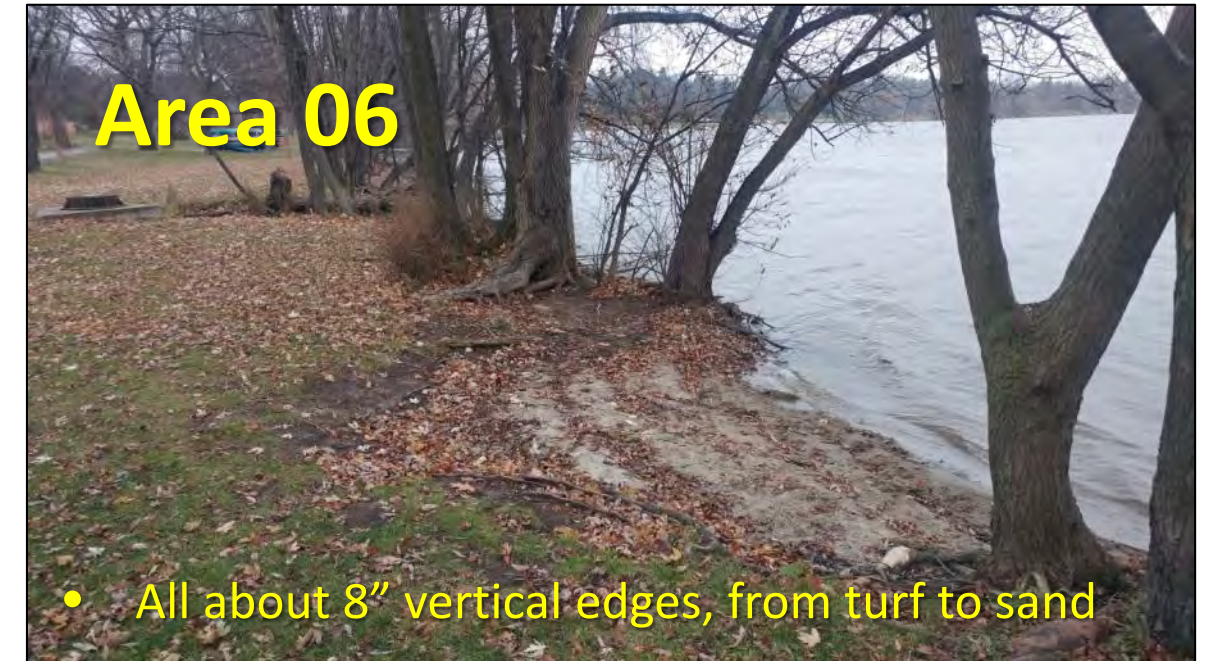
## Existing Conditions

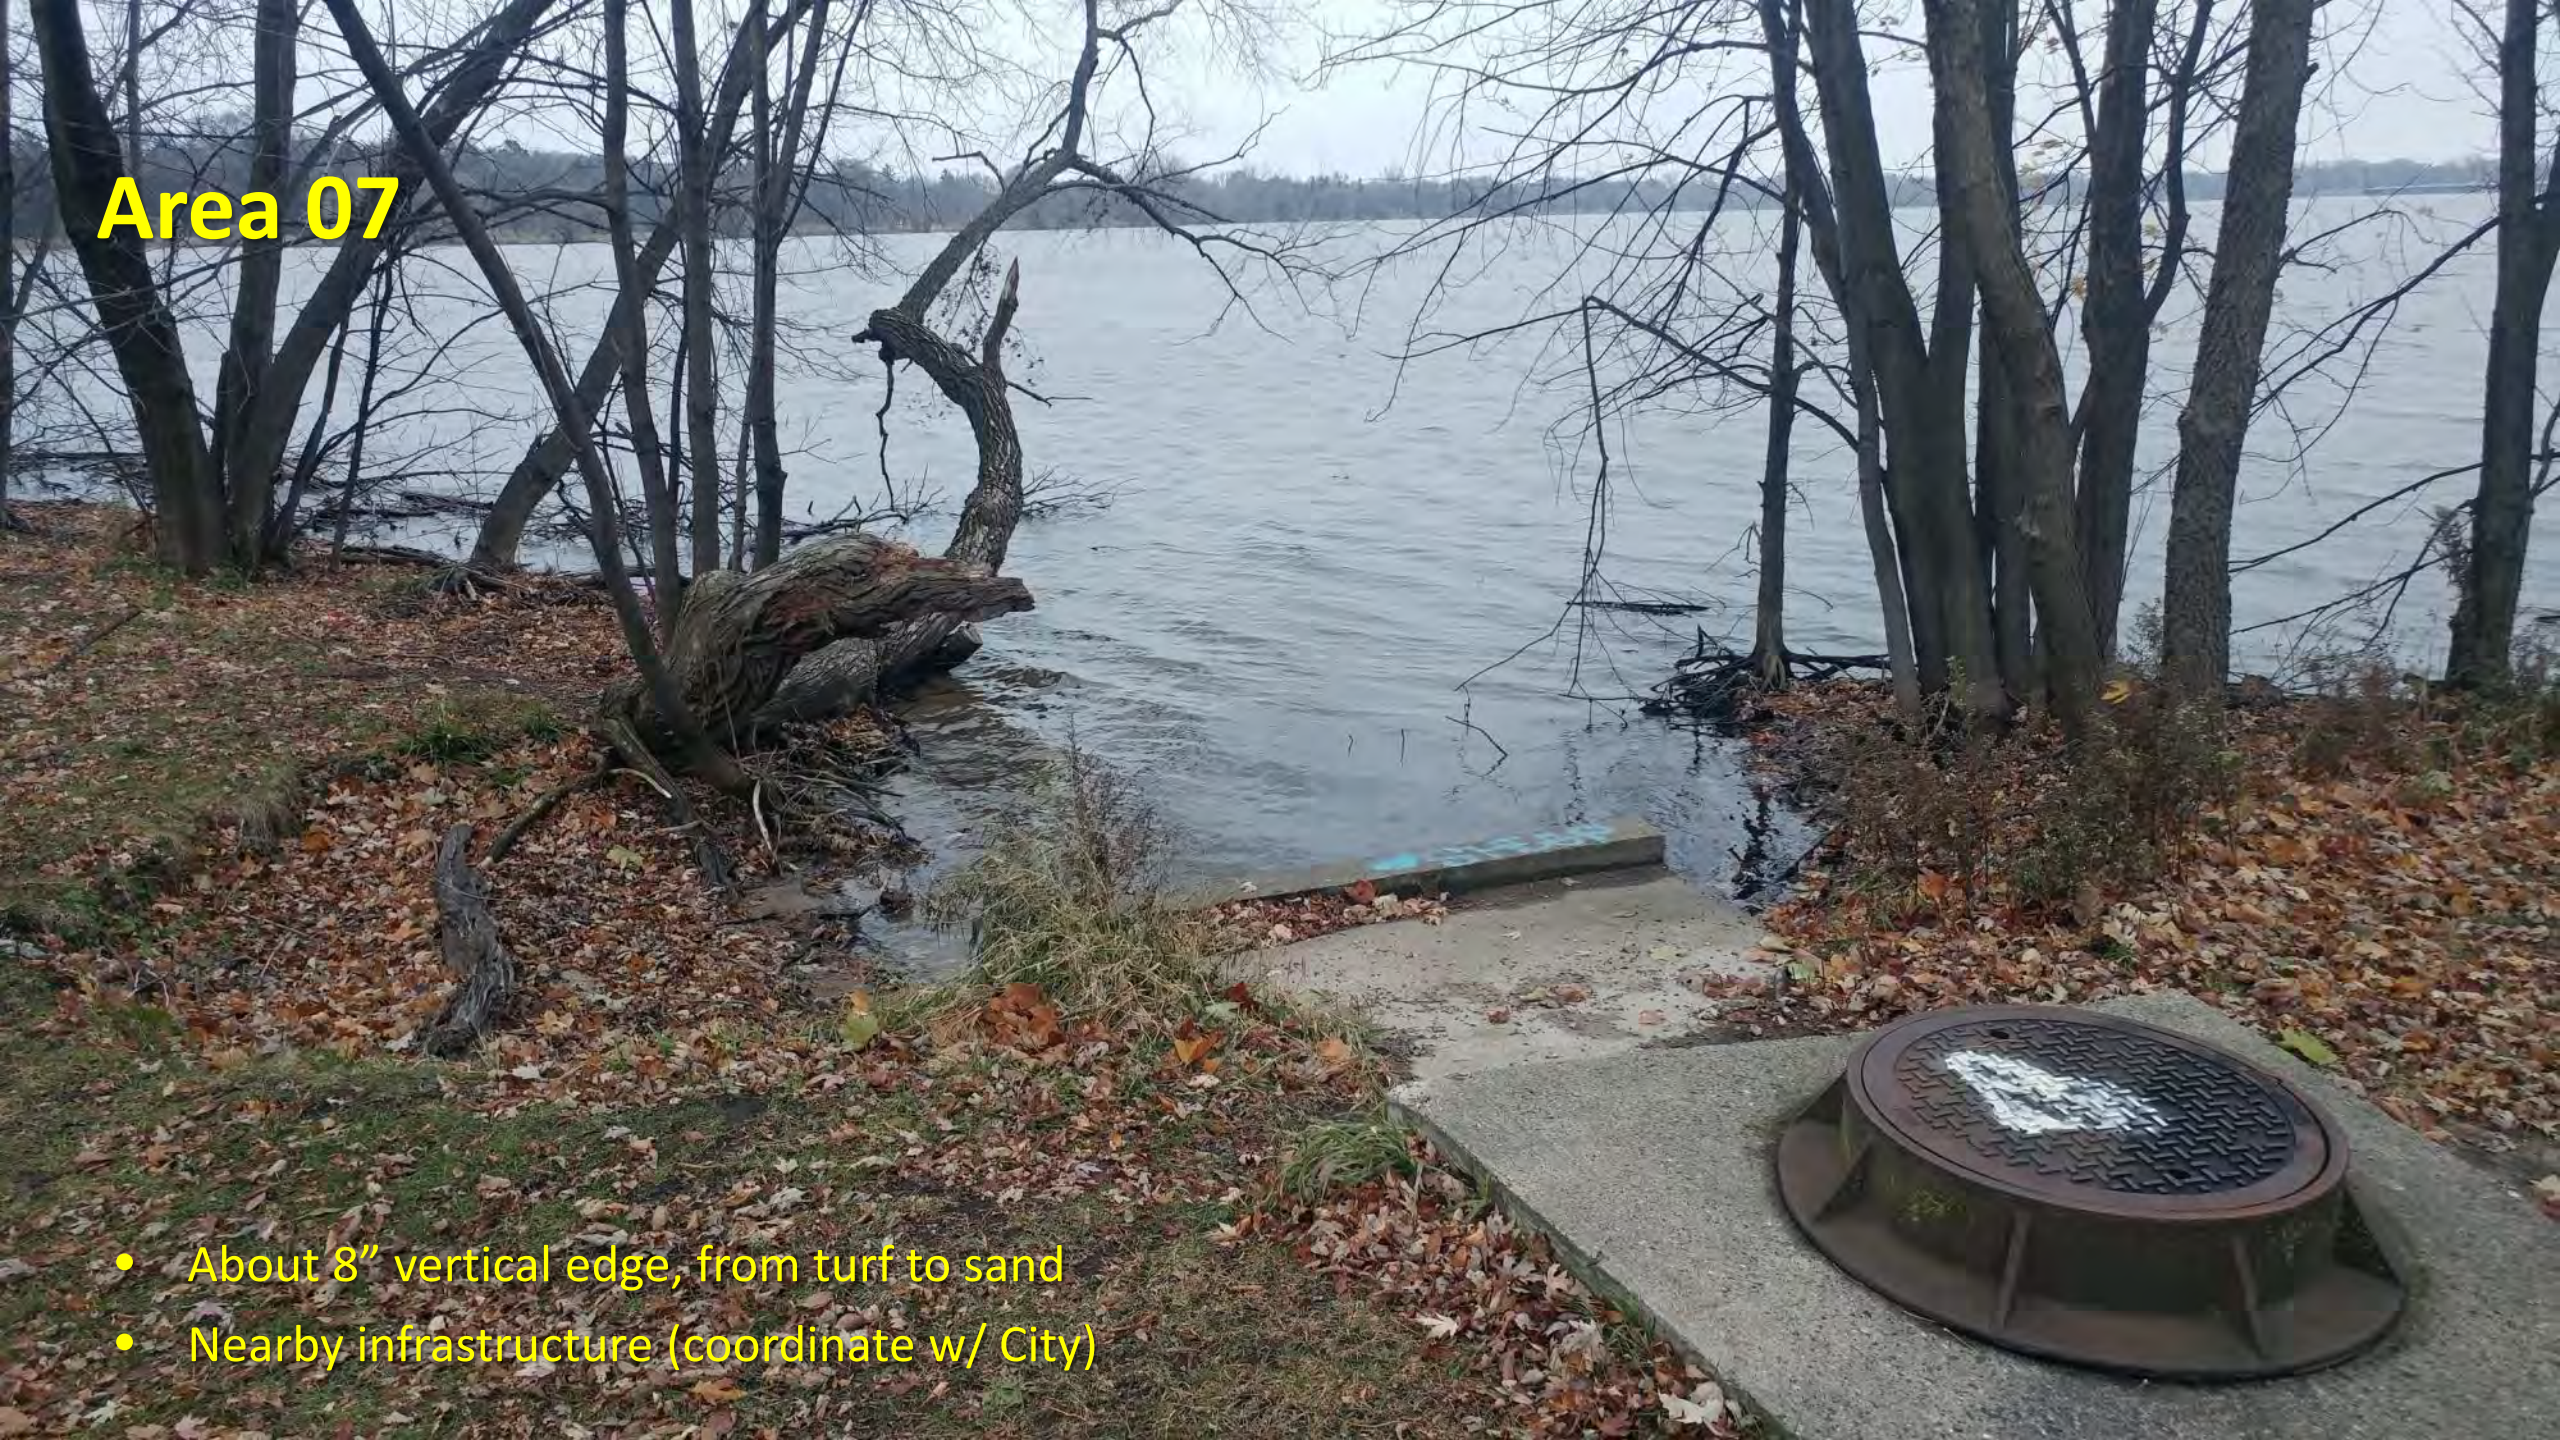
## Area 07

- About 8" vertical edge, from turf to sand
- Nearby infrastructure (coordinate w/ City)

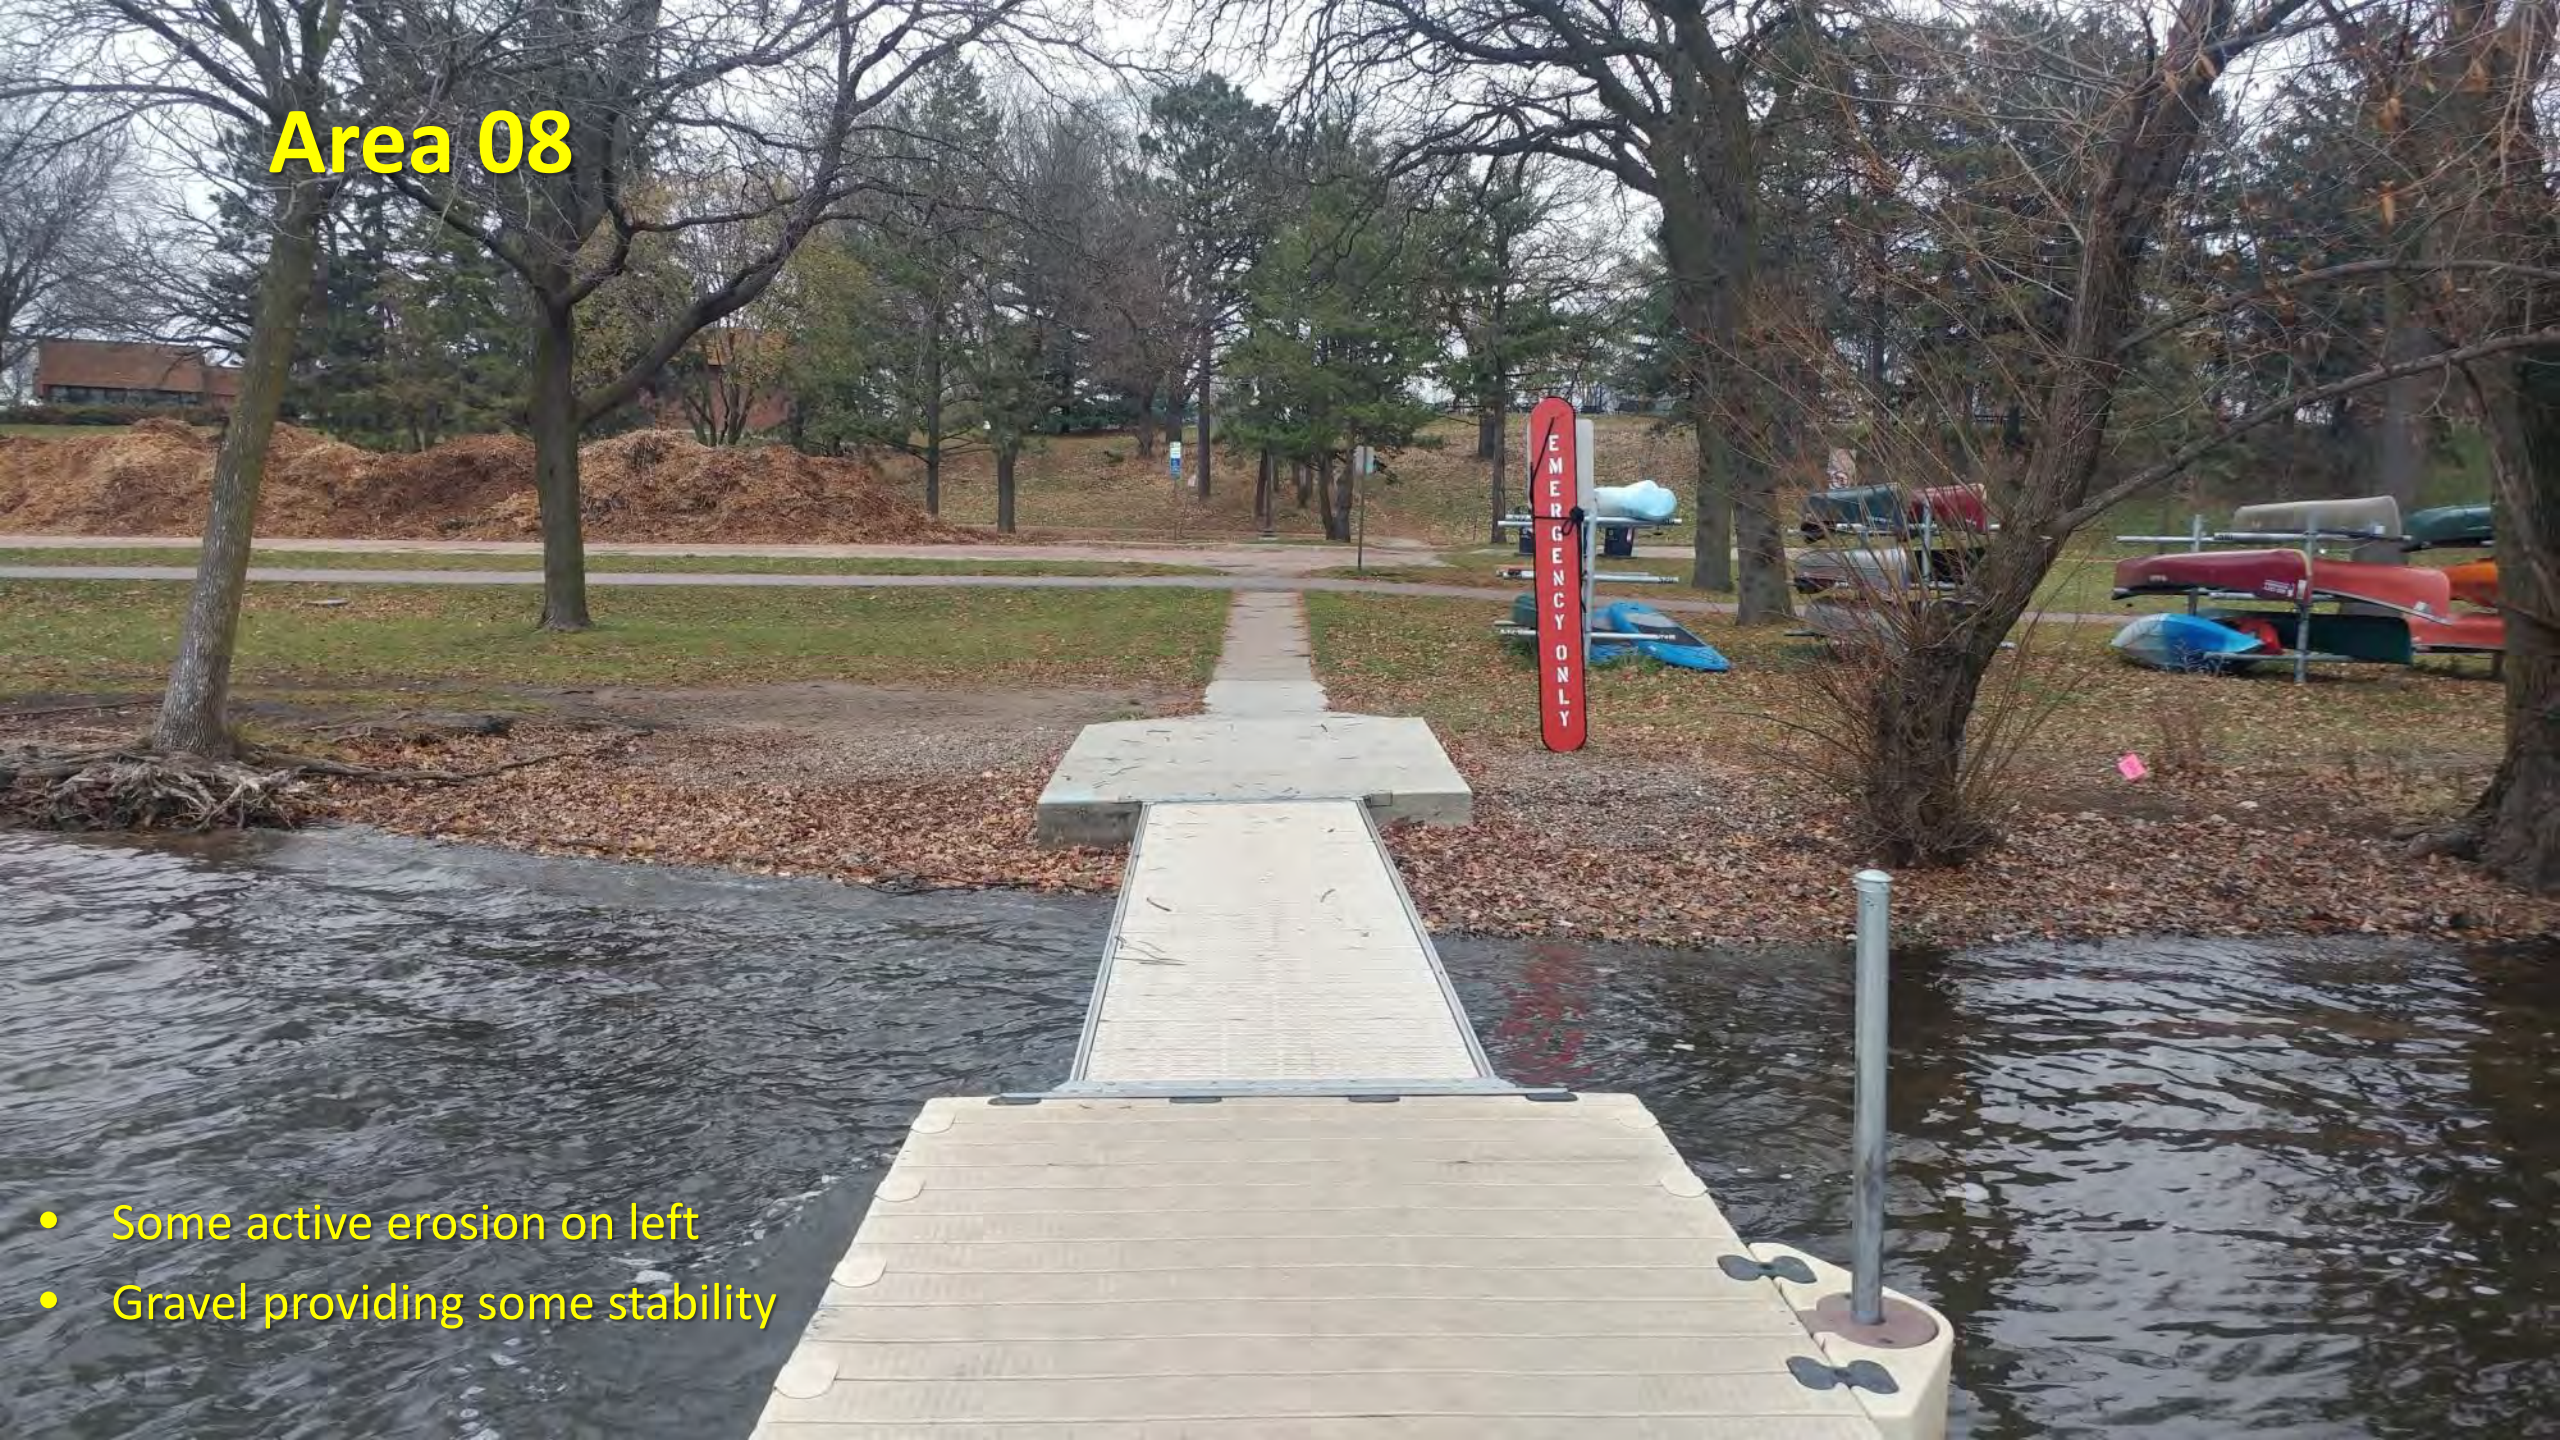
# Area 08

- Some active erosion on left
- Gravel providing some stability

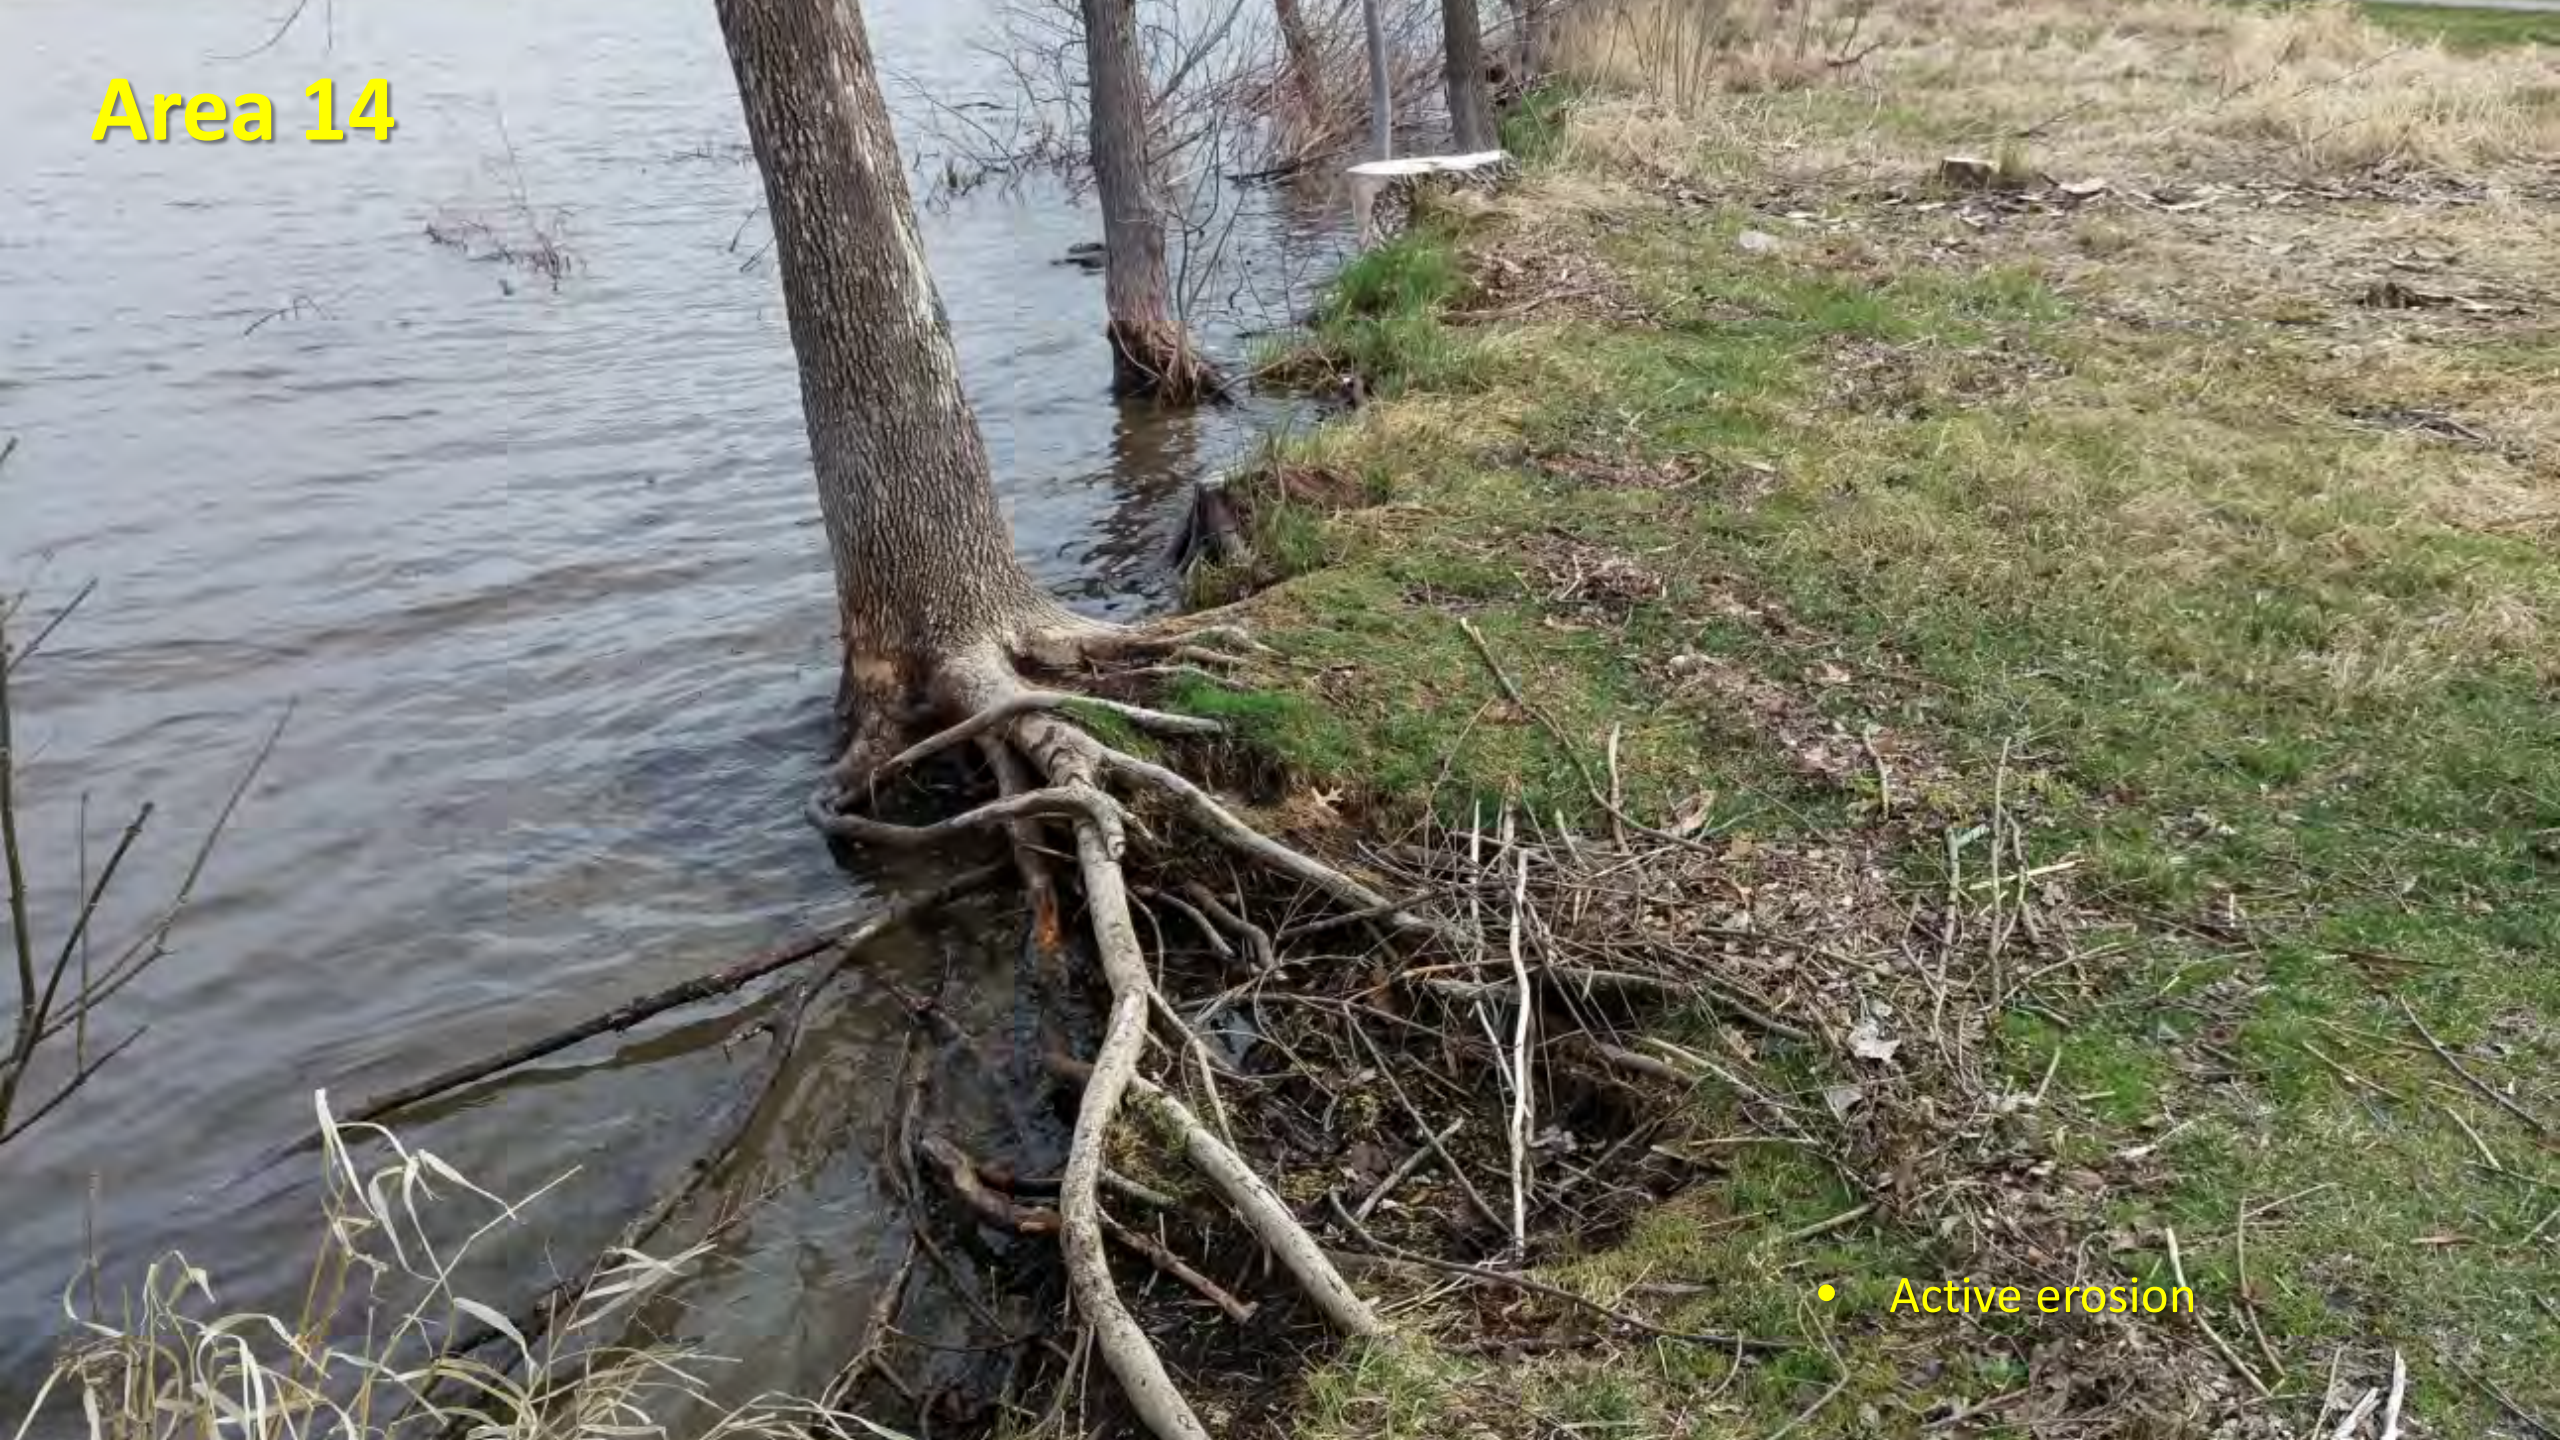
# Area 14

- Active erosion

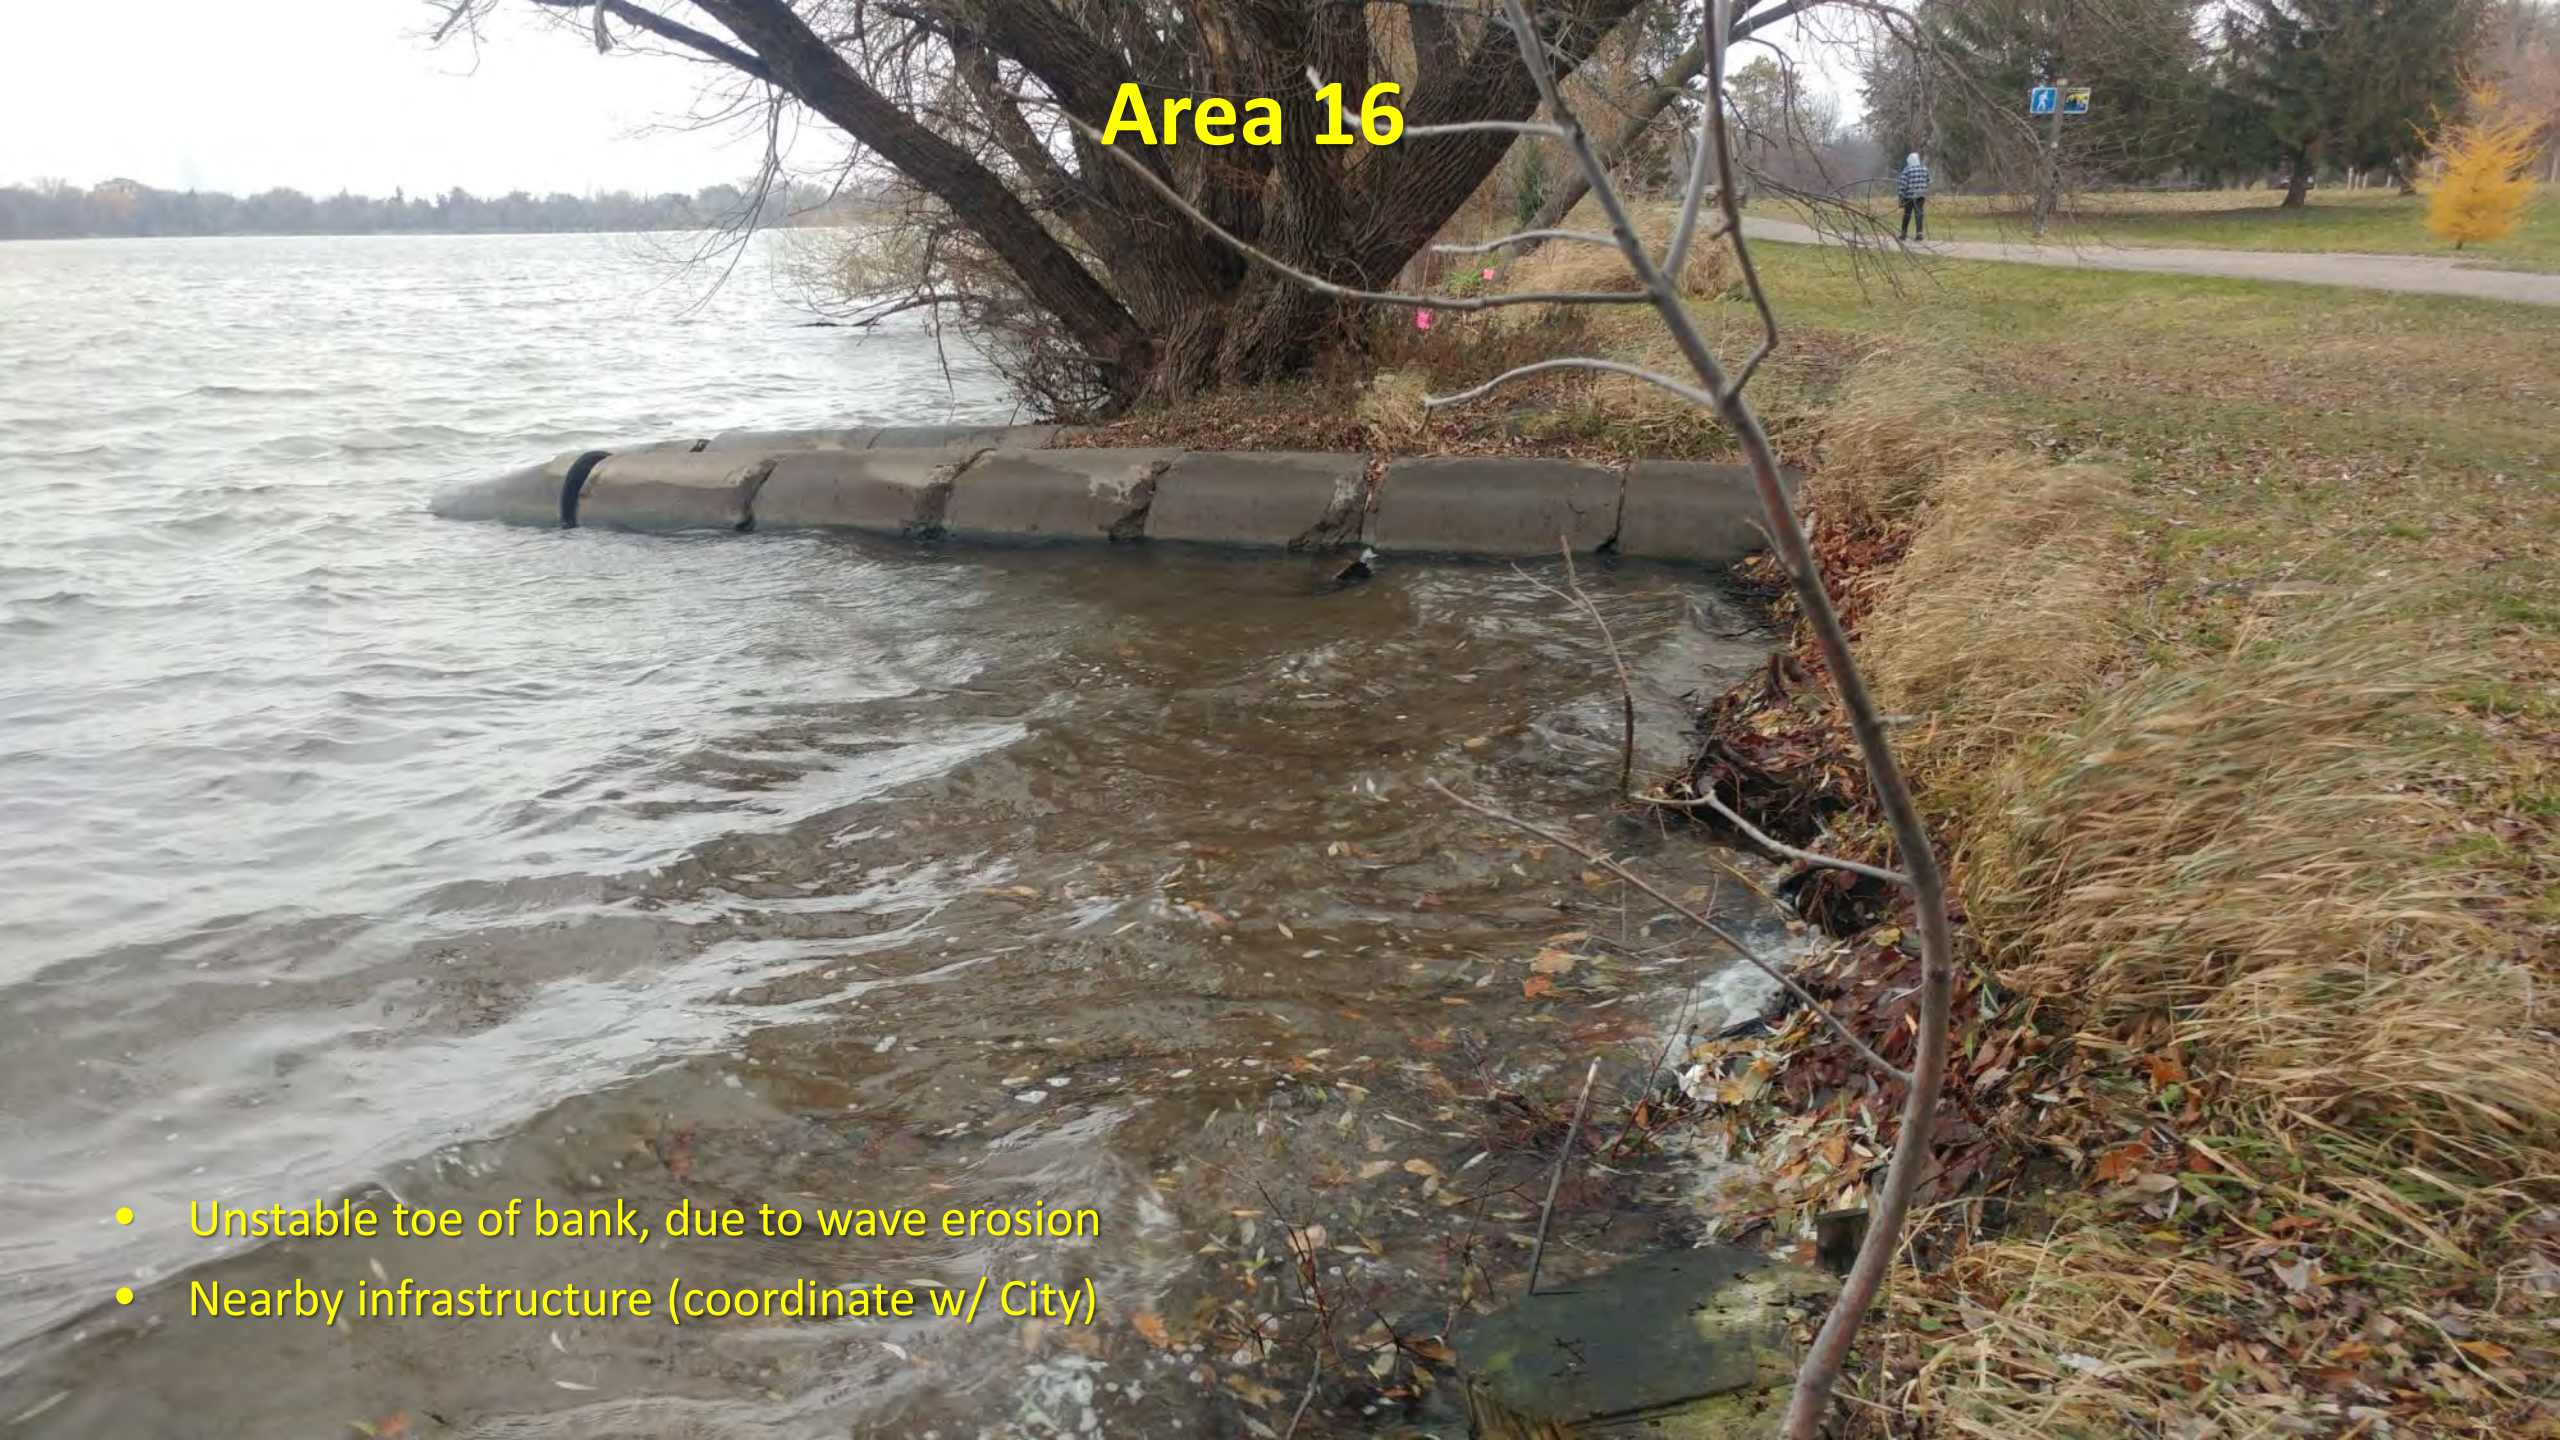
# Area 16

- Unstable toe of bank, due to wave erosion
- Nearby infrastructure (coordinate w/ City)
