# Lake Nokomis Shoreline Enhancement Project

## Community Meeting 2

February 13, 2018

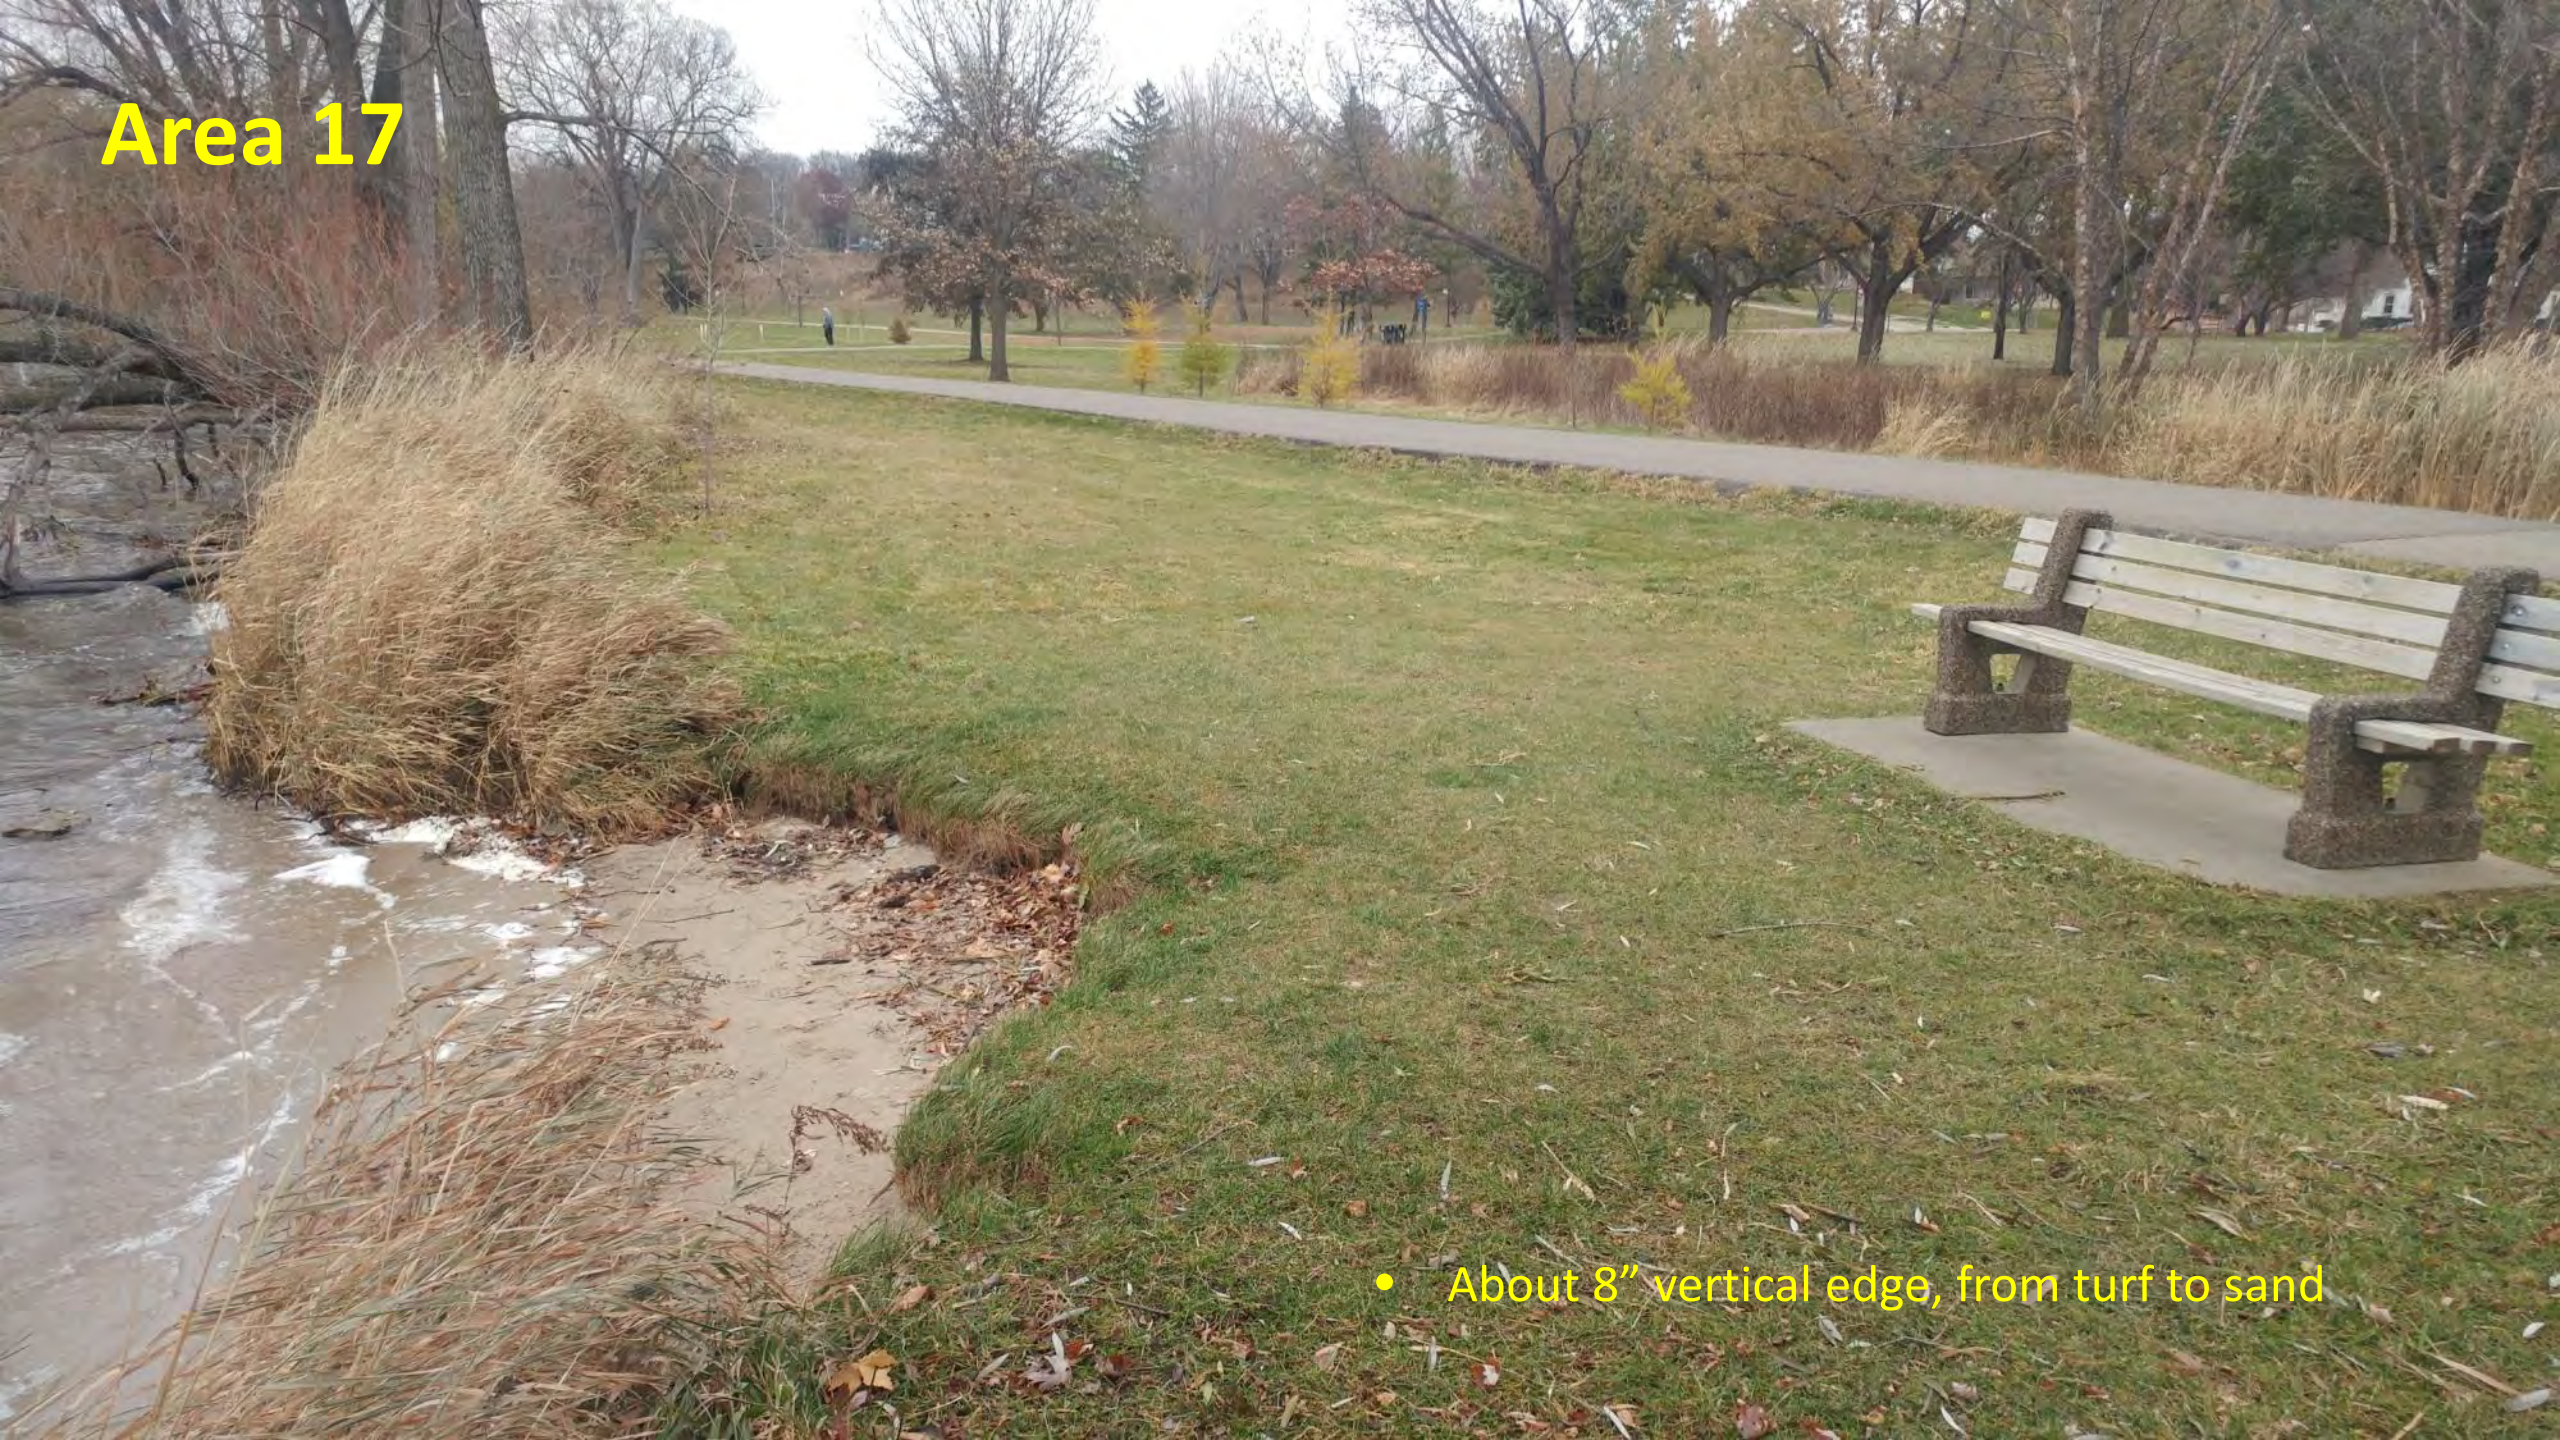
# Area 17

- About 8" vertical edge, from turf to sand

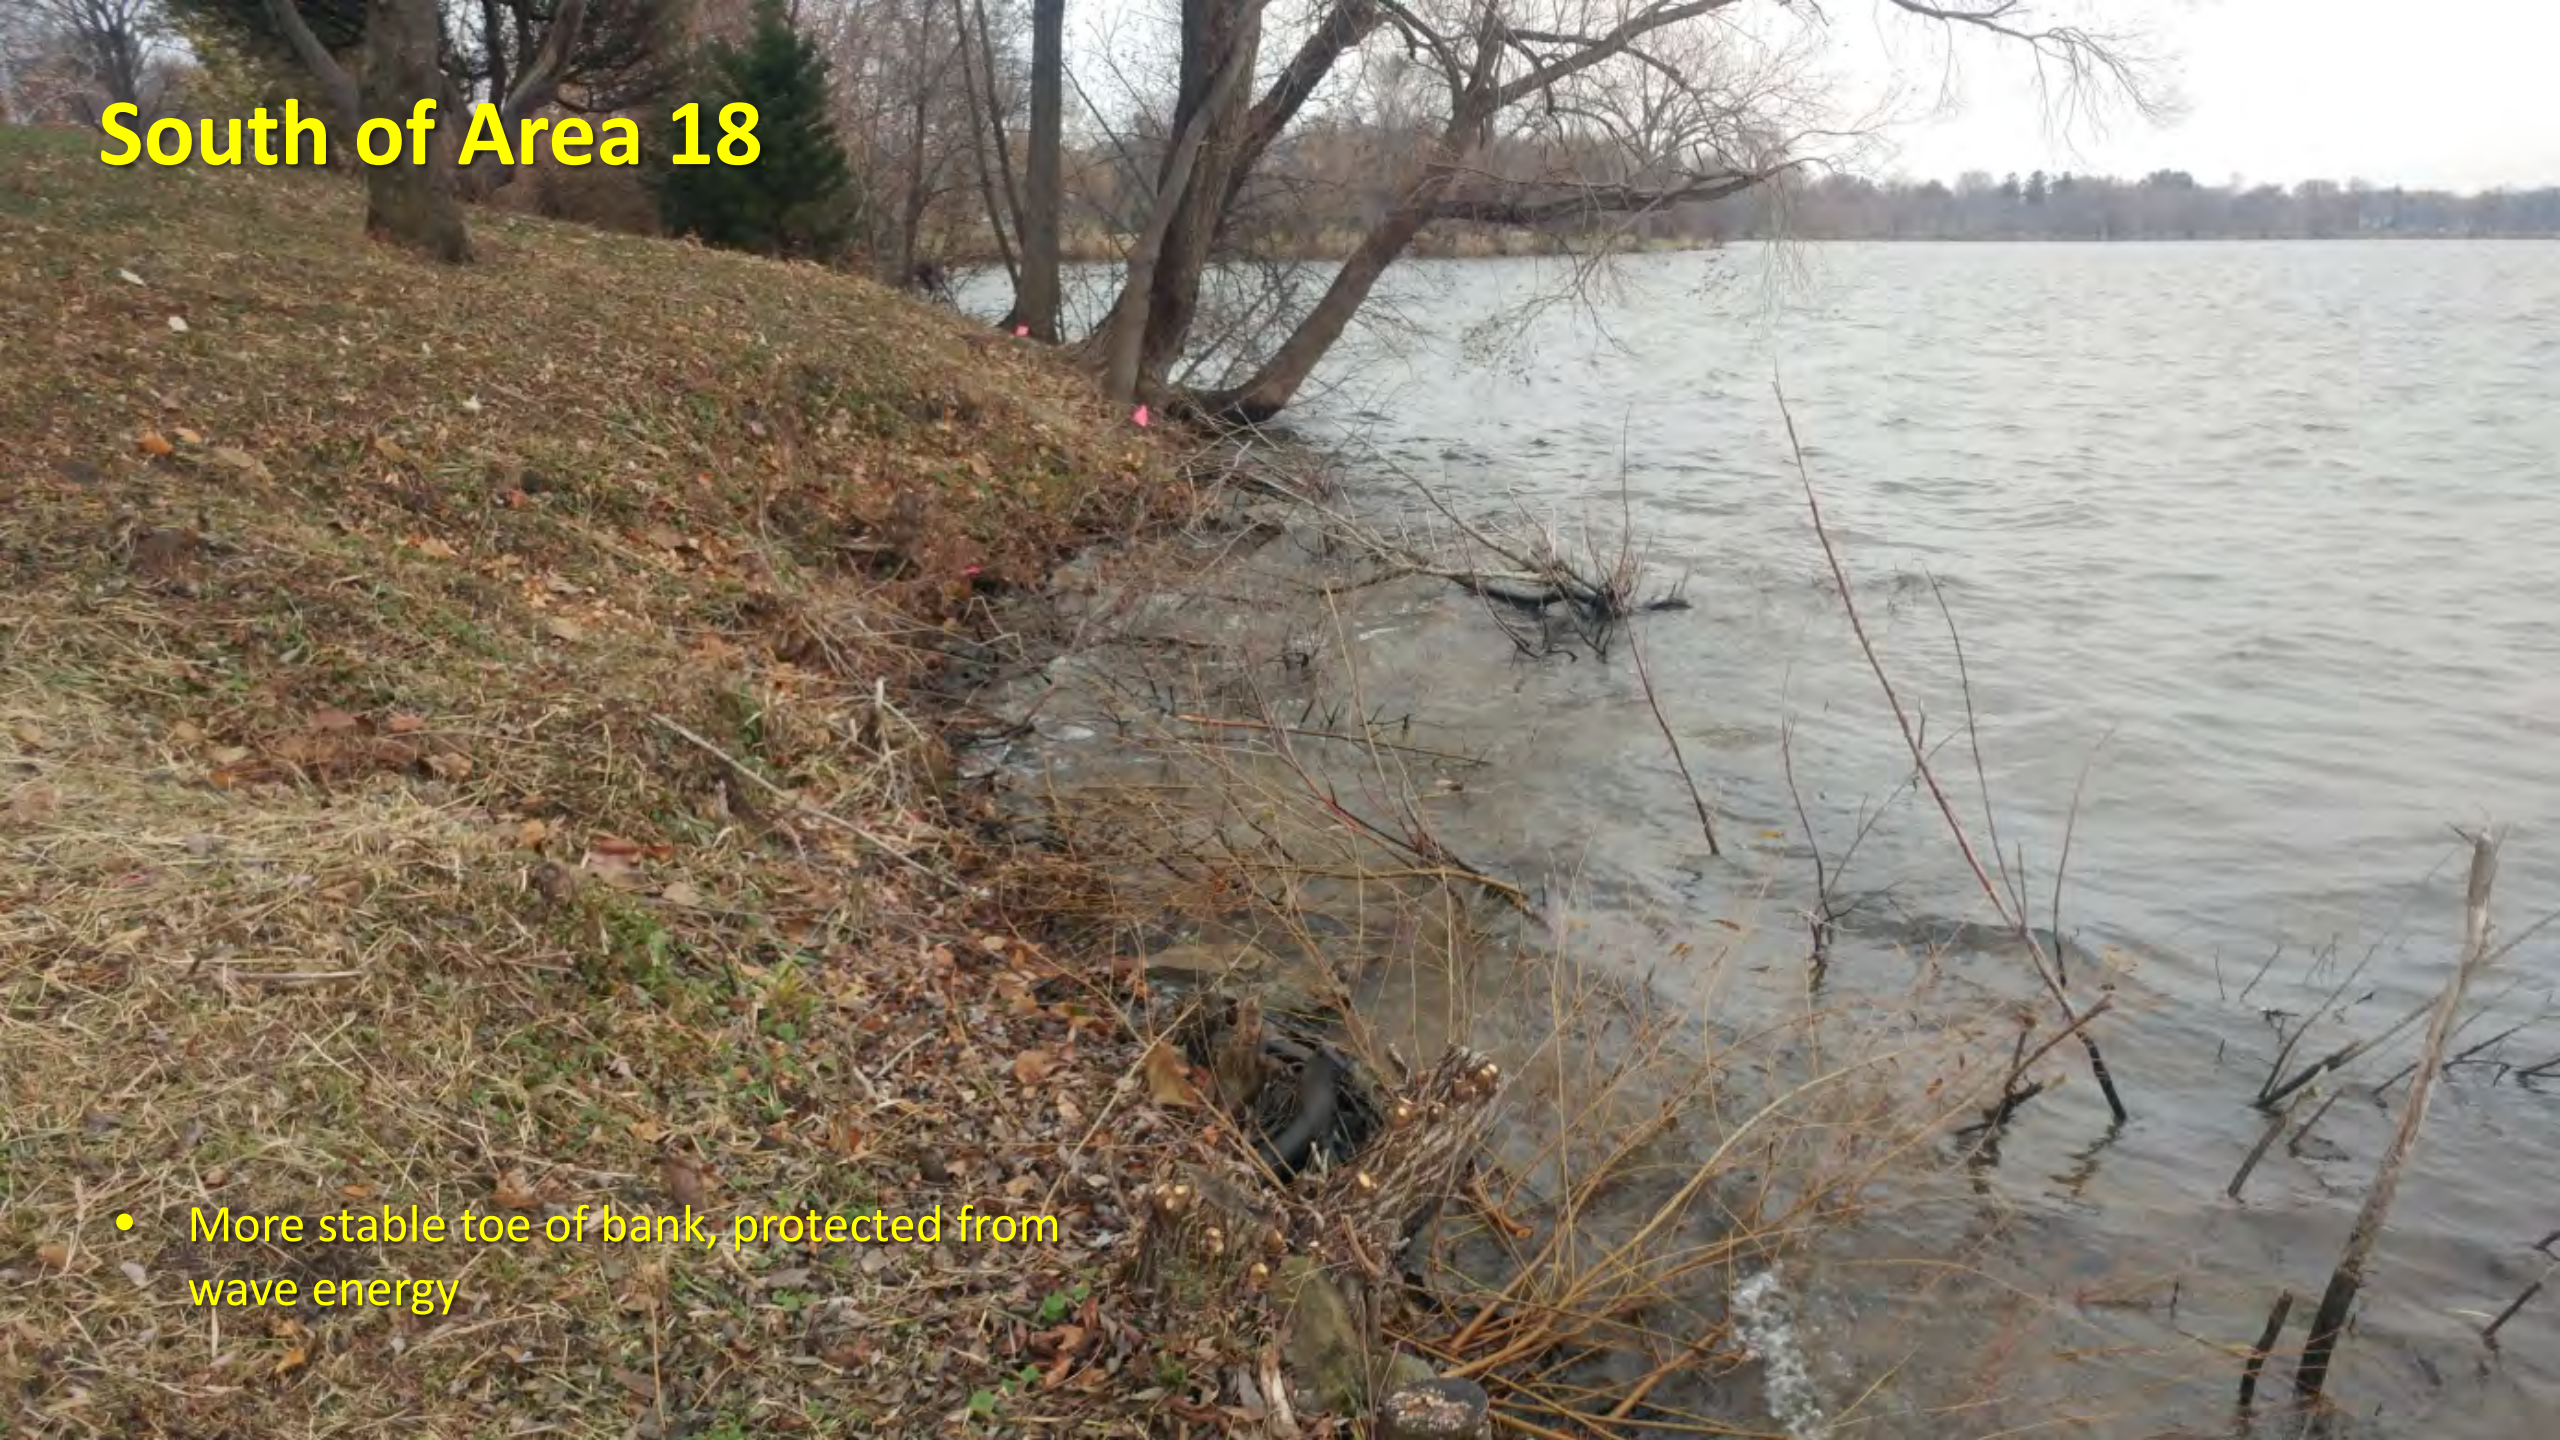
## Area 18

- Unstable toe of bank, due to wave erosion
- Potential WPA walls may limit interventions here

- More stable toe of bank, protected from wave energy

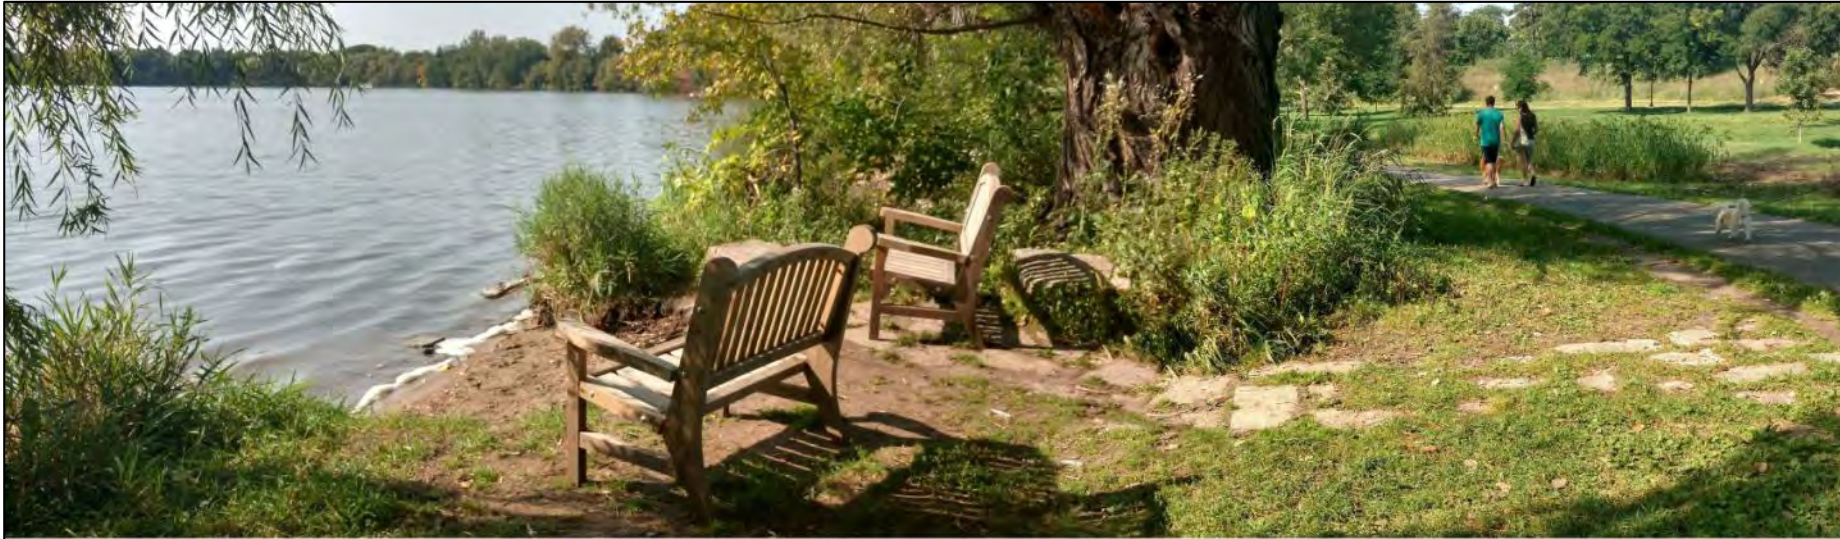
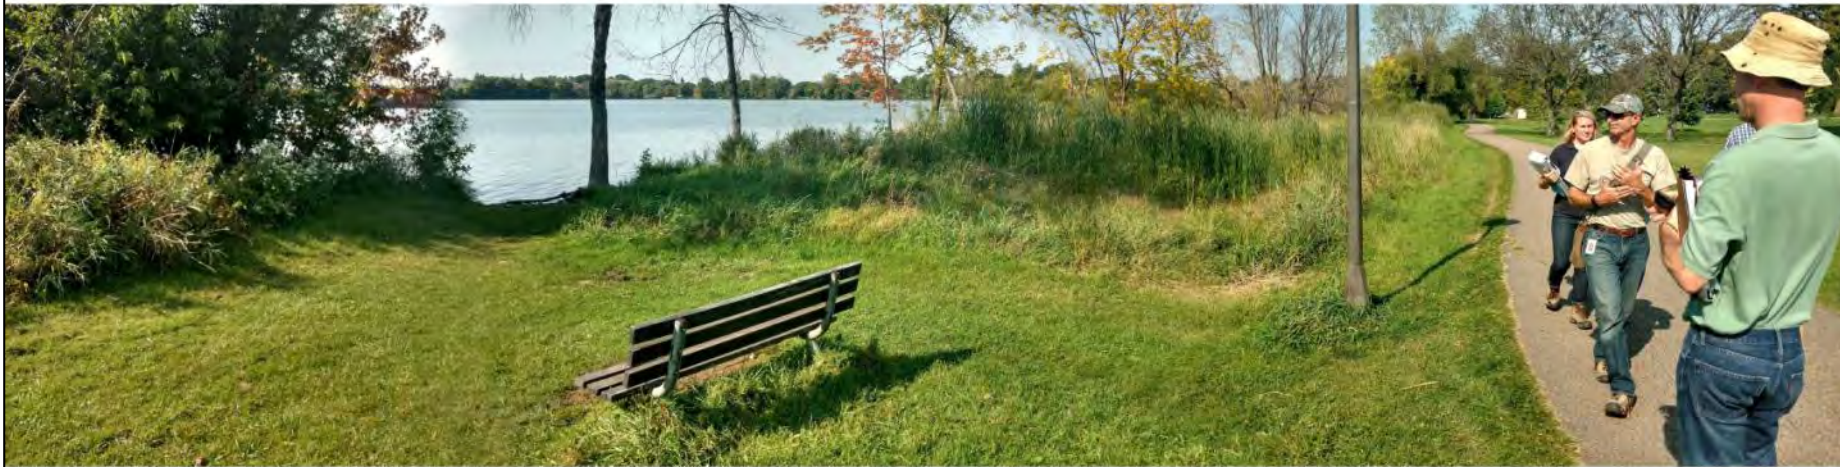
# Existing Lakeshore Access

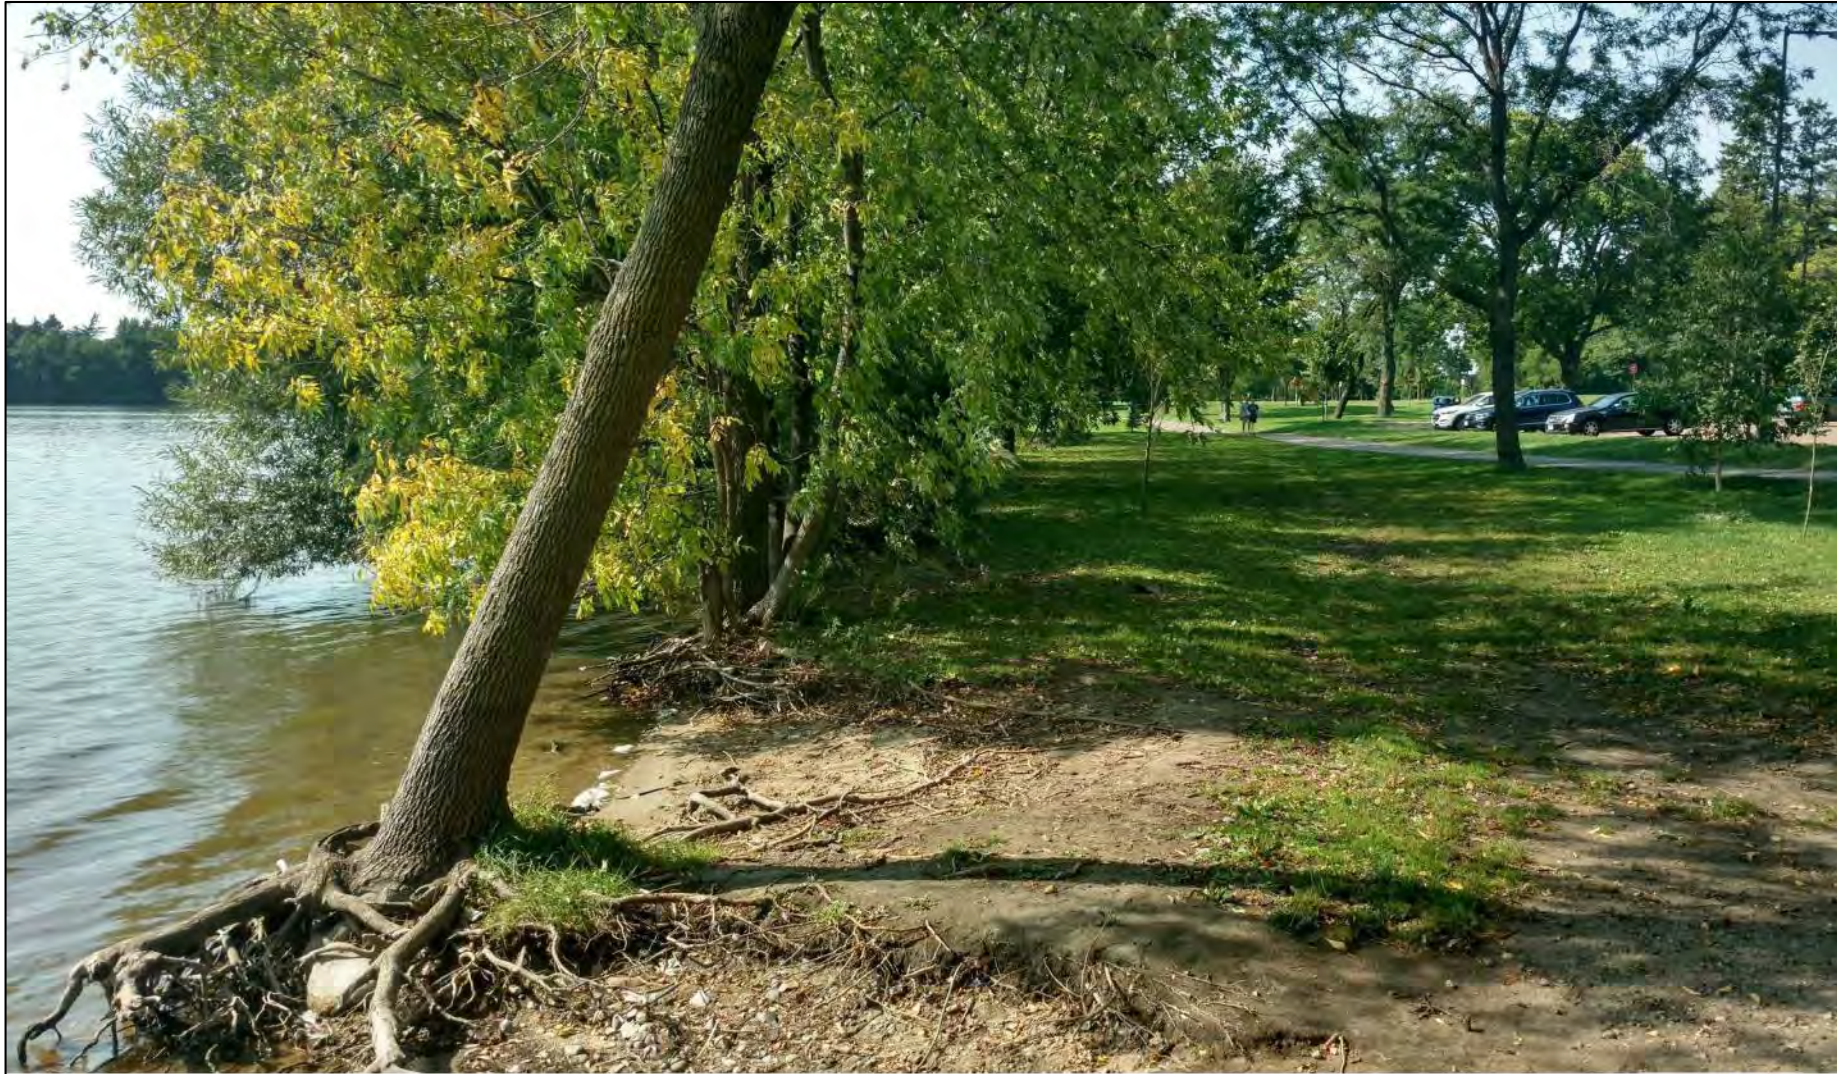
# Existing Lakeshore Access

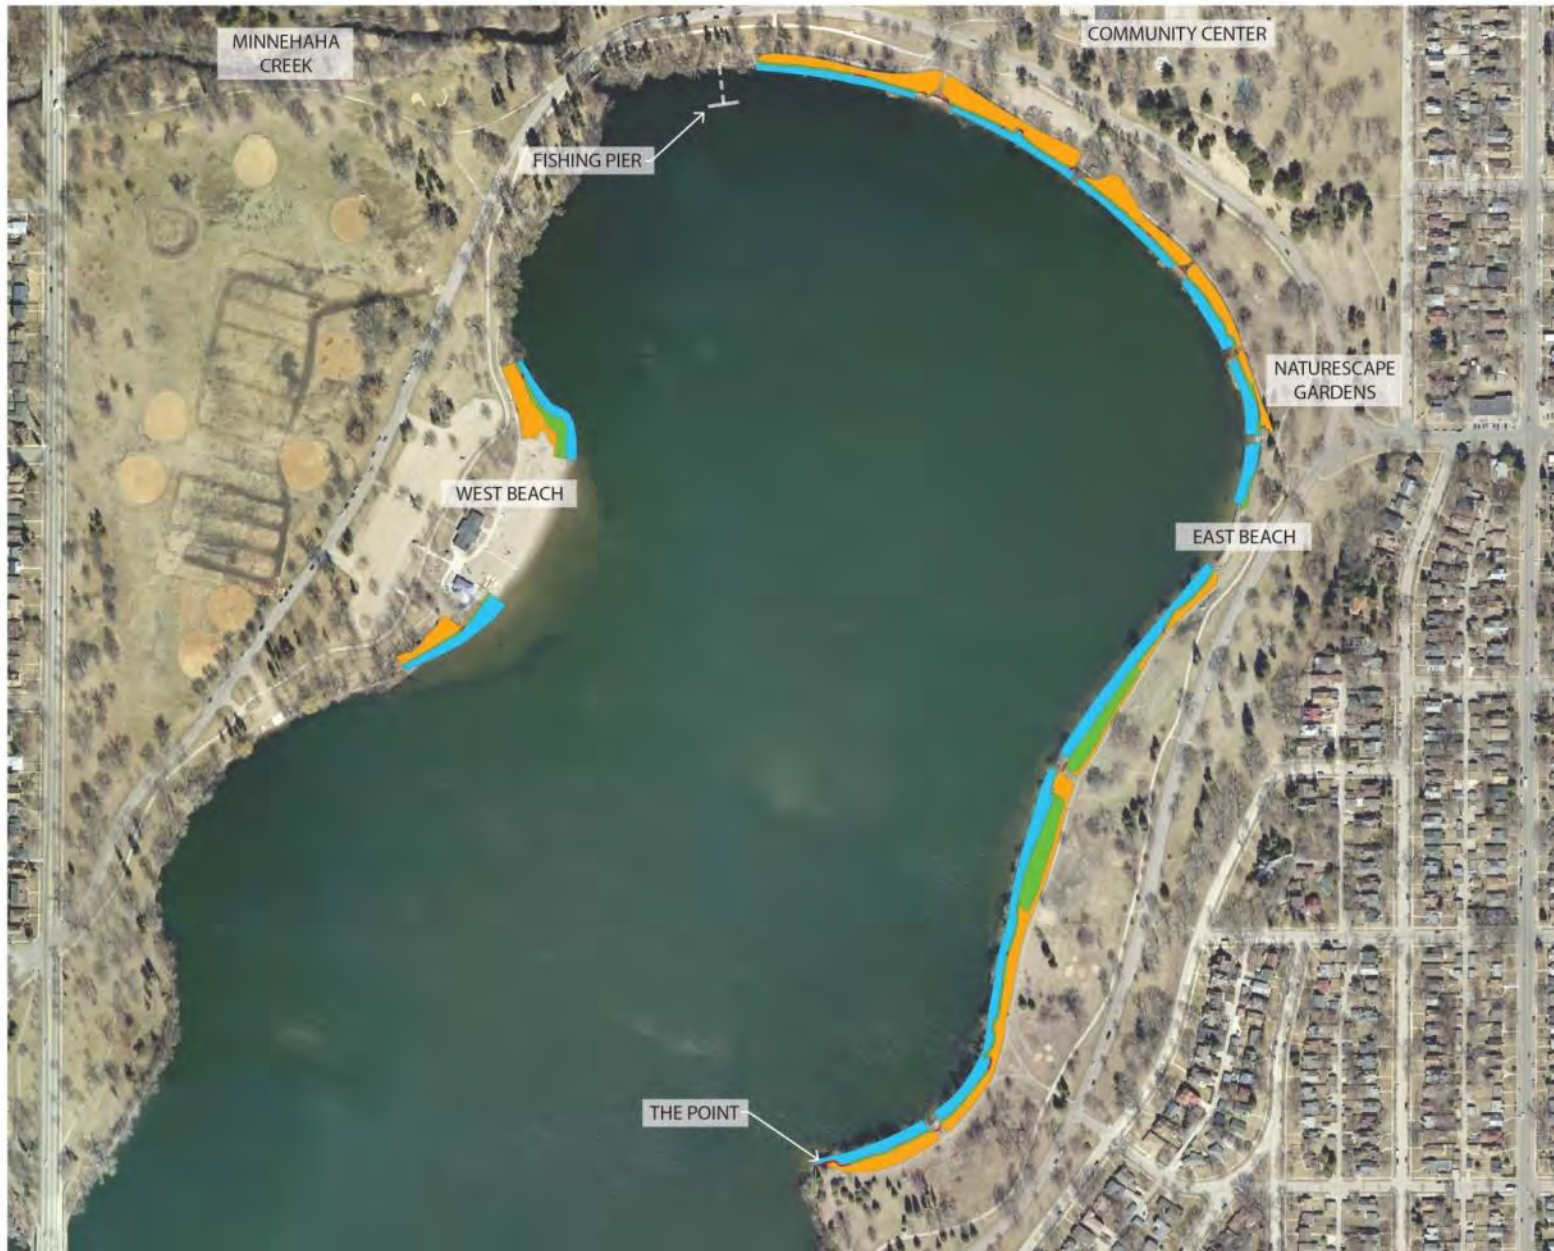
# Draft Schematic Design – Restoration Zones

- from within 2ft of trail to wetland delineation line
- mostly short mesic prairie and areas of wet prairie (depressions in turf)

- from wetland delineation line to water's edge (at ~OHWL)
- mostly wet prairie/wet meadow vegetation
- shoreline stabilization (where warranted) & thinning of woody veg.

- from water's edge to depth of approximately 2ft
- diversity of shallow emergent species near shoreline
- transitioning to only hardstem bulrush out to 2ft depth

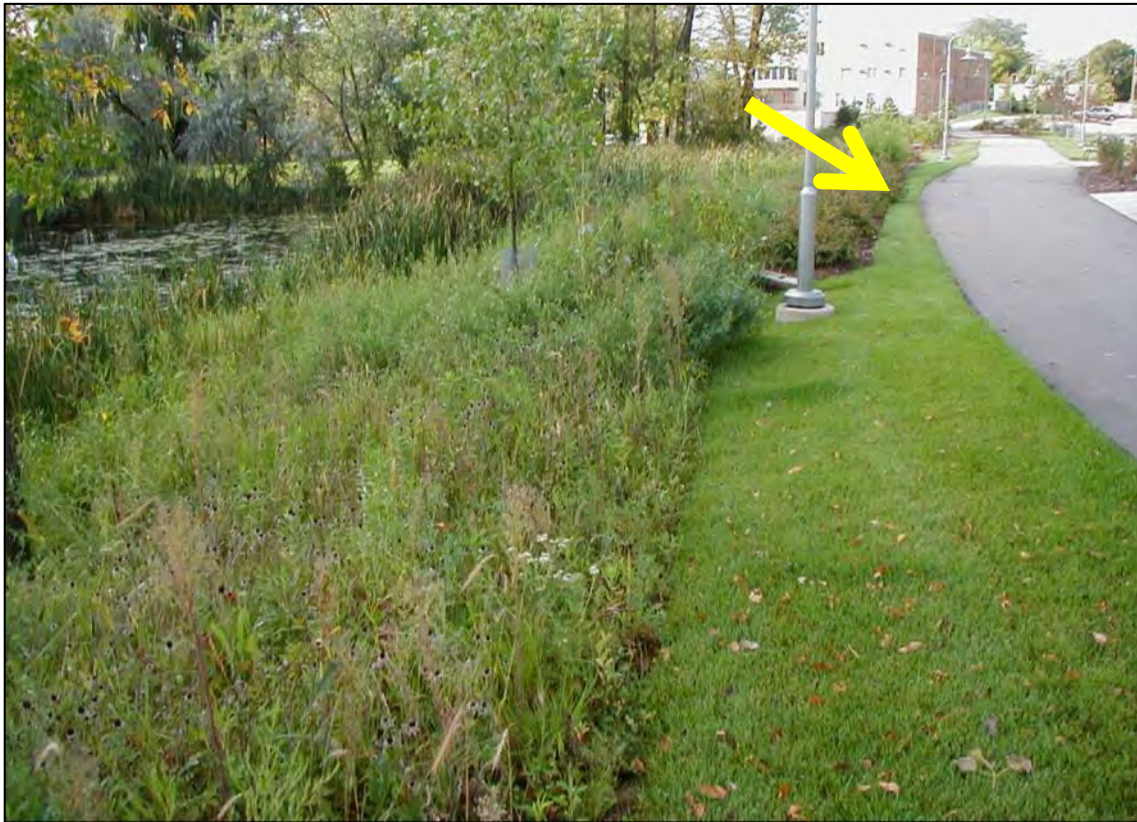
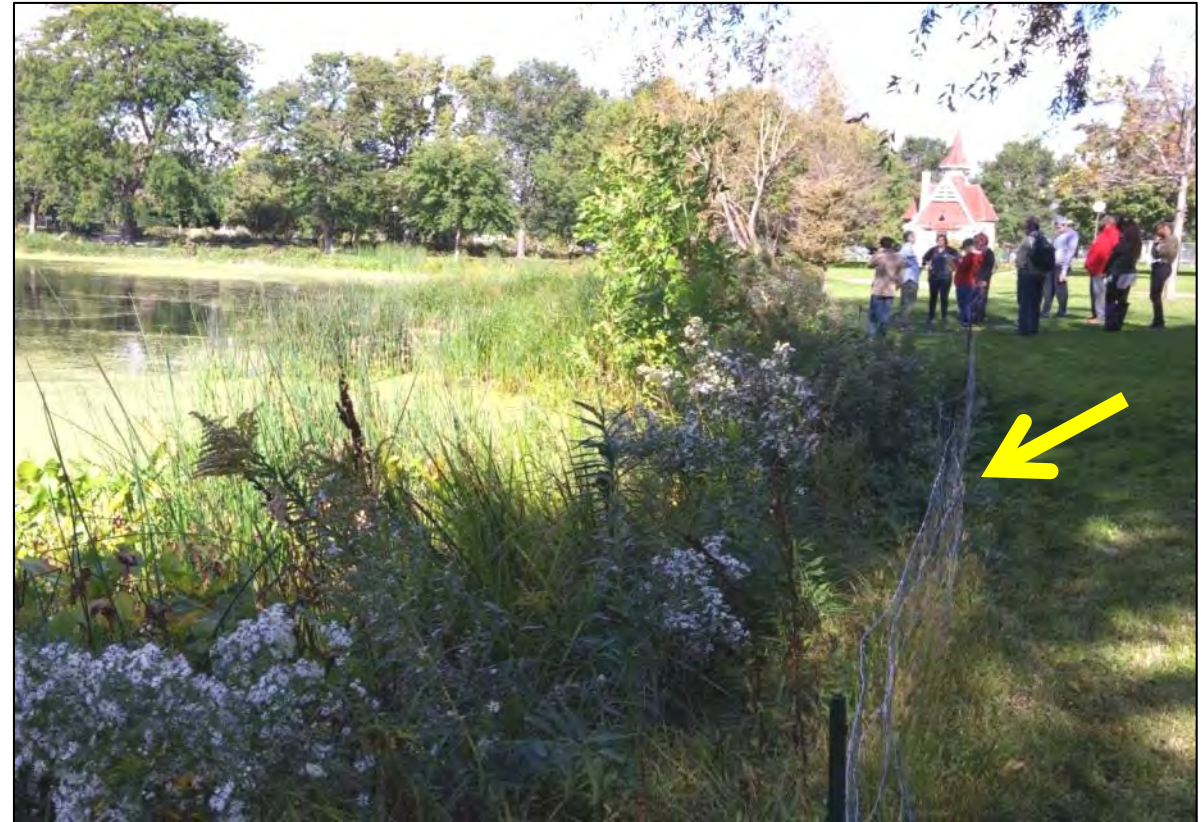
# Upland Buffer

- ~2-foot mowed turf edge along paved trail
- Temporary wire mesh fence to protect plantings, ~2 feet from paved trail

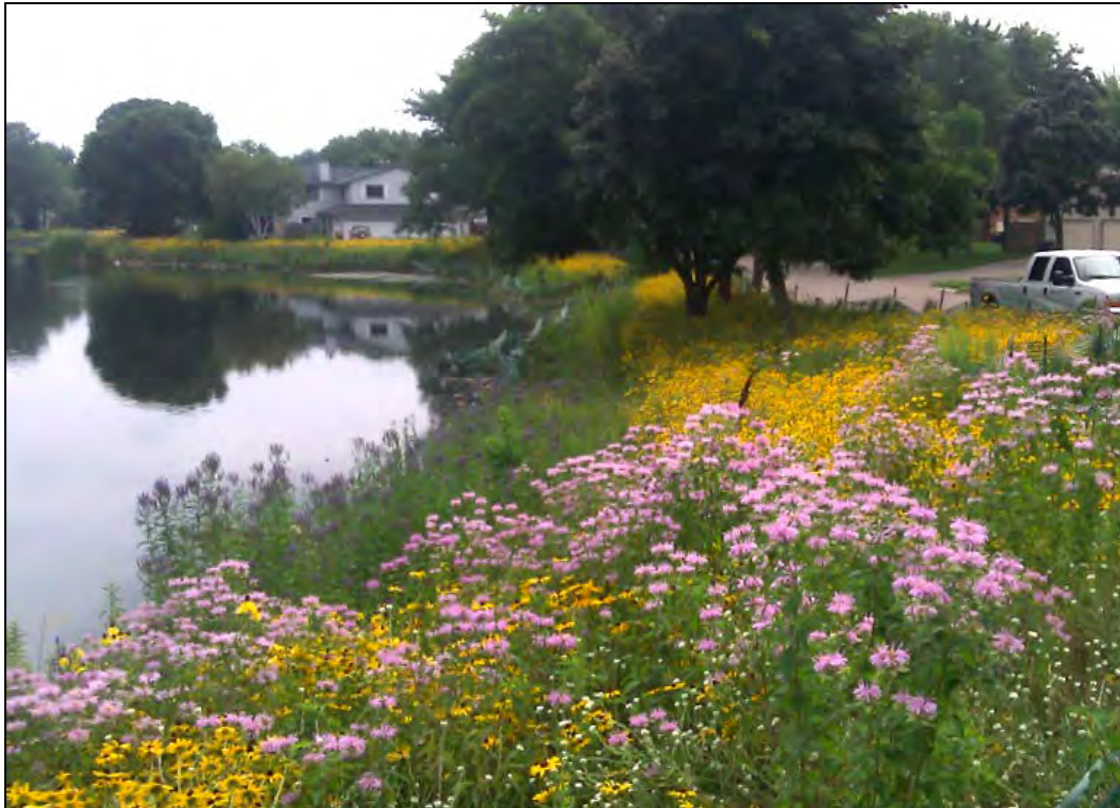
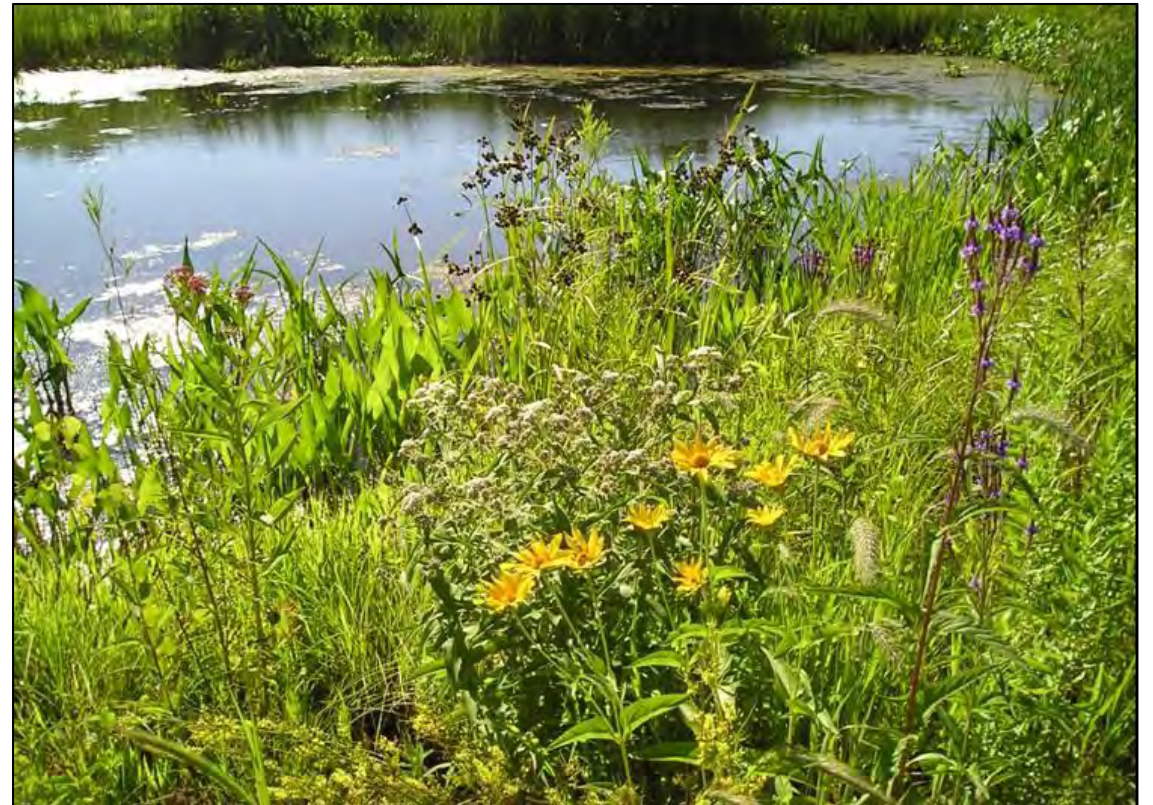
# Upland Buffer & Shoreline Buffer

- Diverse native shorelines (including many pollinator species)
- Mostly shorter species, with areas of taller plants

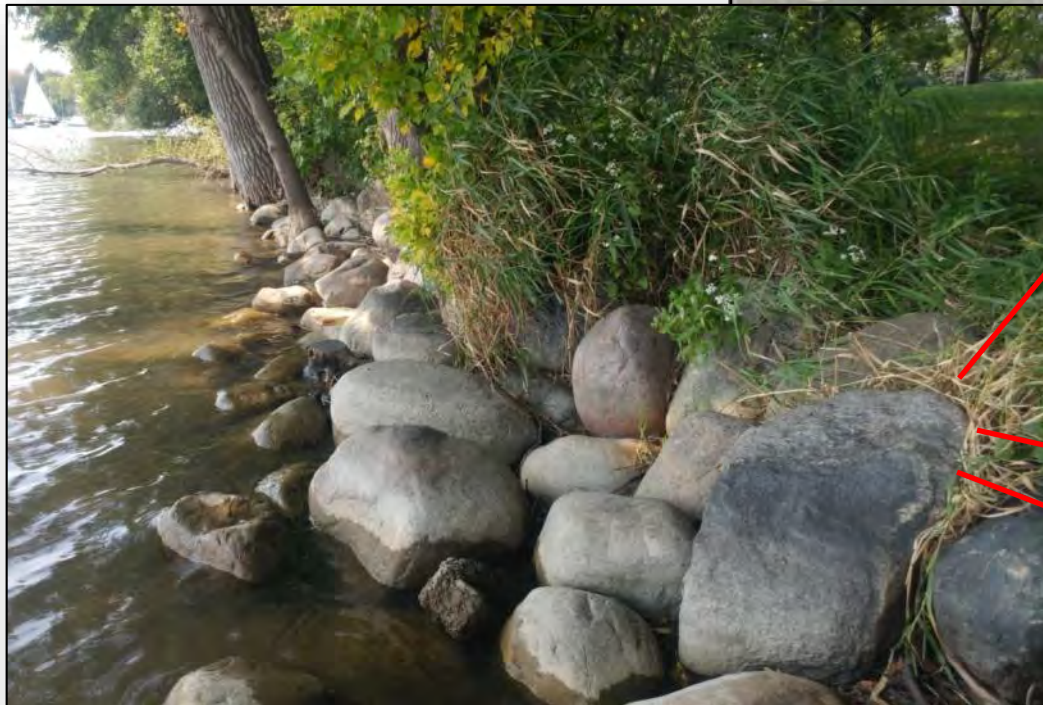
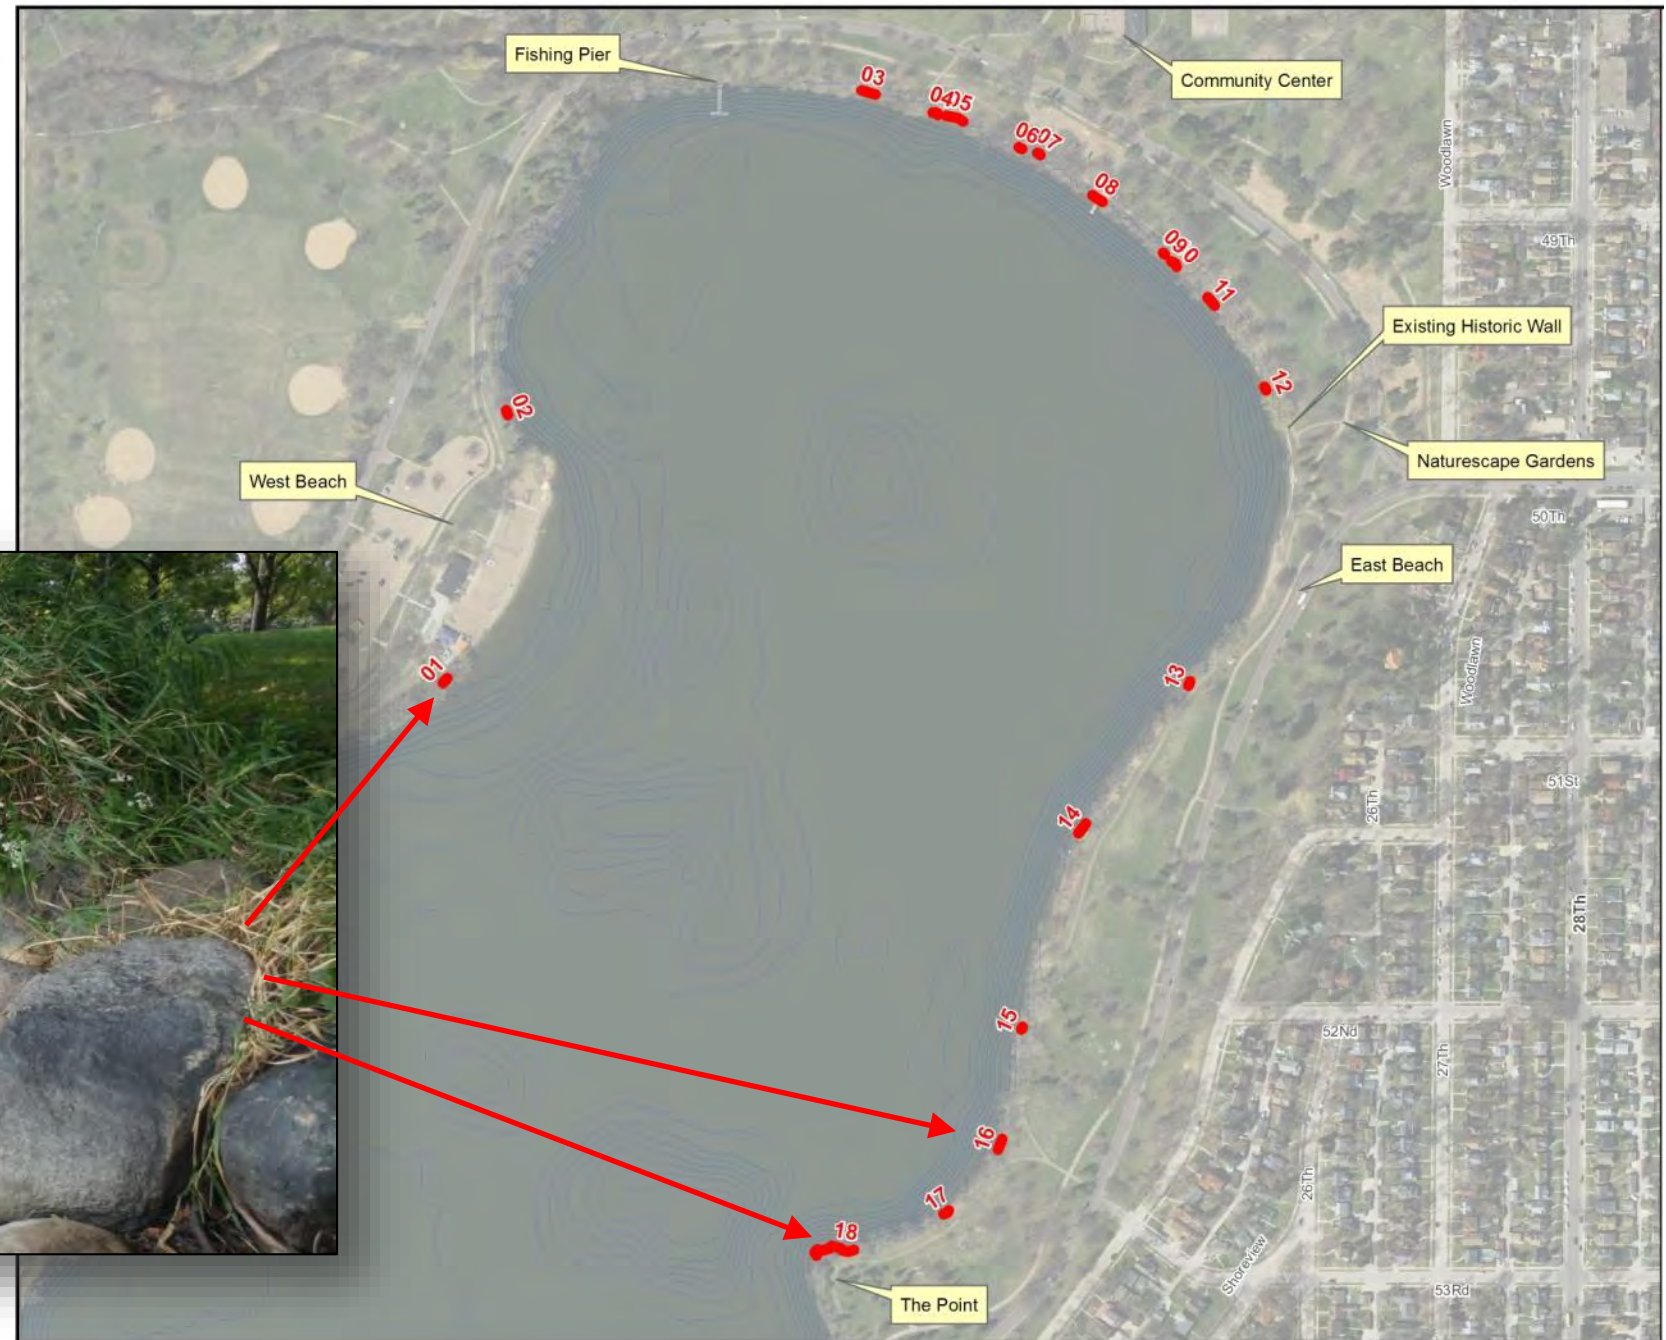
# Shoreline Stabilization

- Riprap toe protection in only 2-3 locations

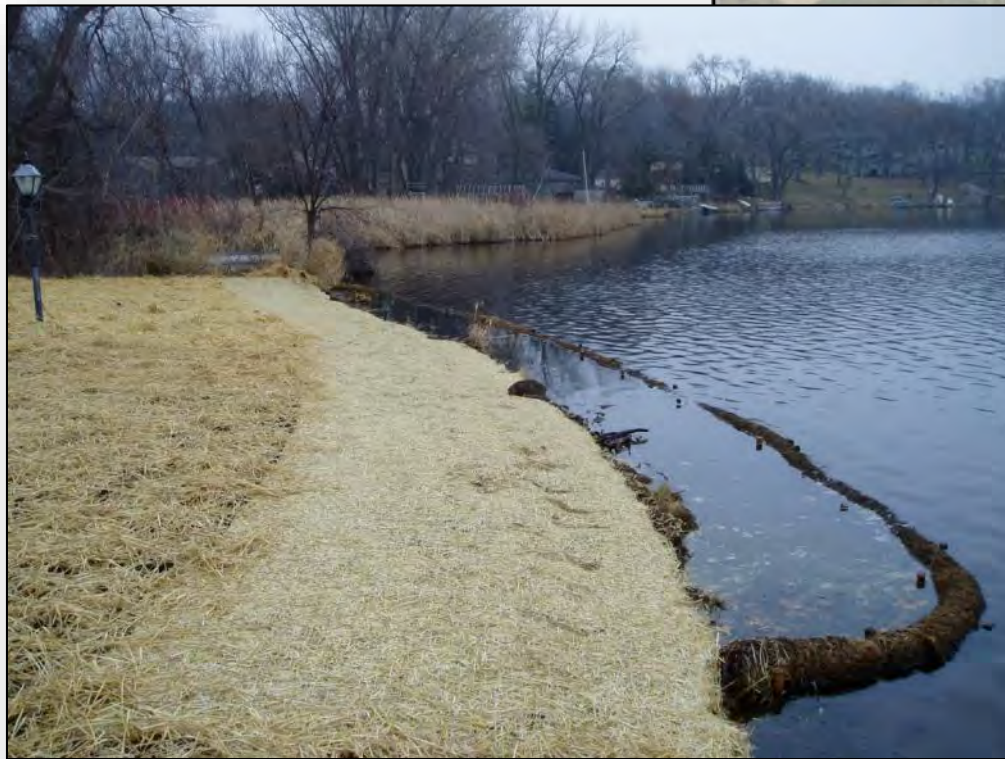
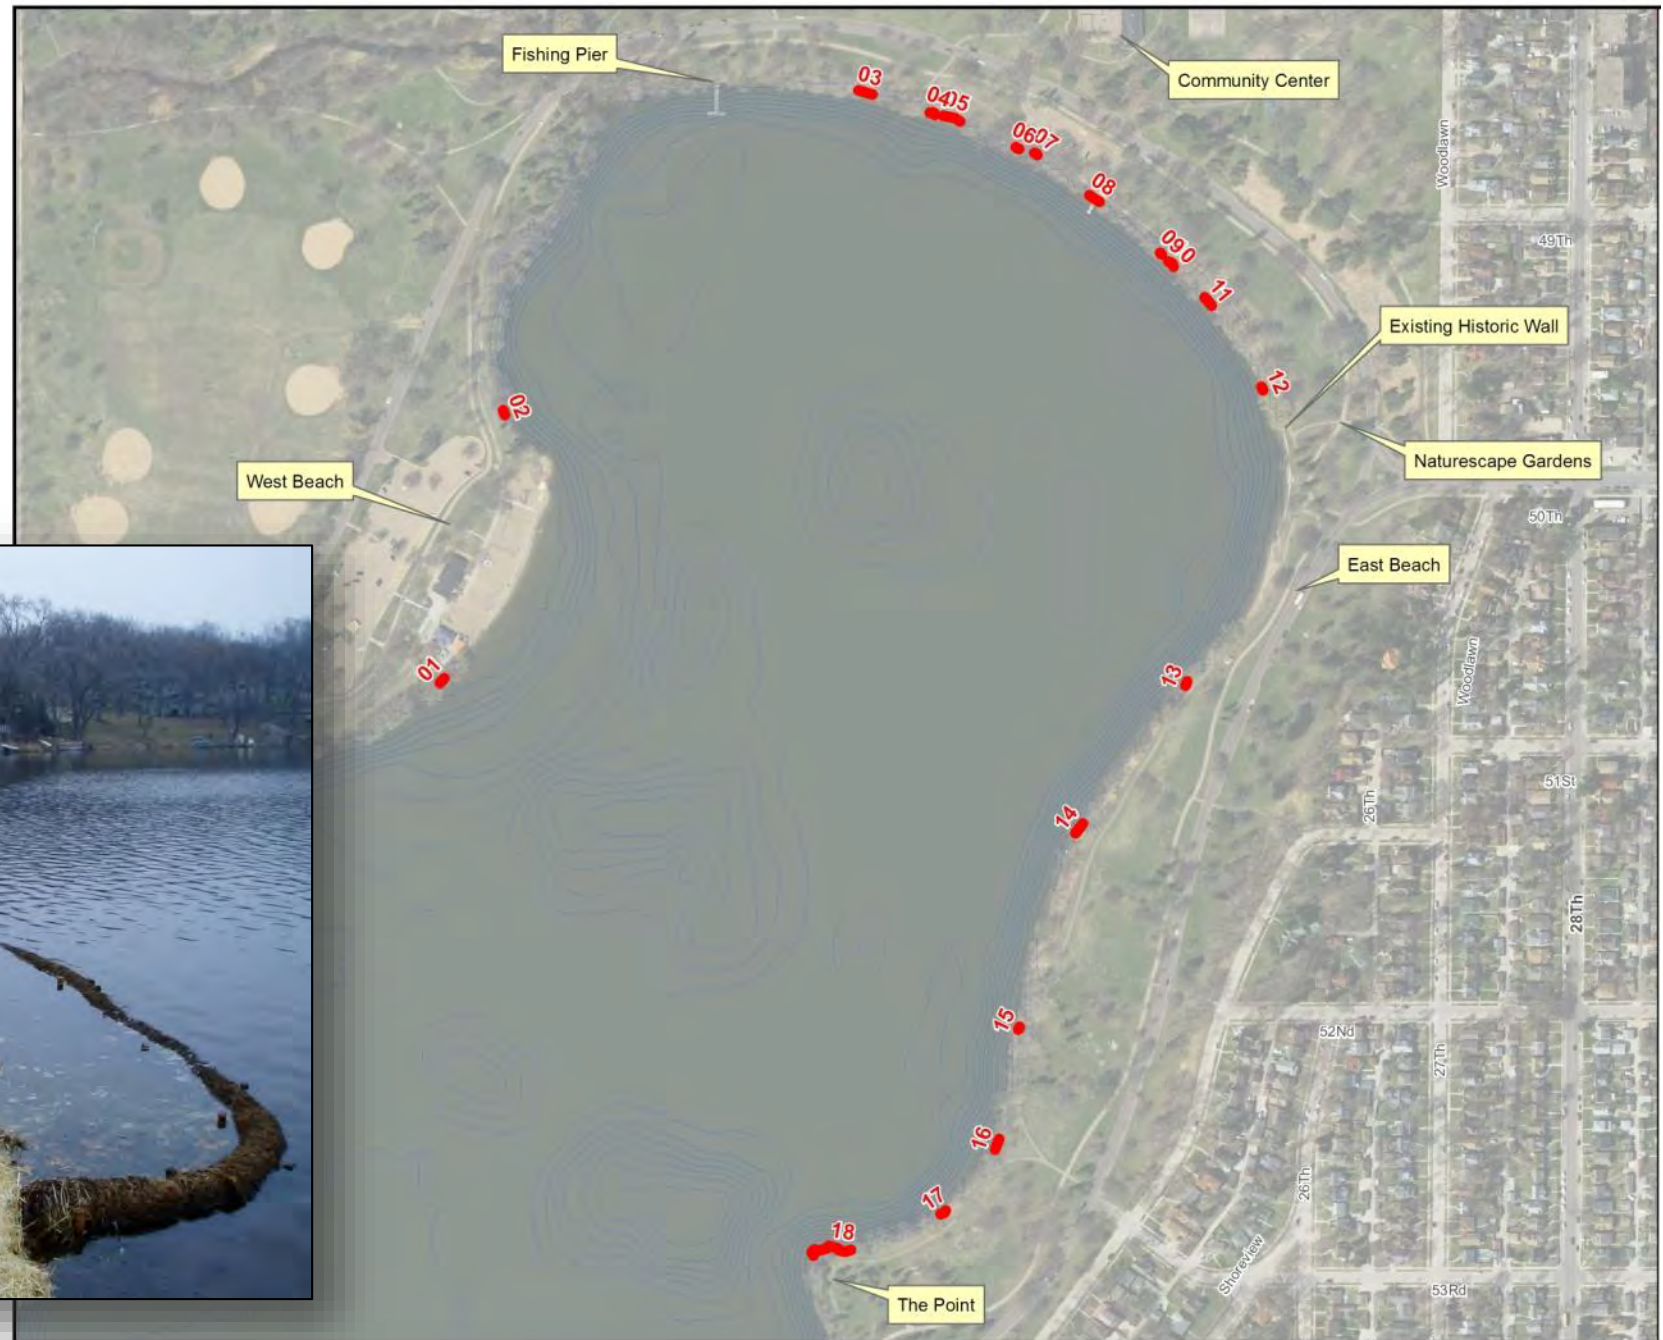
# Shoreline Stabilization

- Most areas minor grading, seed & ECB
