# Lake Nokomis Shoreline Enhancement Project

## Community Meeting 2

February 13, 2018

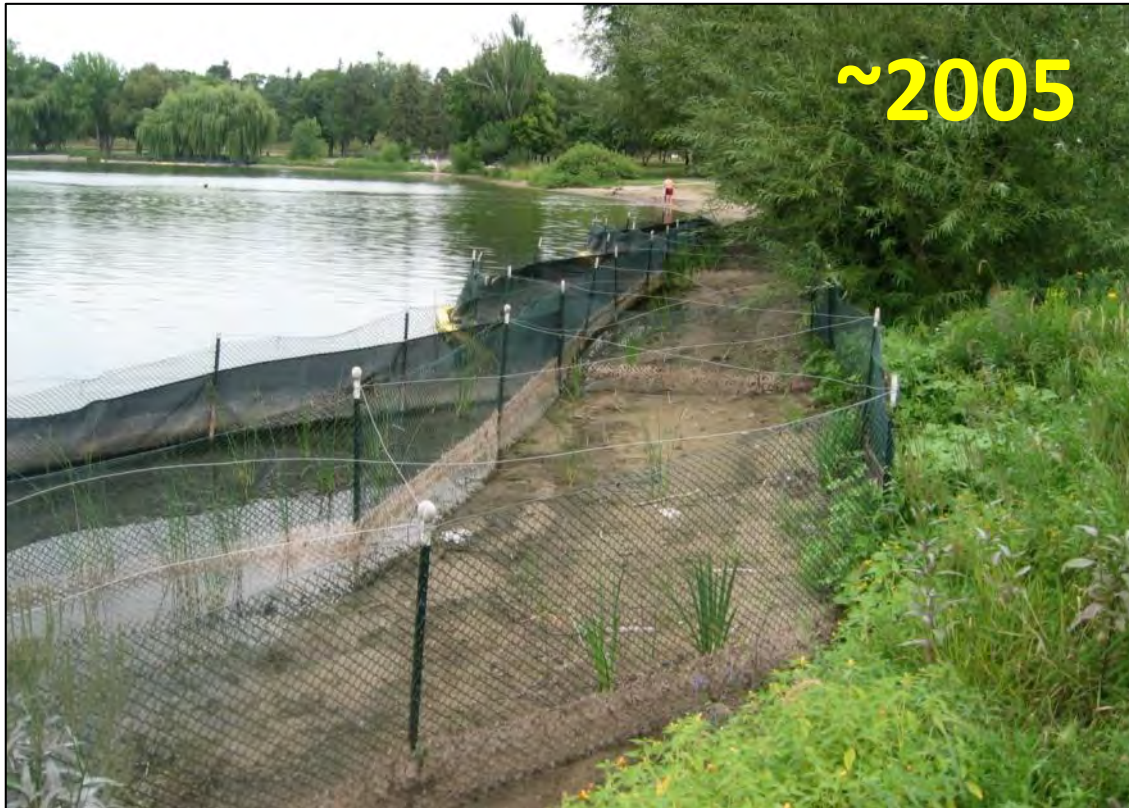
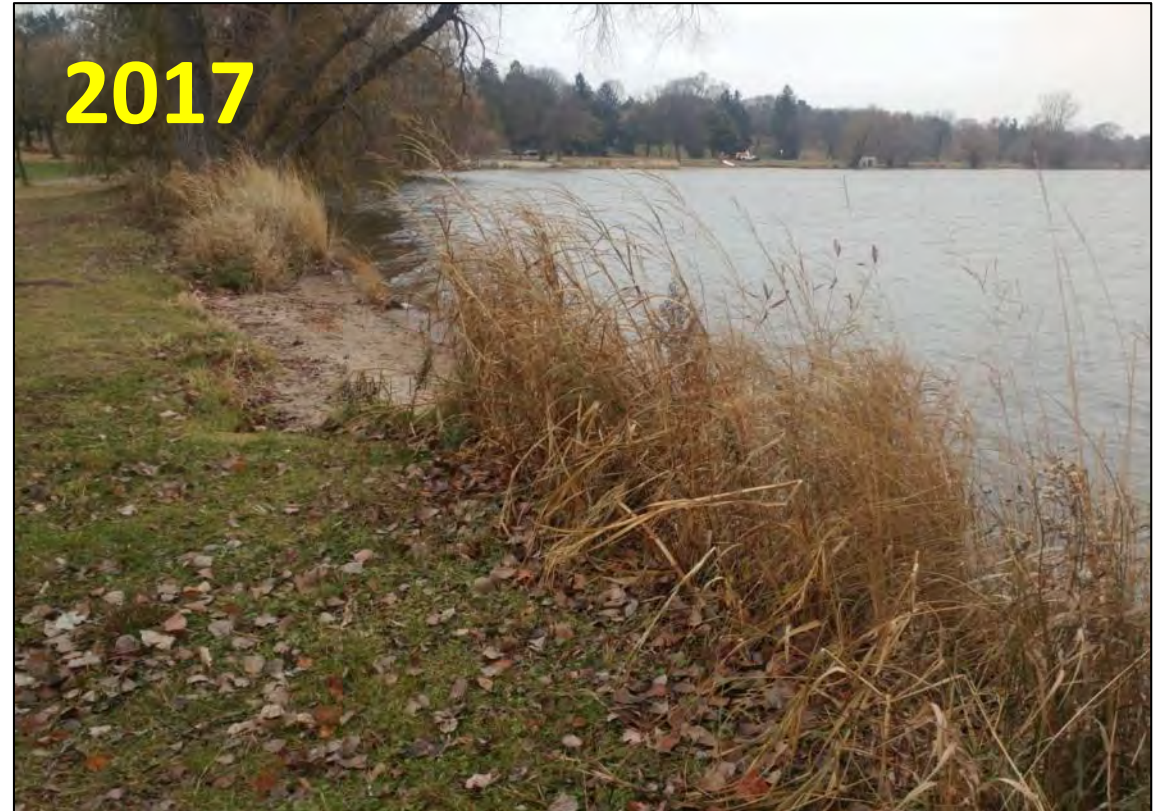
# Emergent & Shoreline Plantings

- Some upland/shoreline plantings remain from 2005...  
...but all emergents lost

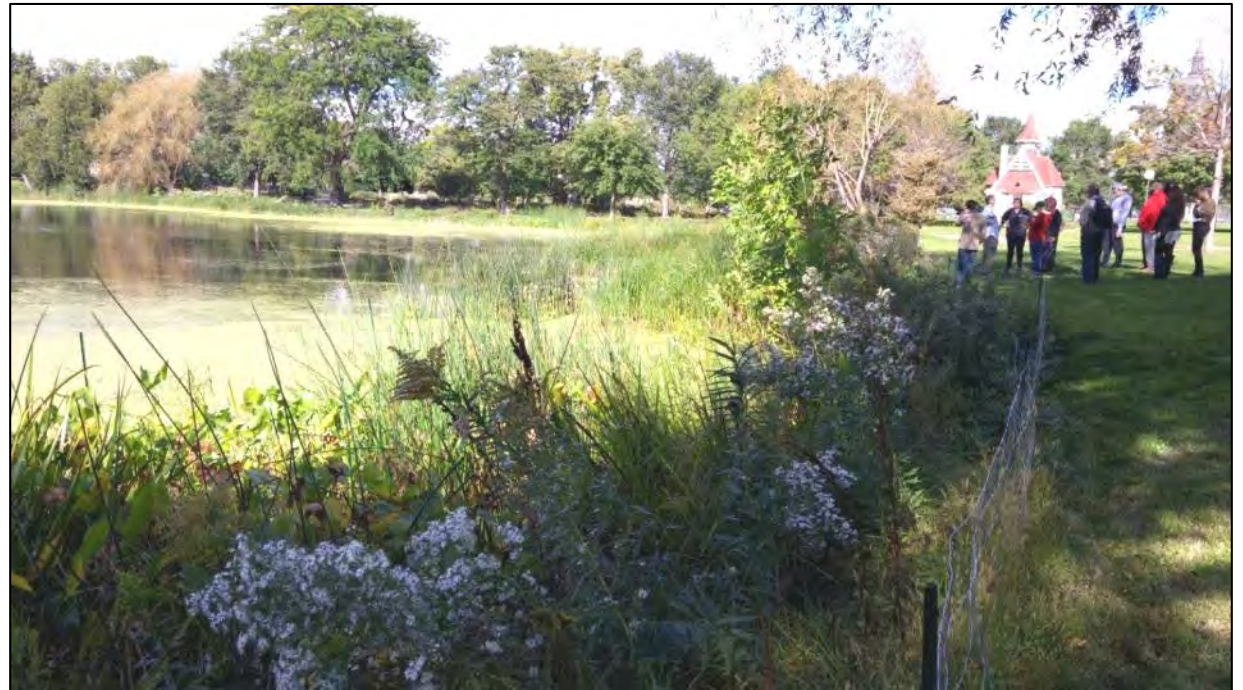
# Emergent Plantings

- Emergent wetland restoration strategies
  - Adequate wave protection (temporary silt fence backed with mesh on T-posts)
  - Protect from herbivory (bury silt fence bottom and wrap to shoreline)
  - Adequate planting density (2-ft centers)
  - Phased approach
  - Appropriate emergent and shoreline species
  - Reserve fund for adaptive management

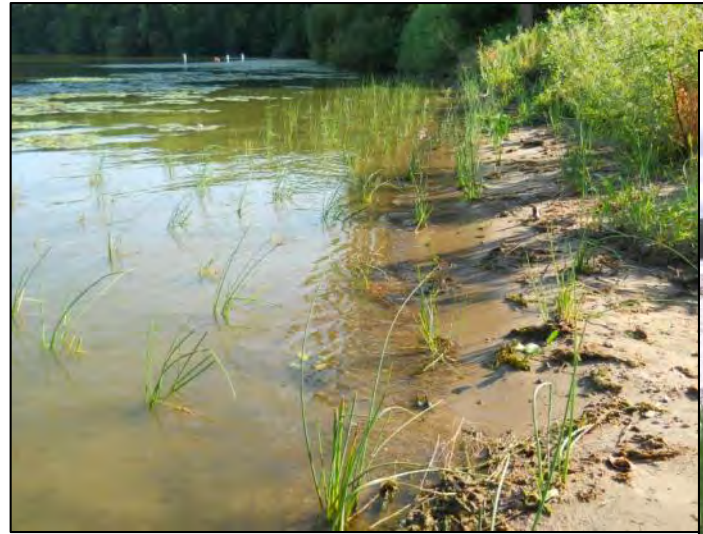
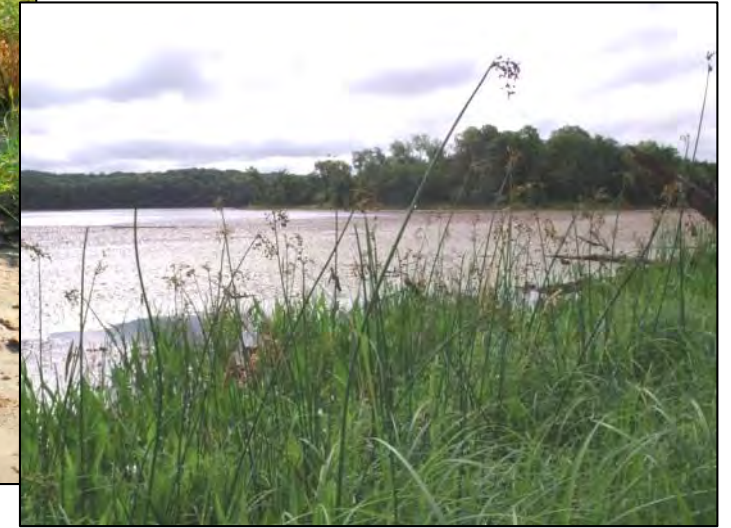
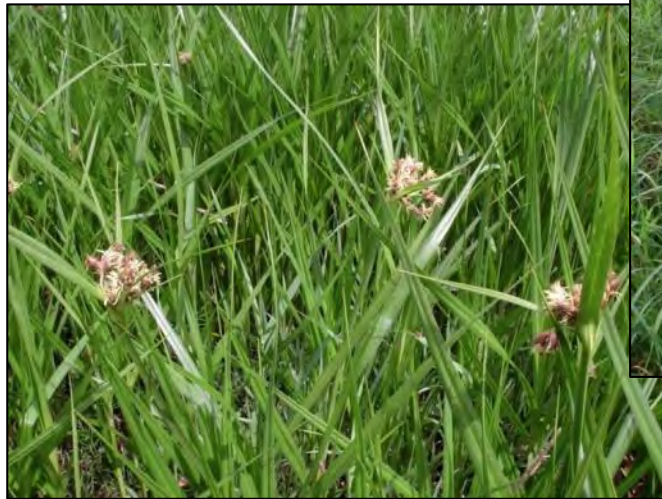
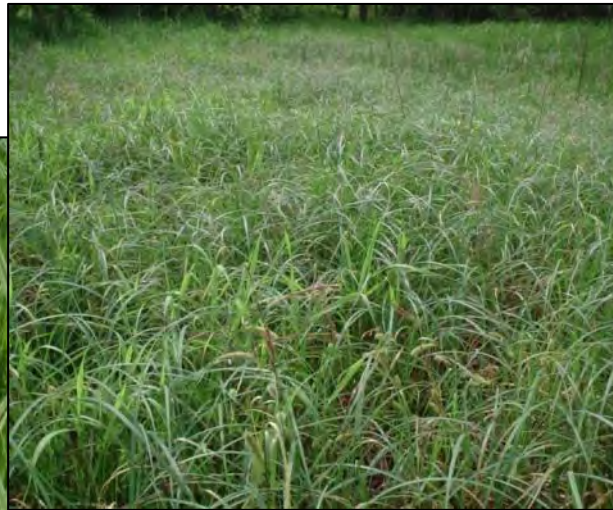
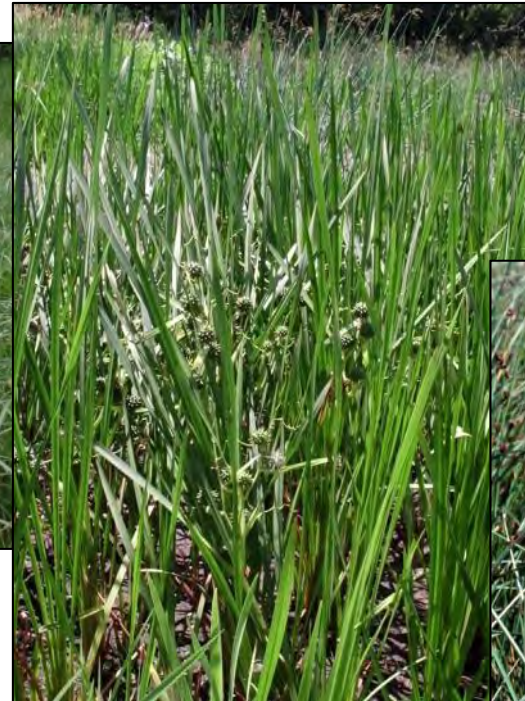
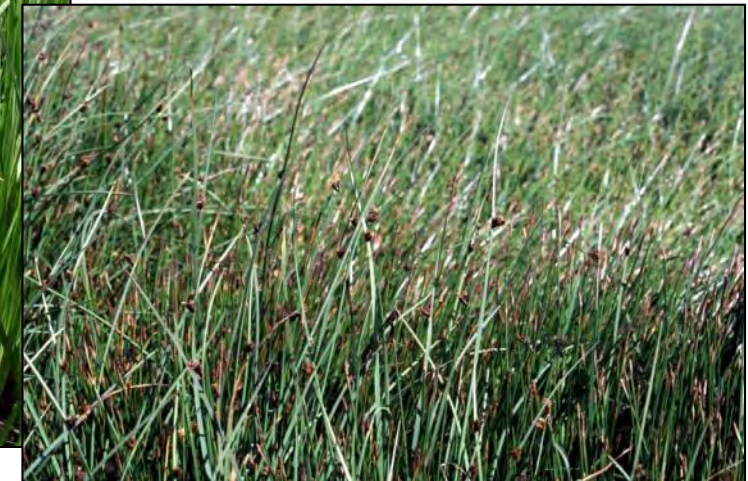
# Emergent Plantings

- Hardstem bulrush
- River bulrush
- Lake sedge
- Giant bur-reed
- Common three-square

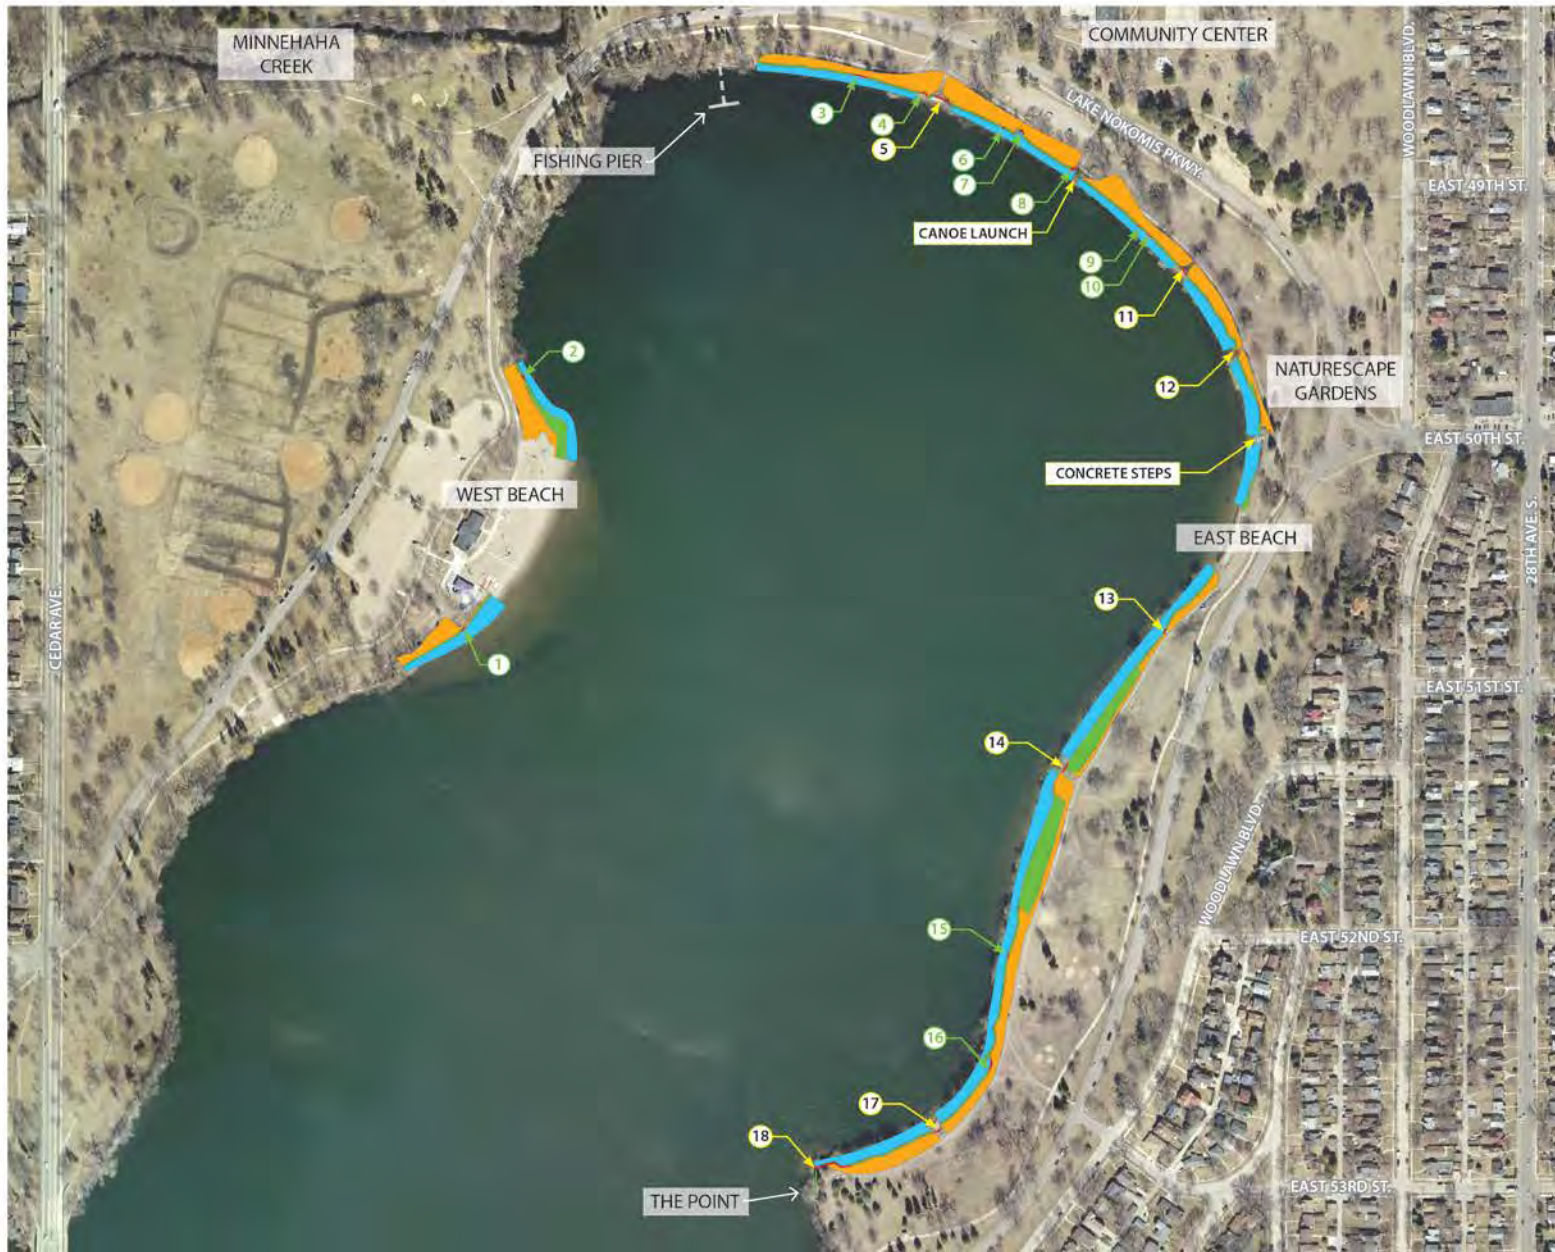
# Shoreline Access

- Priority of park users
- Not all shoreline access locations are alike
- Access locations often associated with localized shoreline erosion
- This project will retain most existing lake access points, and re-design for improved durability
- Of the 18 erosion areas within project area, we propose:
  - 11 will be stabilized and revegetated
  - 7 will be stabilized and still provide lake access

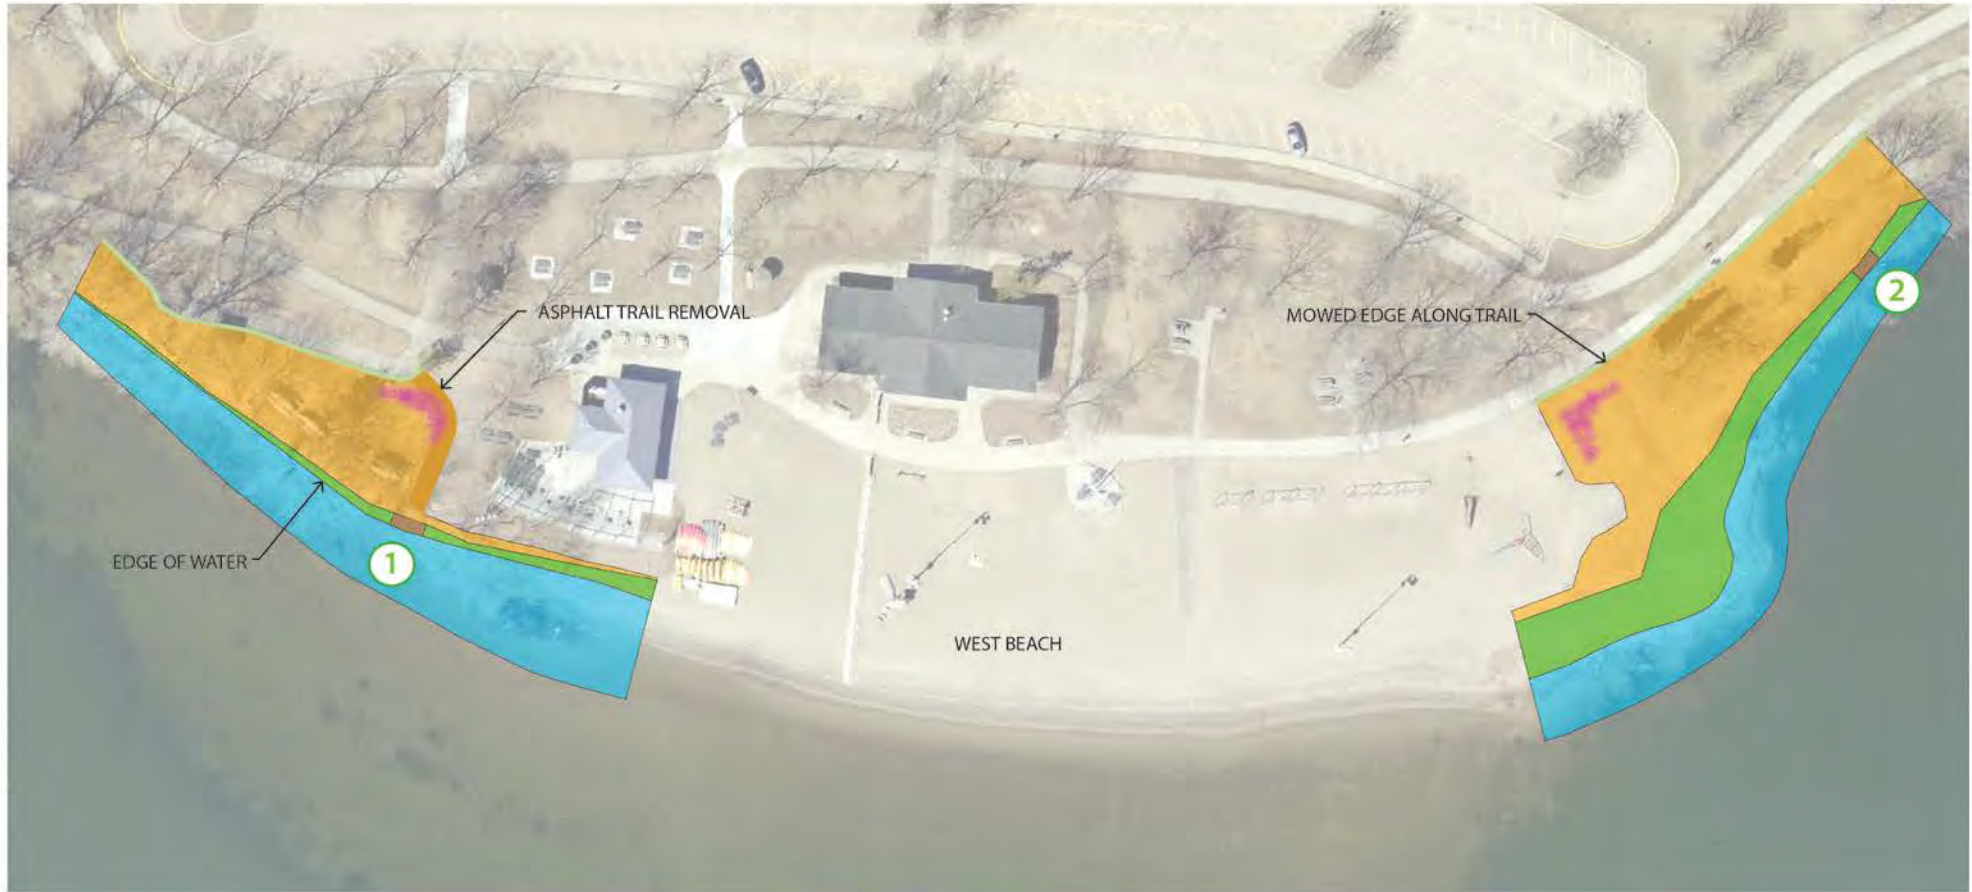
- UPLAND BUFFER (2.57 acres)
- SHORELINE BUFFER (1.05 acres)
- EMERGENT WETLAND (2.55 acres)
- SHORELINE EROSION REPAIR (449 LF)
- # STABILIZE SHORELINE AND RE-VEGETATE (11 LOCATIONS)
- # STABILIZE AND RETAIN SHORELINE ACCESS (7 LOCATIONS)

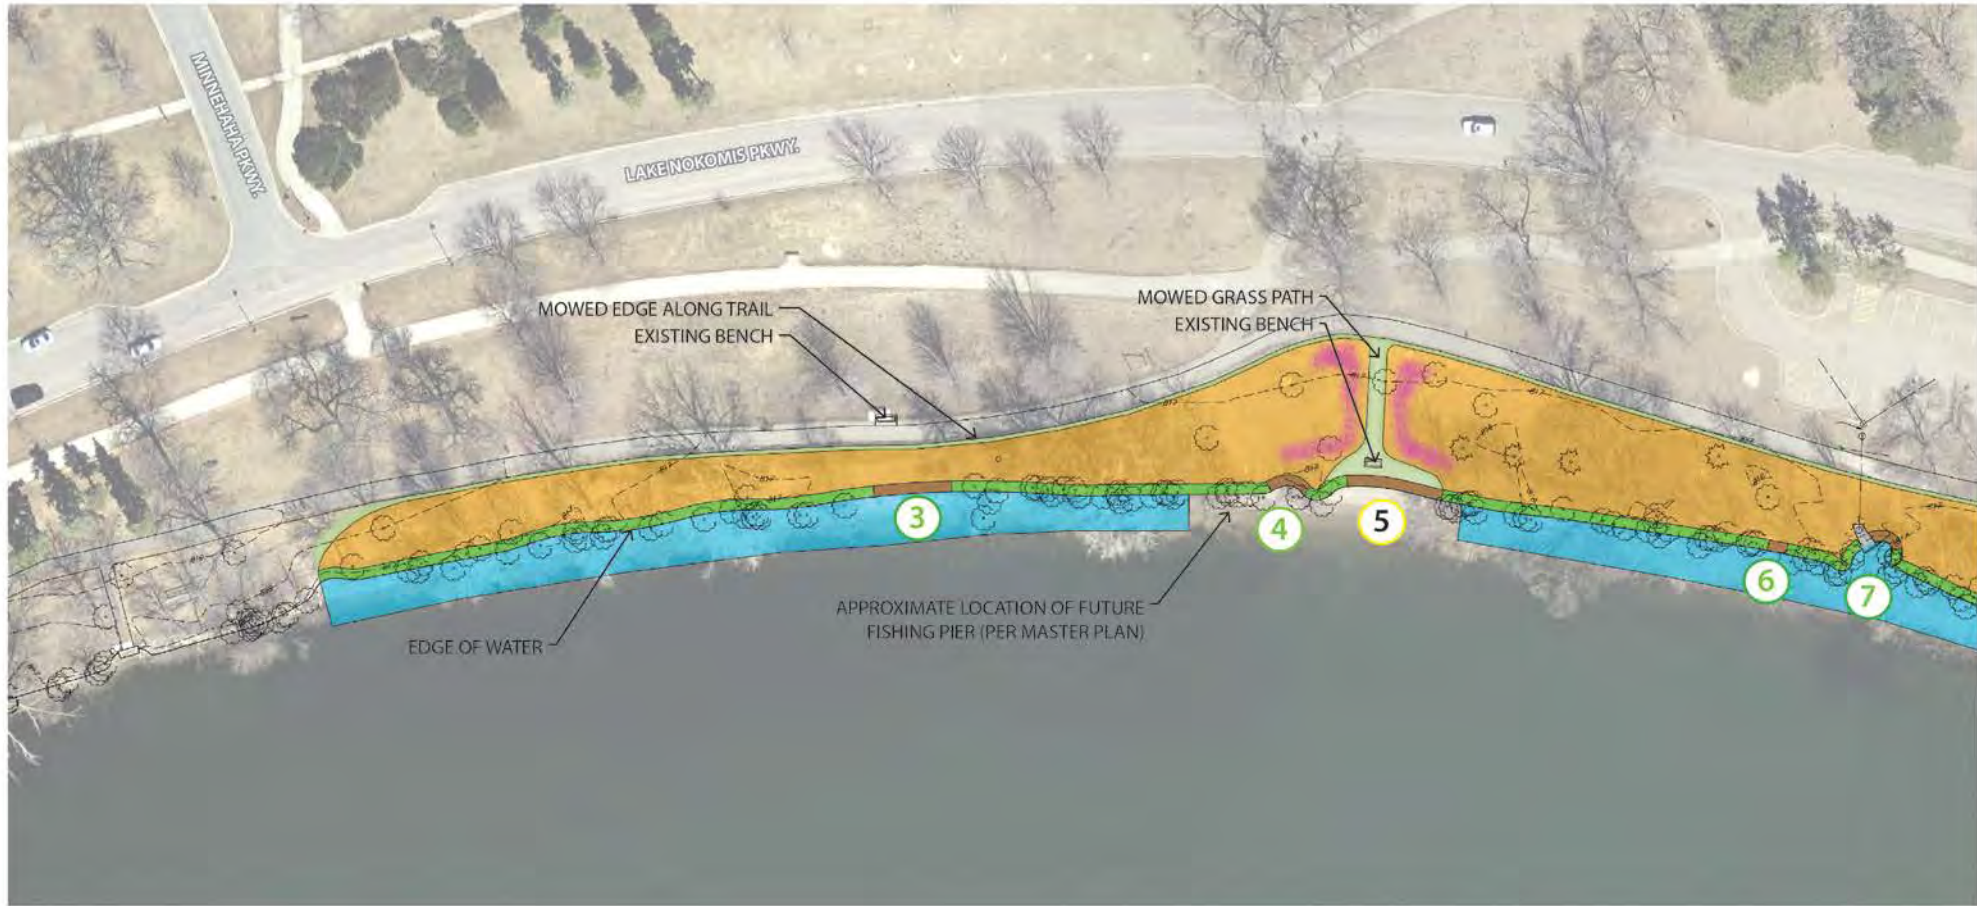
RESTORATION ZONES		LEGEND	
 	UPLAND BUFFER (2.57 acres)	 	ENHANCED PLANTING OPPORTUNITY AREA
 	SHORELINE BUFFER (1.05 acres)	 	MAINTAINED TURF GRASS
 	EMERGENT WETLAND (2.55 acres)	 	STABILIZE SHORELINE AND RE-VEGETATE (11 LOCATIONS)
 	SHORELINE EROSION REPAIR	 	STABILIZE AND RETAIN SHORELINE ACCESS (7 LOCATIONS)

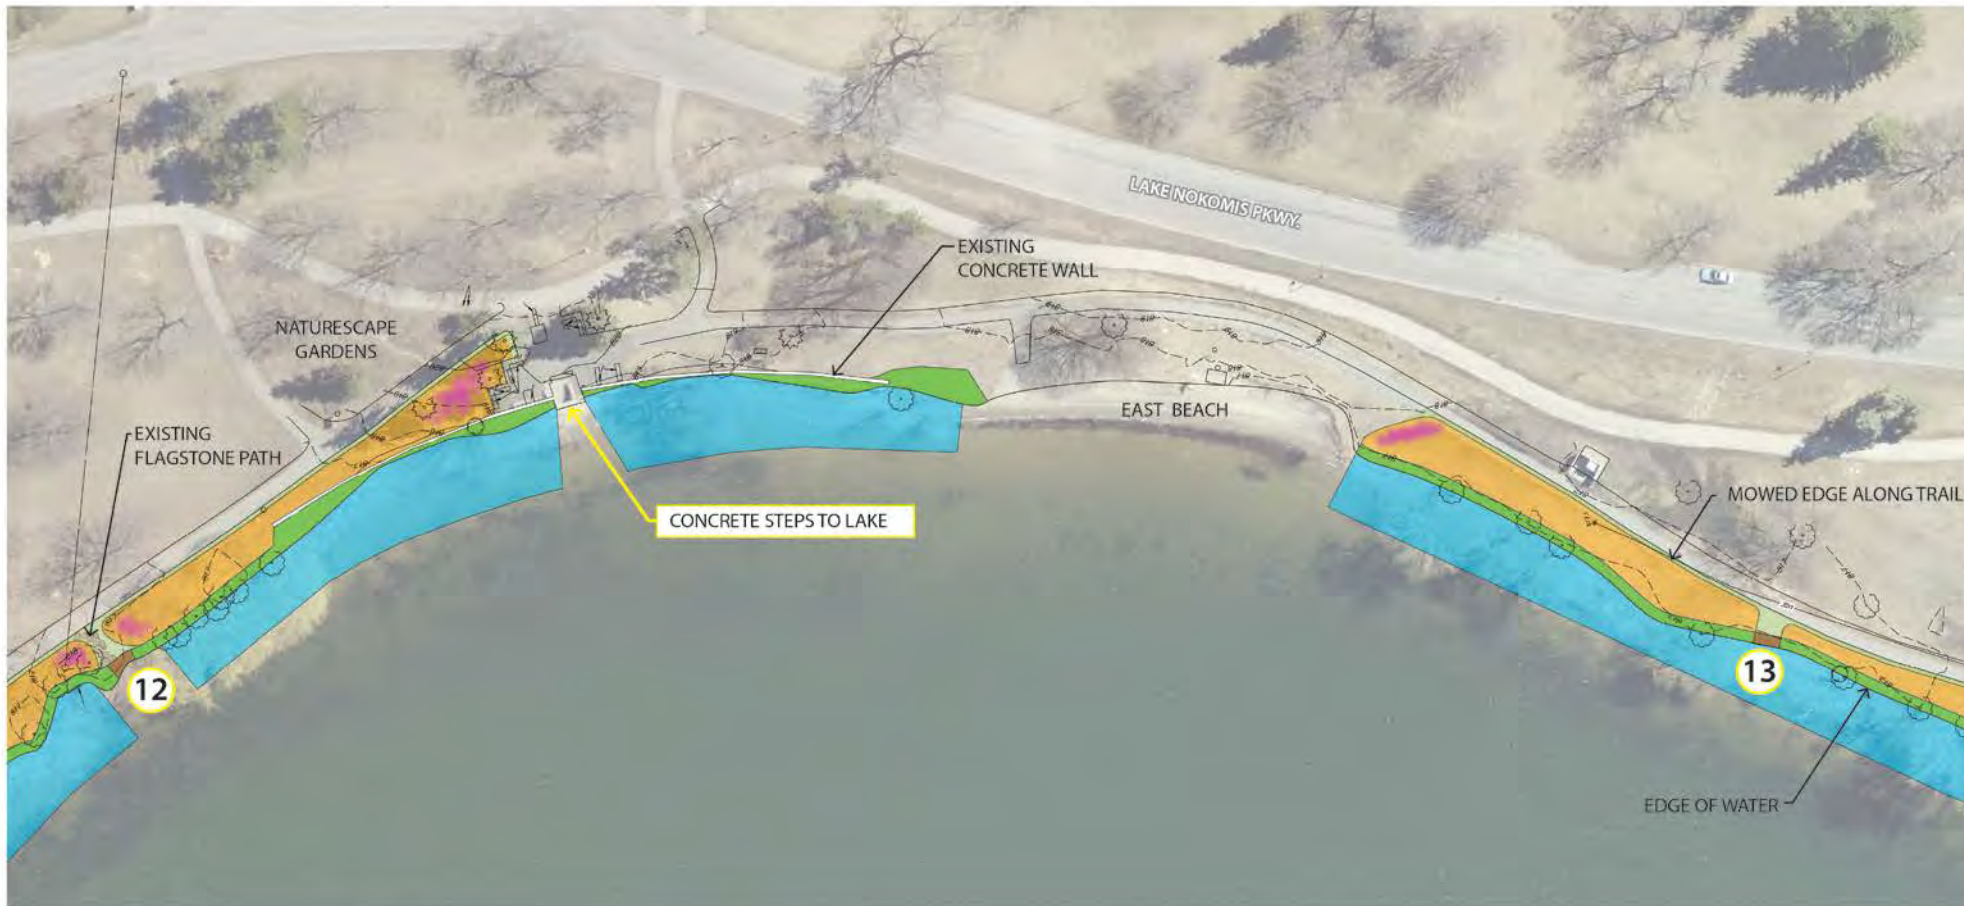
LOCATION PLAN

LEGEND	
<b>RESTORATION ZONES</b>

UPLAND BUFFER (2.57 acres)

SHORELINE BUFFER (1.05 acres)

EMERGENT WETLAND (2.55 acres)

SHORELINE EROSION REPAIR

ENHANCED PLANTING OPPORTUNITY AREA

MAINTAINED TURF GRASS

STABILIZE SHORELINE AND RE-VEGETATE (11 LOCATIONS)

STABILIZE AND RETAIN SHORELINE ACCESS (7 LOCATIONS)

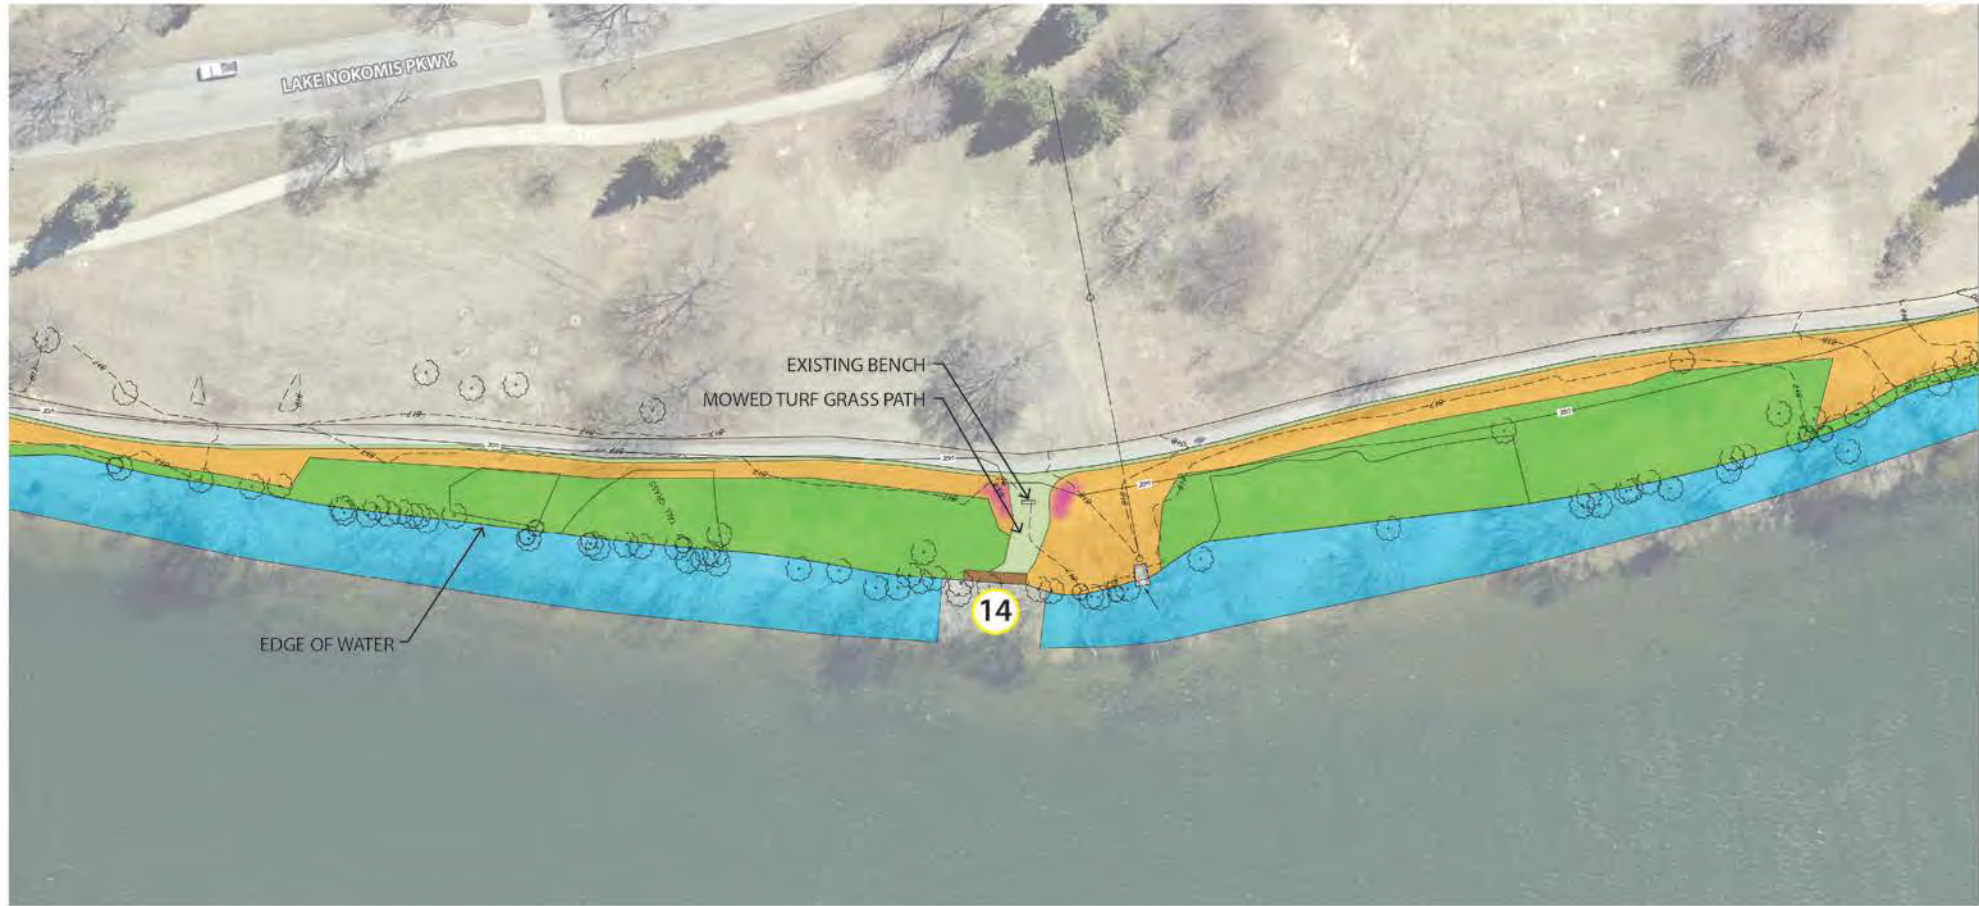
LOCATION PLAN

LEGEND	
<b>RESTORATION ZONES</b>	
 	UPLAND BUFFER (2.57 acres)

SHORELINE BUFFER (1.05 acres)
 	EMERGENT WETLAND (2.55 acres)
 	SHORELINE EROSION REPAIR
 	ENHANCED PLANTING OPPORTUNITY AREA
 	MAINTAINED TURF GRASS

STABILIZE SHORELINE AND RE-VEGETATE (11 LOCATIONS)
 	STABILIZE AND RETAIN SHORELINE ACCESS (7 LOCATIONS)

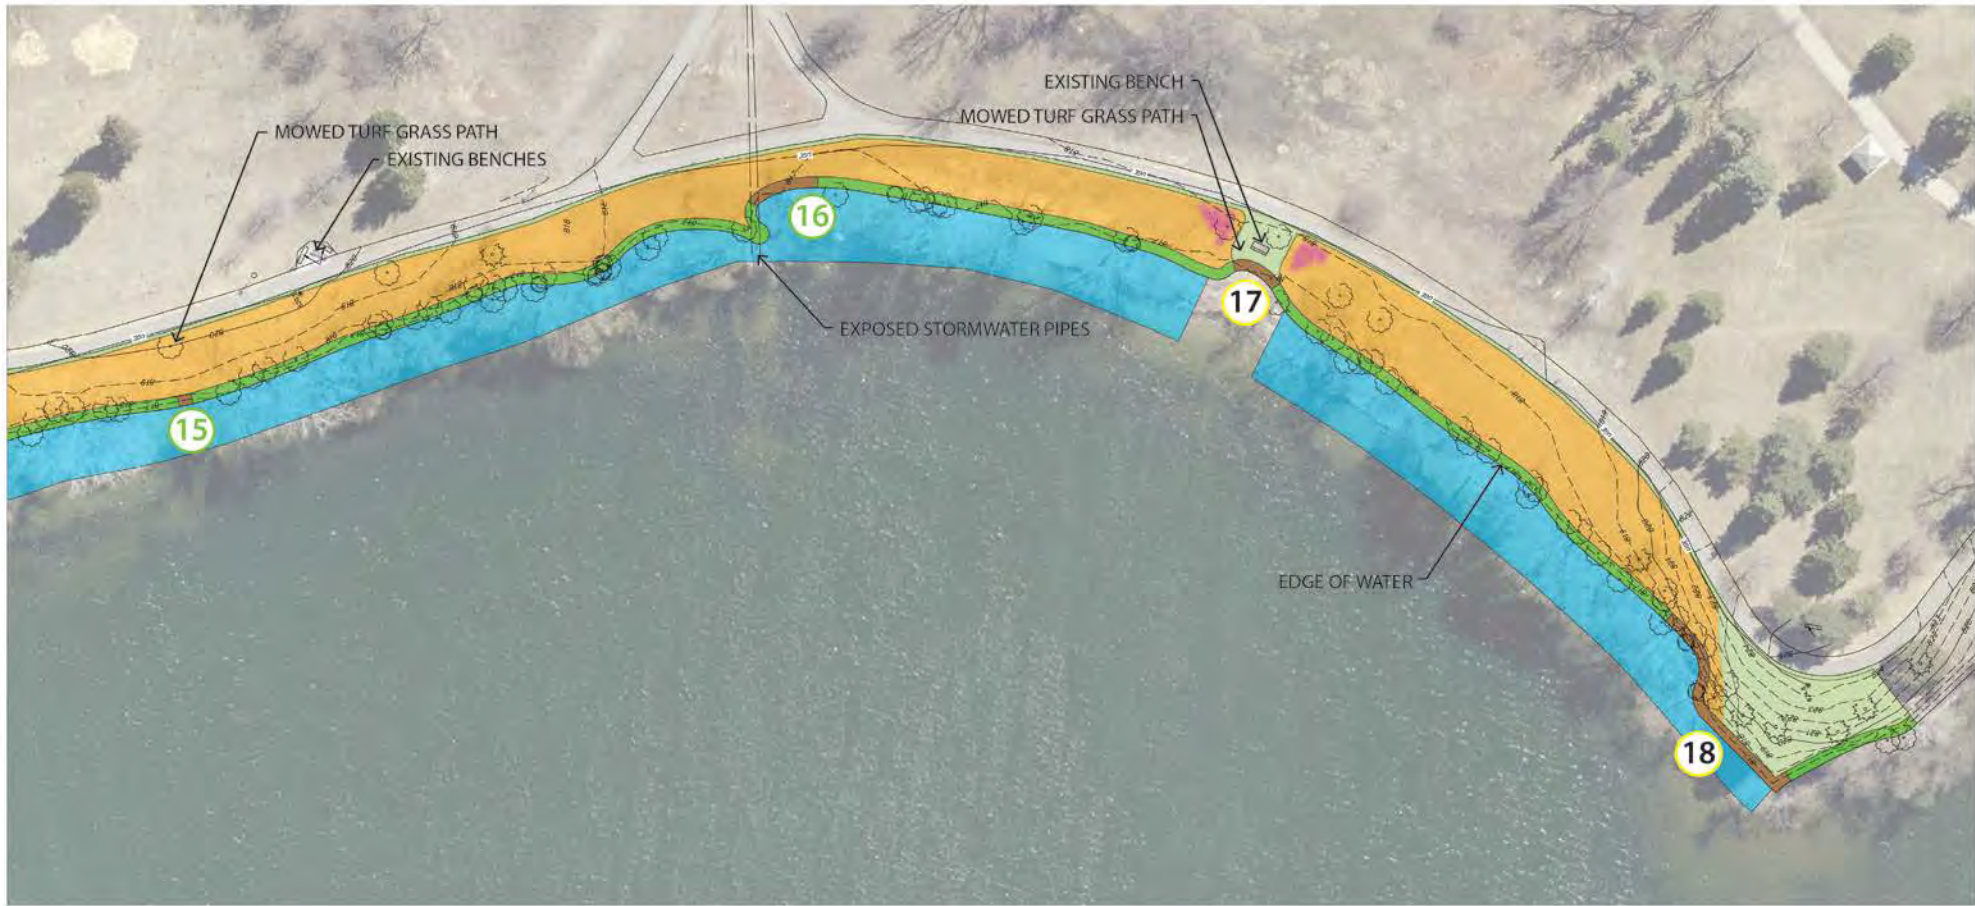
LOCATION PLAN

LEGEND	
<b>RESTORATION ZONES</b>	
 	UPLAND BUFFER (2.57 acres)
 	SHORELINE BUFFER (1.05 acres)
 	EMERGENT WETLAND (2.55 acres)

SHORELINE EROSION REPAIR
 	ENHANCED PLANTING OPPORTUNITY AREA
 	MAINTAINED TURF GRASS

STABILIZE SHORELINE AND RE-VEGETATE (11 LOCATIONS)
 	STABILIZE AND RETAIN SHORELINE ACCESS (7 LOCATIONS)
