Services for
**Feasibility Report:
Recreational Bridge
Crossing, Mississippi
River**

Prepared for:
Minneapolis Park and Recreation Board
(MPRB)

Feasibility Report: Recreational Bridge Crossing, Mississippi River

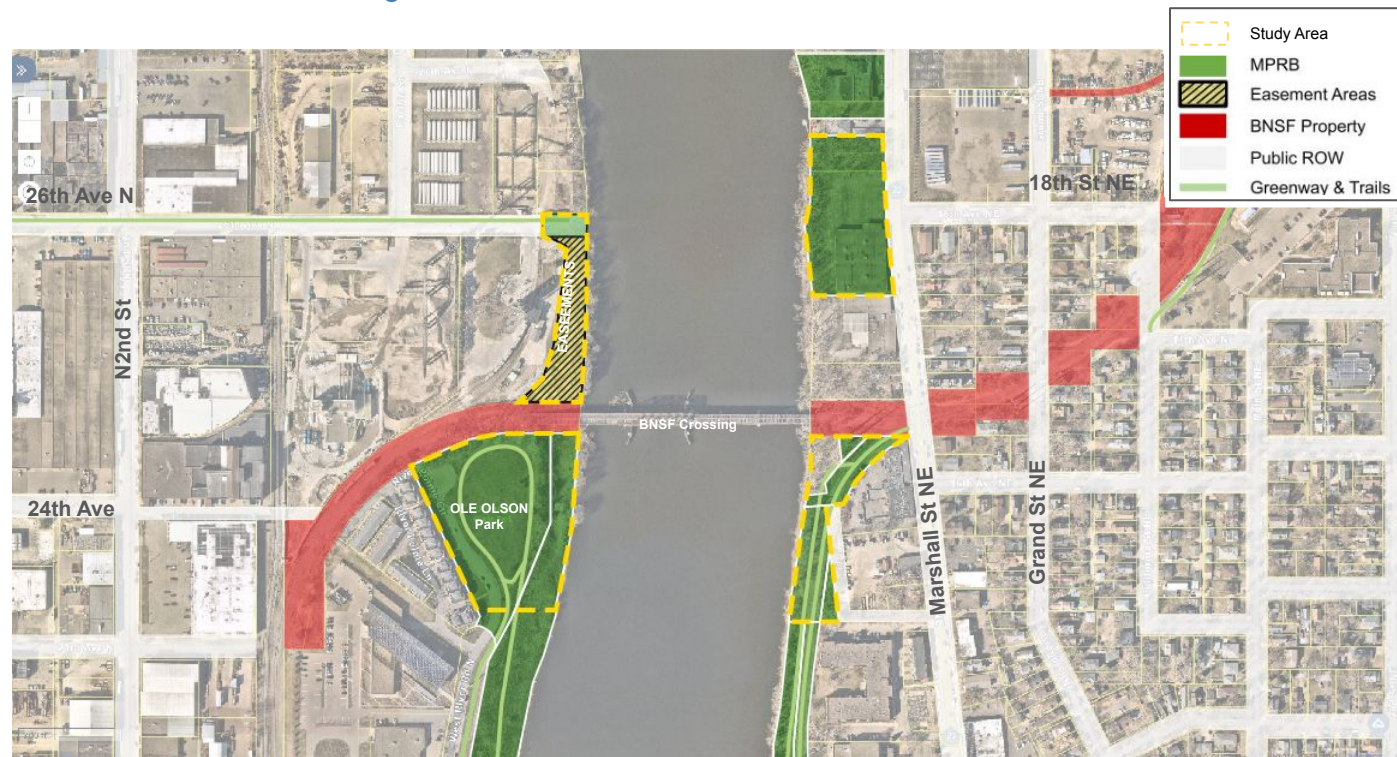
Figure 1.1.3 Study Area and Adjacent Land Ownership

The study area is approximately 800-feet downstream from the US Army Corps of Engineers' 856 mile marker of the Mississippi River. This section of the river is being studied to determine the feasibility for a new, recreational (non-vehicular) crossing which is approximately aligned with 26th Ave N on the west bank of the river and 18th Ave NE on the east bank.

The MPRB currently has a use permit with the City of Minneapolis (City) to operate a park at the terminus of 26th Ave N, where the new 26th Avenue North Overlook now sits. The Overlook is a new space that introduces northside residents and trail users to the river. It is assumed the bridge's western end would land near this site. The MPRB and Continental Cement have agreed to a riverfront easement just south of the Overlook and is currently undergoing negotiations with BNSF to acquire an easement under their bridge, each allowing for the construction of a new trail that connects existing trails at the Overlook and Ole Olson Park. The MPRB owns 1720 Marshall St NE on the east bank of the river within Above the Falls Regional Park. The riverfront site has a derelict, two-story brick building requiring demolition and terraced parking lots that step down towards the river. It is assumed the bridge's eastern end would land at this site.

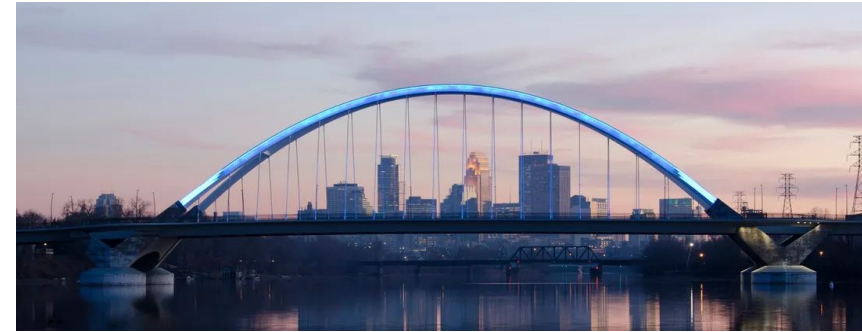
Lowry Street Bridge

- ❑ Built: 2012
- ❑ Type: Steel tied-arch
- ❑ Span: 450ft
- ❑ Height: 37ft
- ❑ Length: 1576ft

The Lowry Avenue Bridge is a steel tied-arch bridge over the Mississippi River. Construction of this new bridge began in 2010 and was completed in 2012. The crossing includes two protected, 12 foot trails on either side for pedestrians and bicyclists.

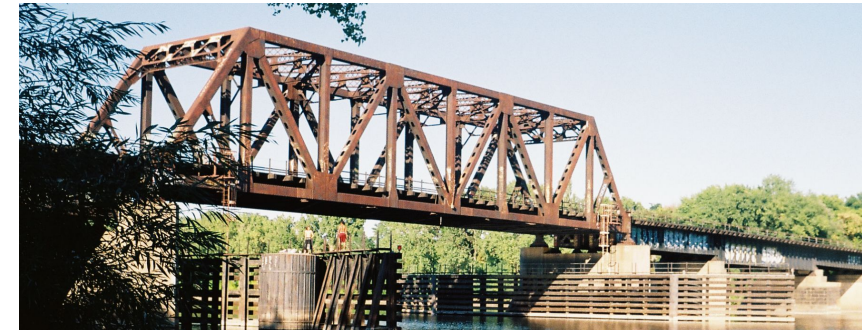
BNSF Bridge

- ❑ Built: 1884
- ❑ Type: Girder, truss
- ❑ Span: 192ft
- ❑ Height: 27ft
- ❑ Length: 801ft

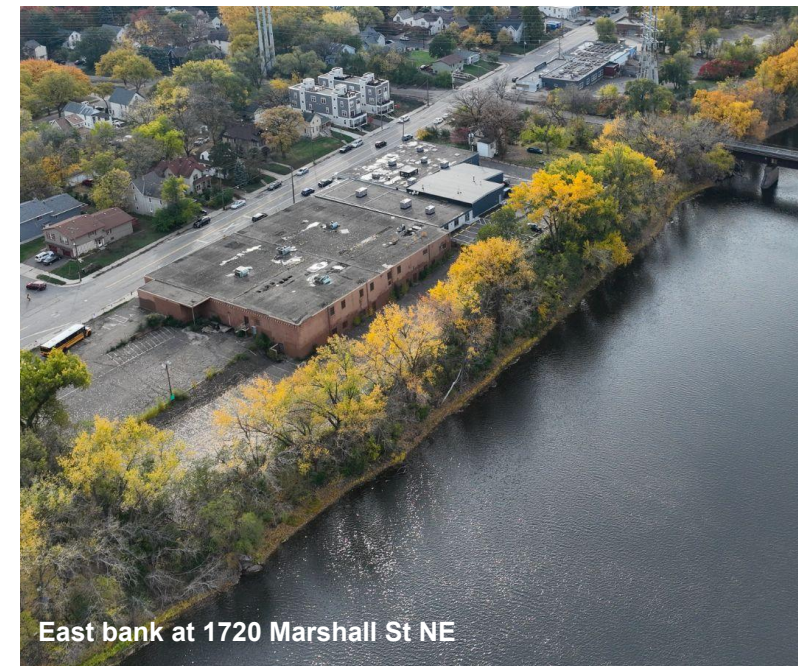
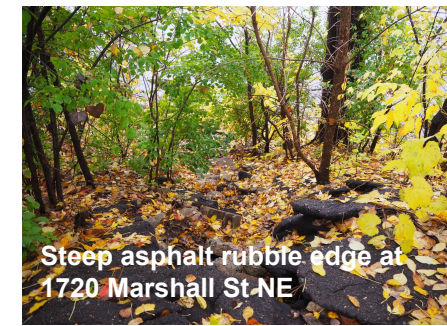
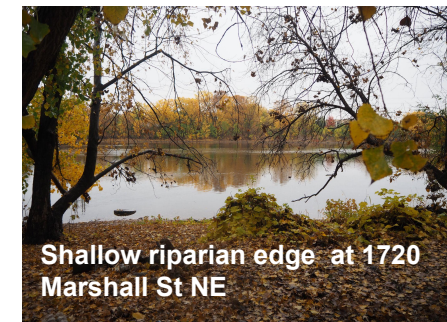
Figure 2.3.3 East Bank Site Photos

The site was entered into the Brownfields Program, where it subsequently received a No Further Action letter from MPCA for petroleum compounds and a NAD. The No Further Action letter states that it should be assumed that petroleum contamination is present when considering future development of the site. The site was referred to the MPCA Site Assessment Program in April 2023 to determine if cleanup actions are required.

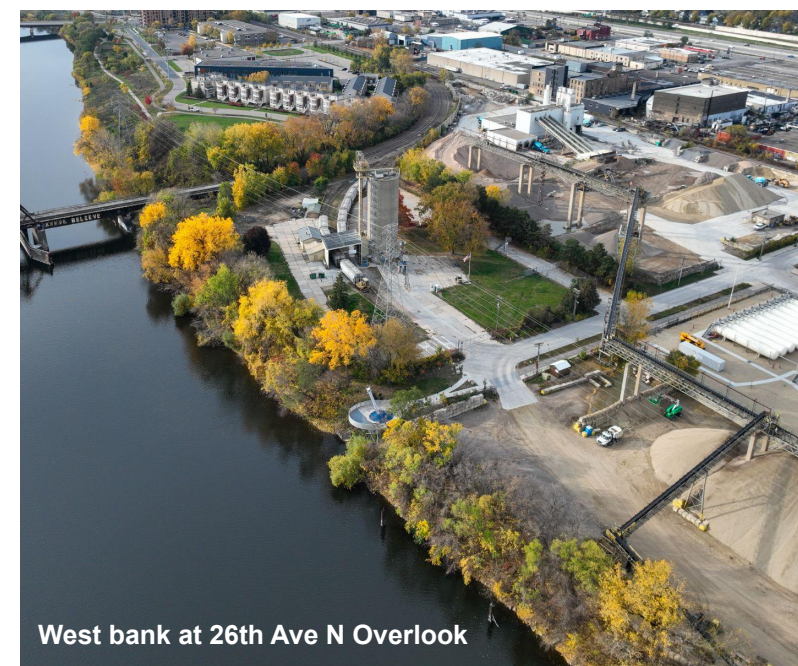
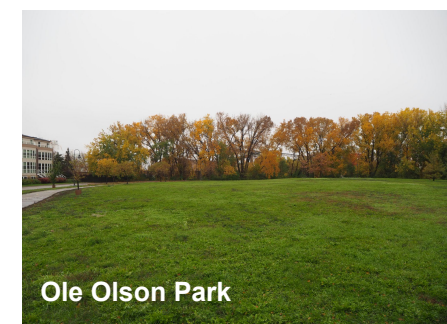
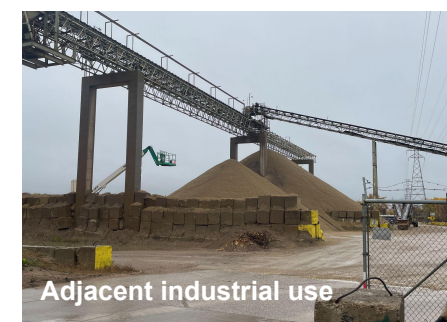
Figure 2.3.4 West Bank Site Photos

- **Onsite Identified Release BF0002611** – Test pits were advanced at 33 26th Ave. N (Continental Cement) and 2325 West River Rd. N (Ole Olson Park) to assess environmental conditions prior to construction for an MPRB trail expansion project just south of the 26th Avenue North Overlook. Debris and fill were encountered in the test pits and analytical results indicated diesel range organics (DRO), benzene, lead, and polycyclic aromatic hydrocarbon (PAH) concentrations in soil were above regulatory criteria. A Response Action Plan (RAP) for the trail expansion project was submitted to the Minnesota Pollution Control Agency (MPCA) and approved in September 2023.

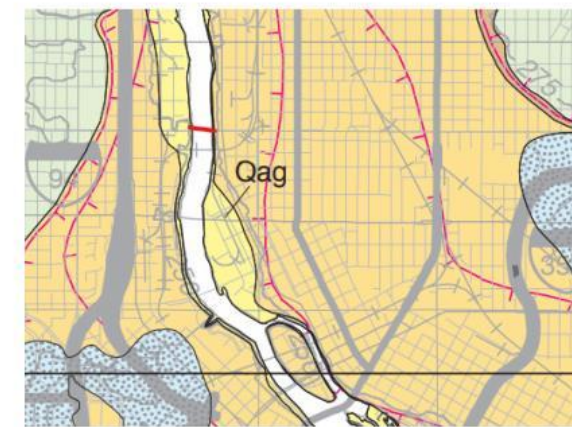
Figure 3: Surficial Geology

Surficial Geology: The map of surficial geology shows terrace sand and gravel, Qat, yellow, at the west bank and sand and gravel, Qag, light orange, at the east bank. This map does not indicate any widespread human/machine dumping of fill material along the river banks (as has been done to create land for developments). Red line indicates approximate river crossing.

Overall, this geologic map review supports the findings from the pile length/bearing elevation review. The available information for BNSF indicates deeper piles than Plymouth or Lowry, which supports the presence of an erosional channel in this area.
