## Memorandum

Project John H. Stevens House

Regarding Fire Damage Condition Assessment

Re: Condition Assessment and Stabilization Recommendations  
John H. Stevens House, Minnehaha Park  
4901 Minnehaha Avenue So, Minneapolis, MN

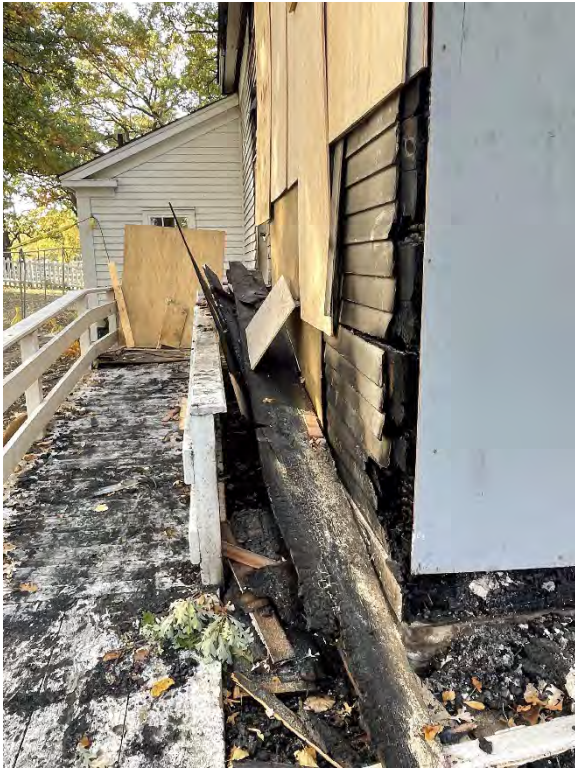
Photo 12 East elevation, looking south.

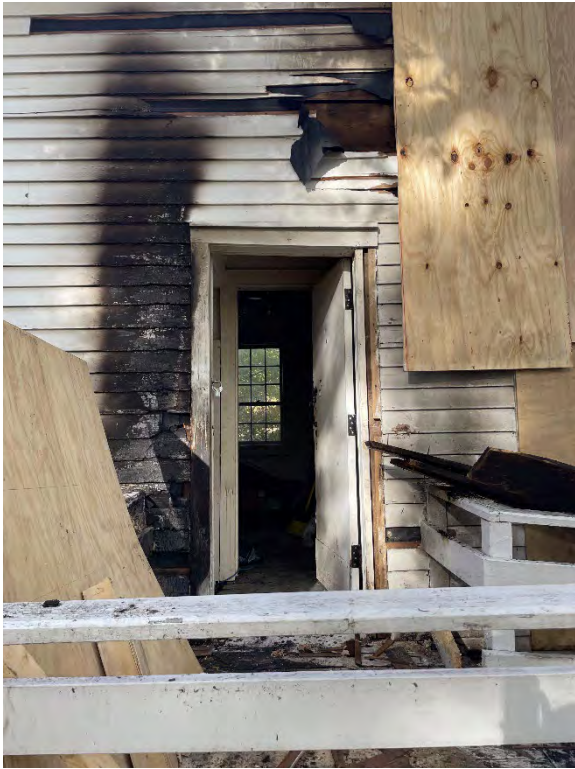
Photo 14 East entry door.

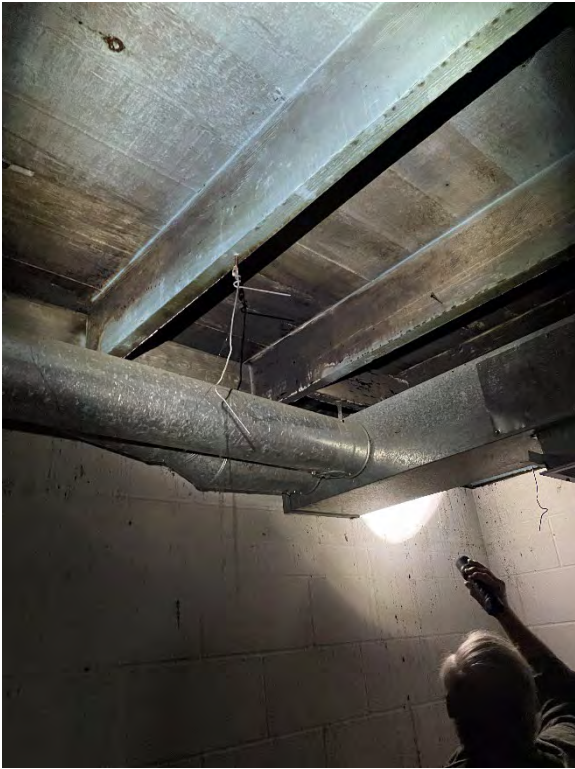
Photo 19 NE corner of basement meeting room.

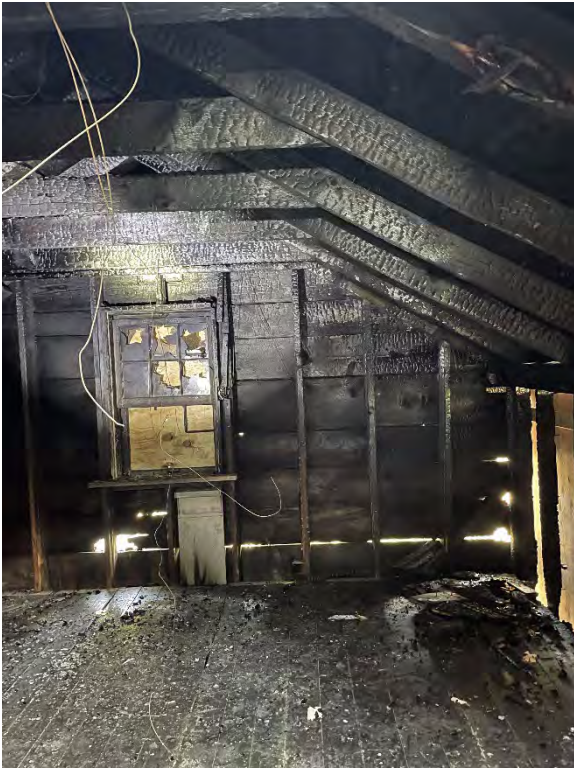
Photo 31 North chamber north elevation.

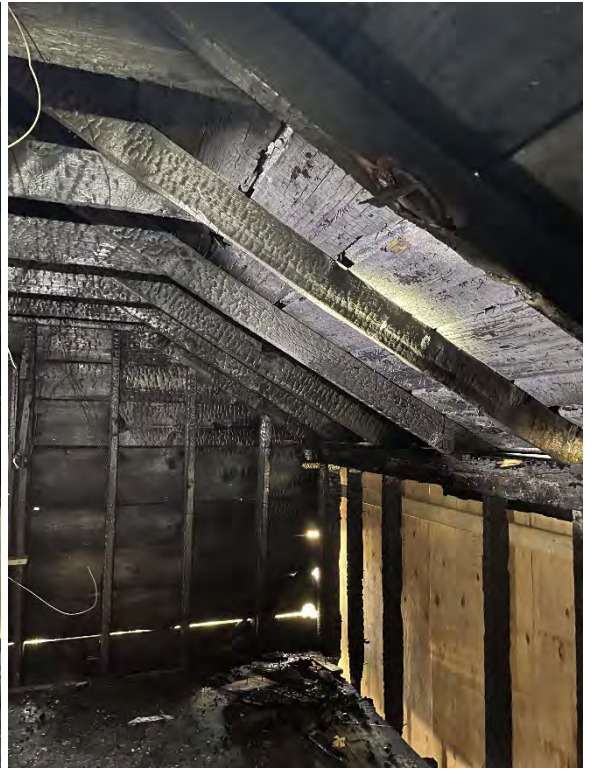
Photo 32 North chamber northeast corner.

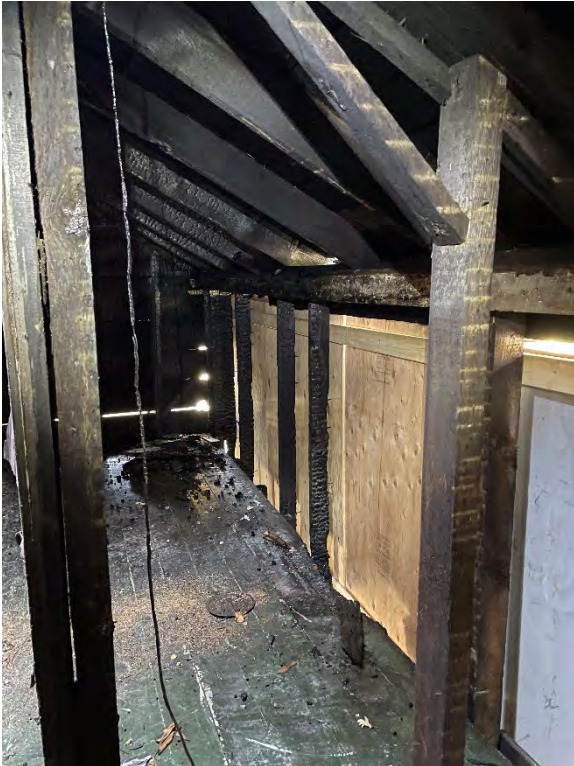
Photo 33 North chamber east elevation.

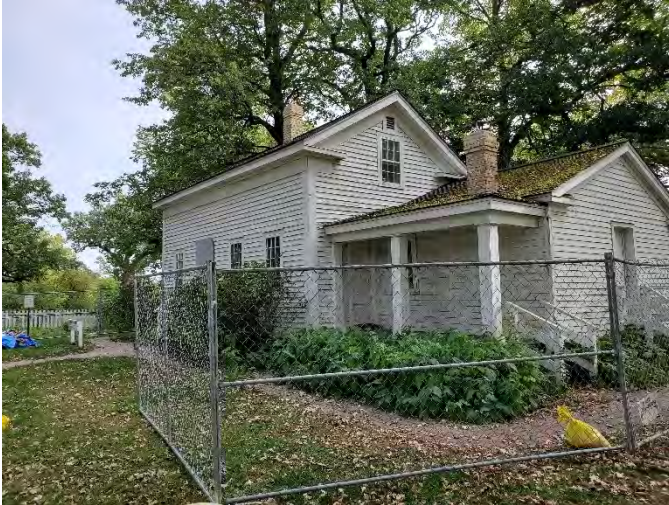
John H. Stevens House  
View from the southwest corner. The one-story kitchen wing in the foreground, the two-story section in the background.

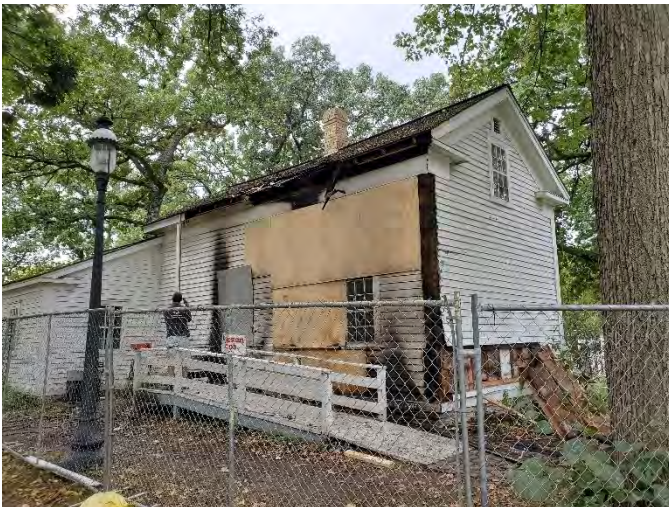
View from the northeast corner. The fires have originated near this corner. This photo is after the second fire event.
