HERITAGE PRESERVATION APPLICATION SUMMARY

Project Name: Boom Island-Nicollet Island Bridge Rehabilitation

Request: To allow rehabilitation of and alterations to the existing Boom Island-Nicollet Island Bridge (Bridge No. 93835).

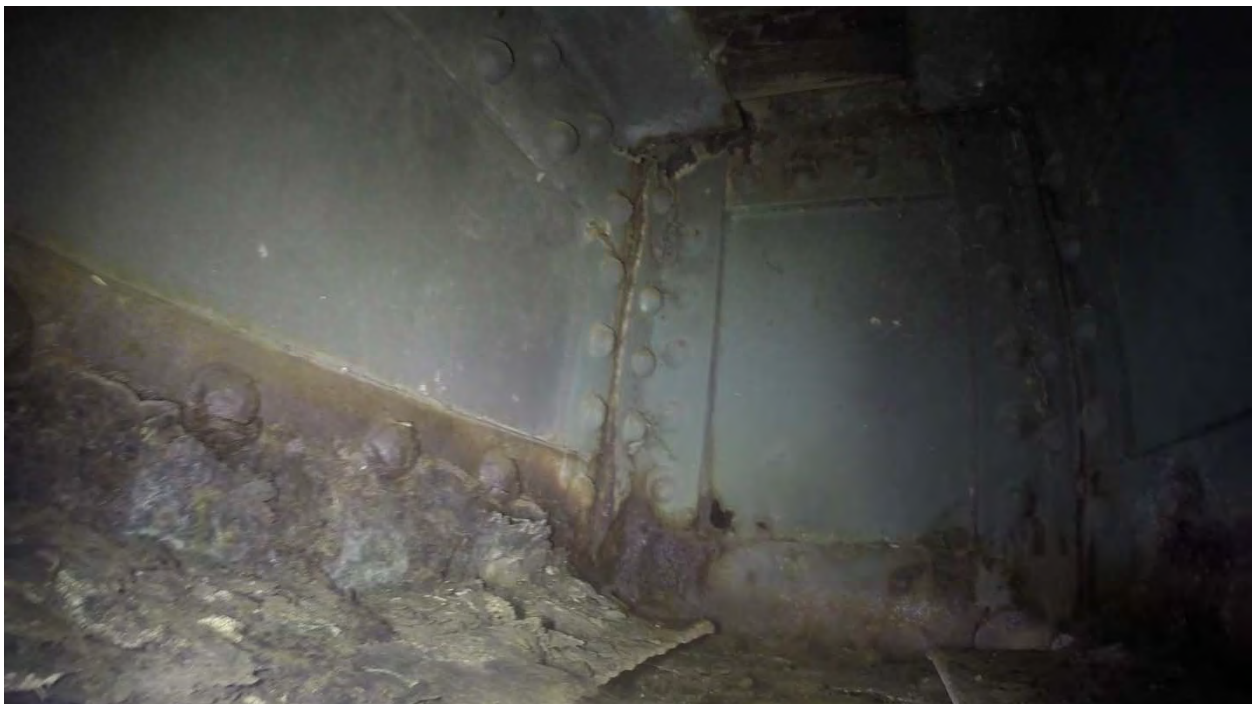
The floor beams are a built-up member consisting of back-to-back 6"x6" angles on the top and bottom with a vertical web plate between the angles. A horizontal cover plate is above and below the angles. The bottom legs of the bottom two angles have significant corrosion between the exterior stringers. The web plate has high levels of corrosion; at least 2 web plates have holes.

Typical Floor Beam and Interior Stringers – note hole in floor beam web plate

The bottom angles are beyond the condition where a repair plate and a good coat of paint can repair the floor beam. The bottom cover plate, angles, and 3" of the bottom of the vertical web plate will be removed. A new vertical web plate will be added to compensate for the section

loss in the existing vertical plate. A new horizontal plate will be welded to the bottom of the new vertical plate. This detail retains the historic “I” shape of the floor beams. The repair does not replace the bottom angles in kind because built-up members are more likely to accumulate pack rust.

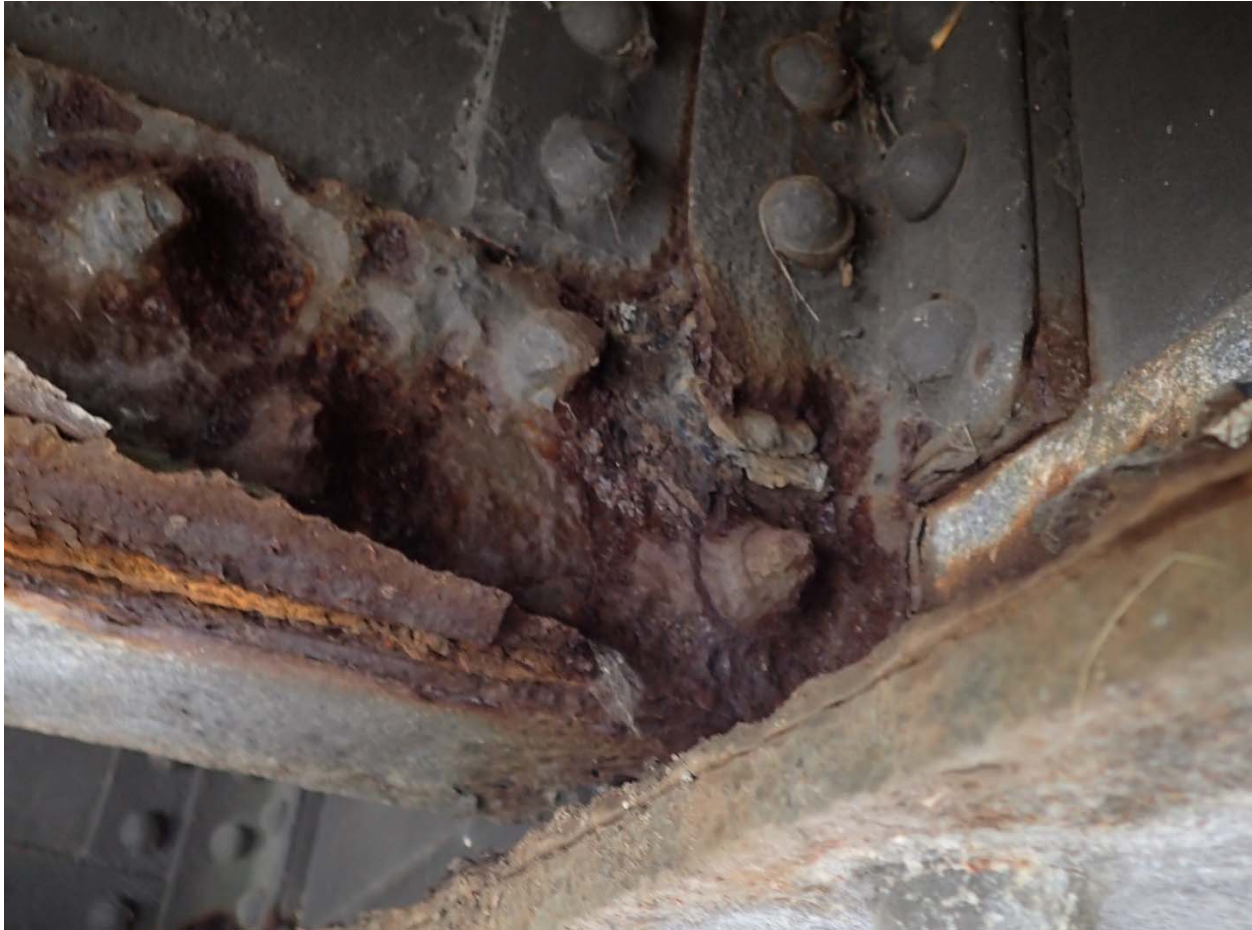
The two interior stringers exhibit the worst deterioration. The bottom leg of the bottom angle has through corrosion in many locations; otherwise, the leg is so thin that it will disappear with the minimal cleaning required to adhere any paint system to preserve the remaining steel. There is significant corrosion in the top leg of the bottom angles as well. The vertical plate is not visible in this location, but it can be reasonably assumed to be deteriorated behind the angle. The vertical web plate would be significantly damaged if the bottom angles are removed.

Typical Interior Stringer - bottom leg of angle is gone which upper leg is almost gone.

The interior stringers are beyond repair and will be removed. In addition, the interior stringers need to be replaced to allow for the structurally needed floor beam vertical repair plate. The holes and significant corrosion in the existing floor beam vertical web plate are between the interior and exterior stringers. With only 6” between the bottom angles of the exterior and interior angles, there is not enough space to adequately repair the floor beams if the interior stringers remain. The interior stringers will be replaced with a similar sized I-beam as a bid alternate if funds allow.

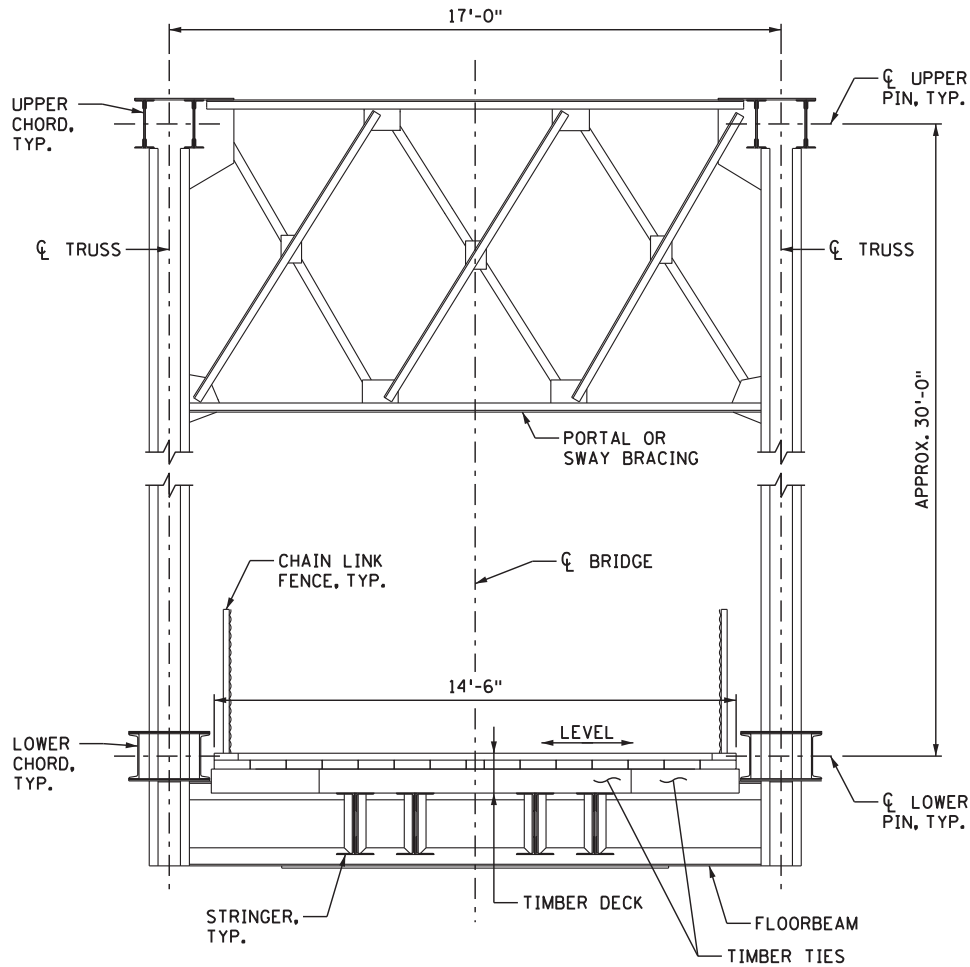
EXISTING TRANSVERSE SECTION

In addition to the floor beams, the existing stringers are deteriorated, and the timber ties and non-original deck are decayed. The timber deck, timber ties, and non-original chain link fence will be removed. The interior stringers possess the worst deterioration and need to be removed.

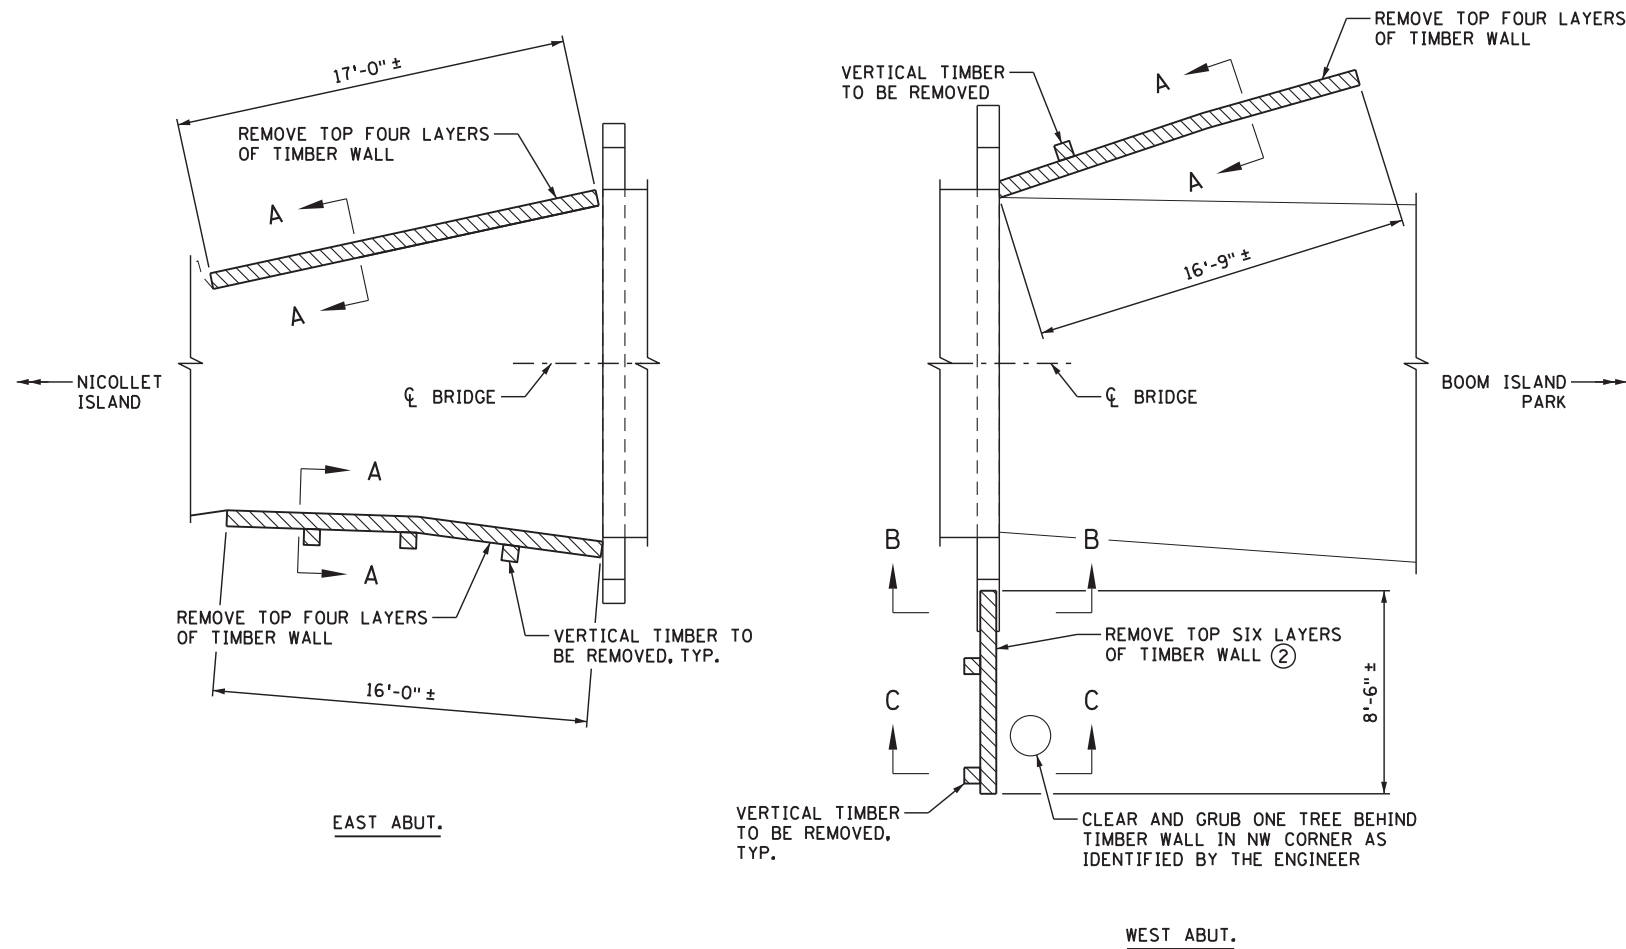
TIMBER WALL PLAN

Timber walls hold up the trail in all four corners of the bridge. These walls were likely placed in 1901 to support the railway, but wood would not be expected to have a service life over 40 years. The timber members were likely replaced throughout the lifetime of the railway. The timber walls have significant decay, splitting, swelling, and are loose. Their lifespan is limited. In addition, they would not be able to accommodate any construction loads required to rehabilitate the bridge.

- NOTES:
- DENOTES REMOVAL.
 - ① TRIM INPLACE THROUGH BOLTS OR DOWELS IF PRESENT.
 - ② THE FIFTH LAYER FROM THE TOP APPEARS TO BE ROTTED AWAY BUT MAY BE PRESENT DURING REMOVALS. ADDITIONAL TIMBERS MAY BE PRESENT BELOW THE SIXTH LAYER.

The timber walls will be reconstructed. The existing horizontal and vertical timbers will be removed. The vertical members will be replaced in-kind, but the horizontal members will be replaced with wider sections to accommodate the railing that is required for safety reasons on top of the walls. The combined drop and steep slopes at the bottom of the wall require the railing protection to prevent people from falling down the steep slopes

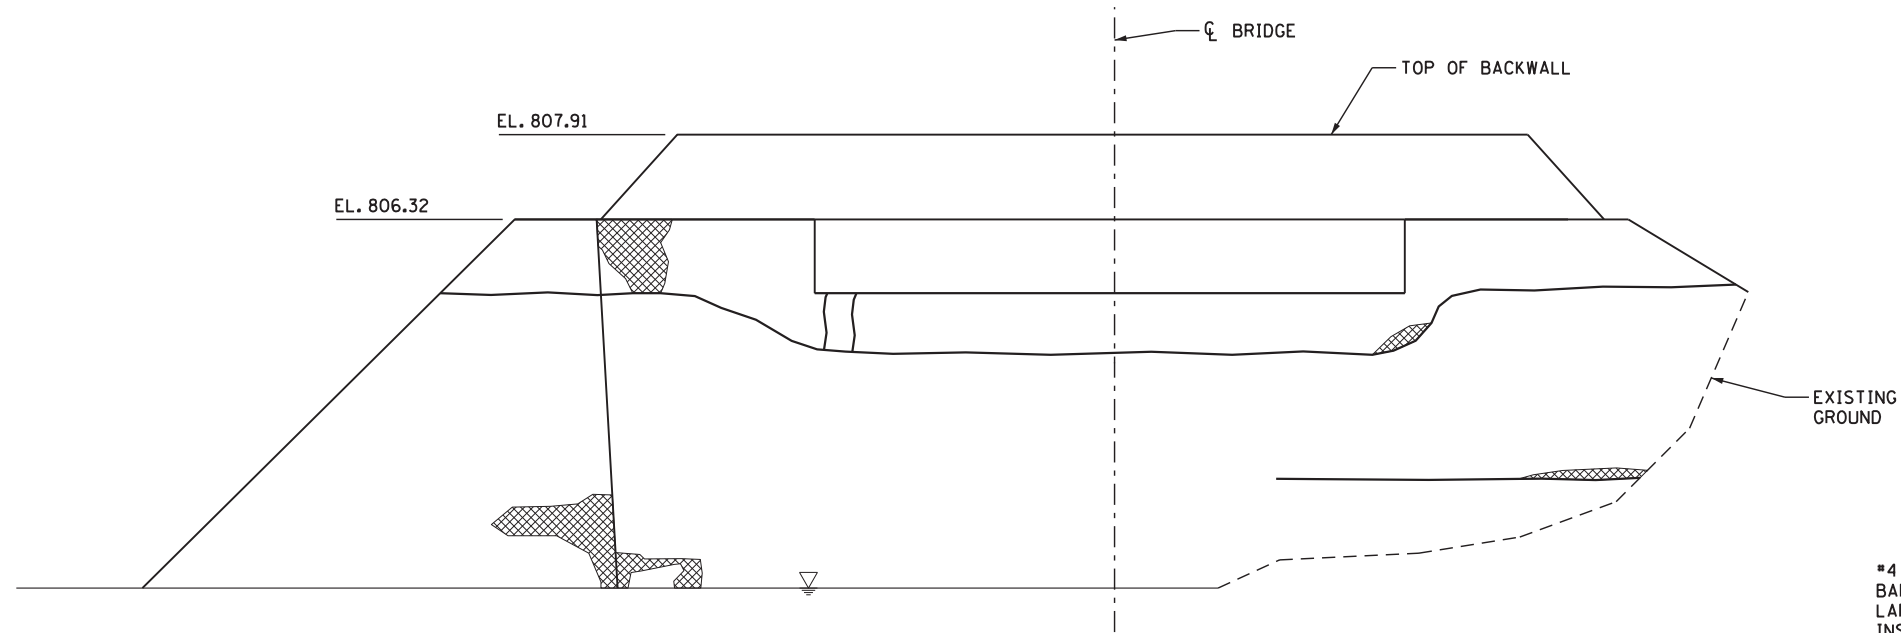
WEST ABUTMENT ELEVATION

~ STRUCTURAL CRACK, SEE CONCRETE SURFACE REPAIR DETAIL.

▨ SPALL, SEE CONCRETE SURFACE REPAIR DETAIL.

The abutments are cracked and spalled. The spalls will be repaired and the cracks will be sealed. In addition, the top of the abutment backwall will be removed and replaced in-kind to provide support for the proposed deck system. The proposed abutment concrete will match the color and texture of the existing concrete.

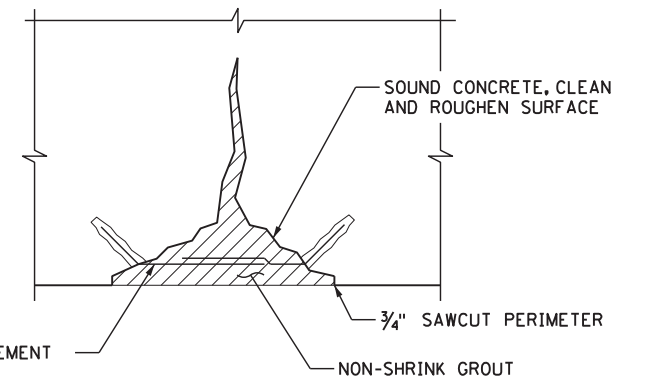
CONCRETE SURFACE REPAIR DETAIL

LOOKING AT SECTION THRU SPALL AND CRACK
