Lake Nokomis landscape restoration projects

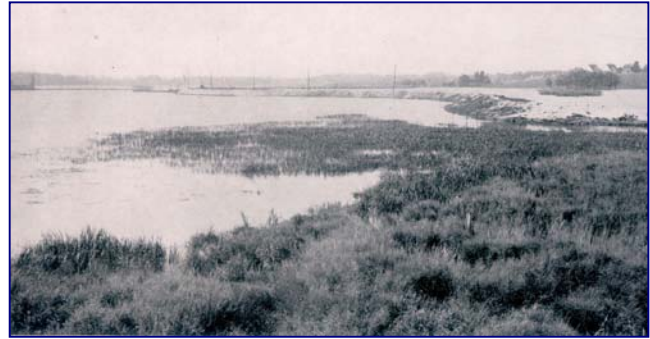
Lake Amelia prior to dredging
