KENNY PARK

1152330-02-01-05 • 06.11.2021

1152330-02-01-06 • 06.11.2021

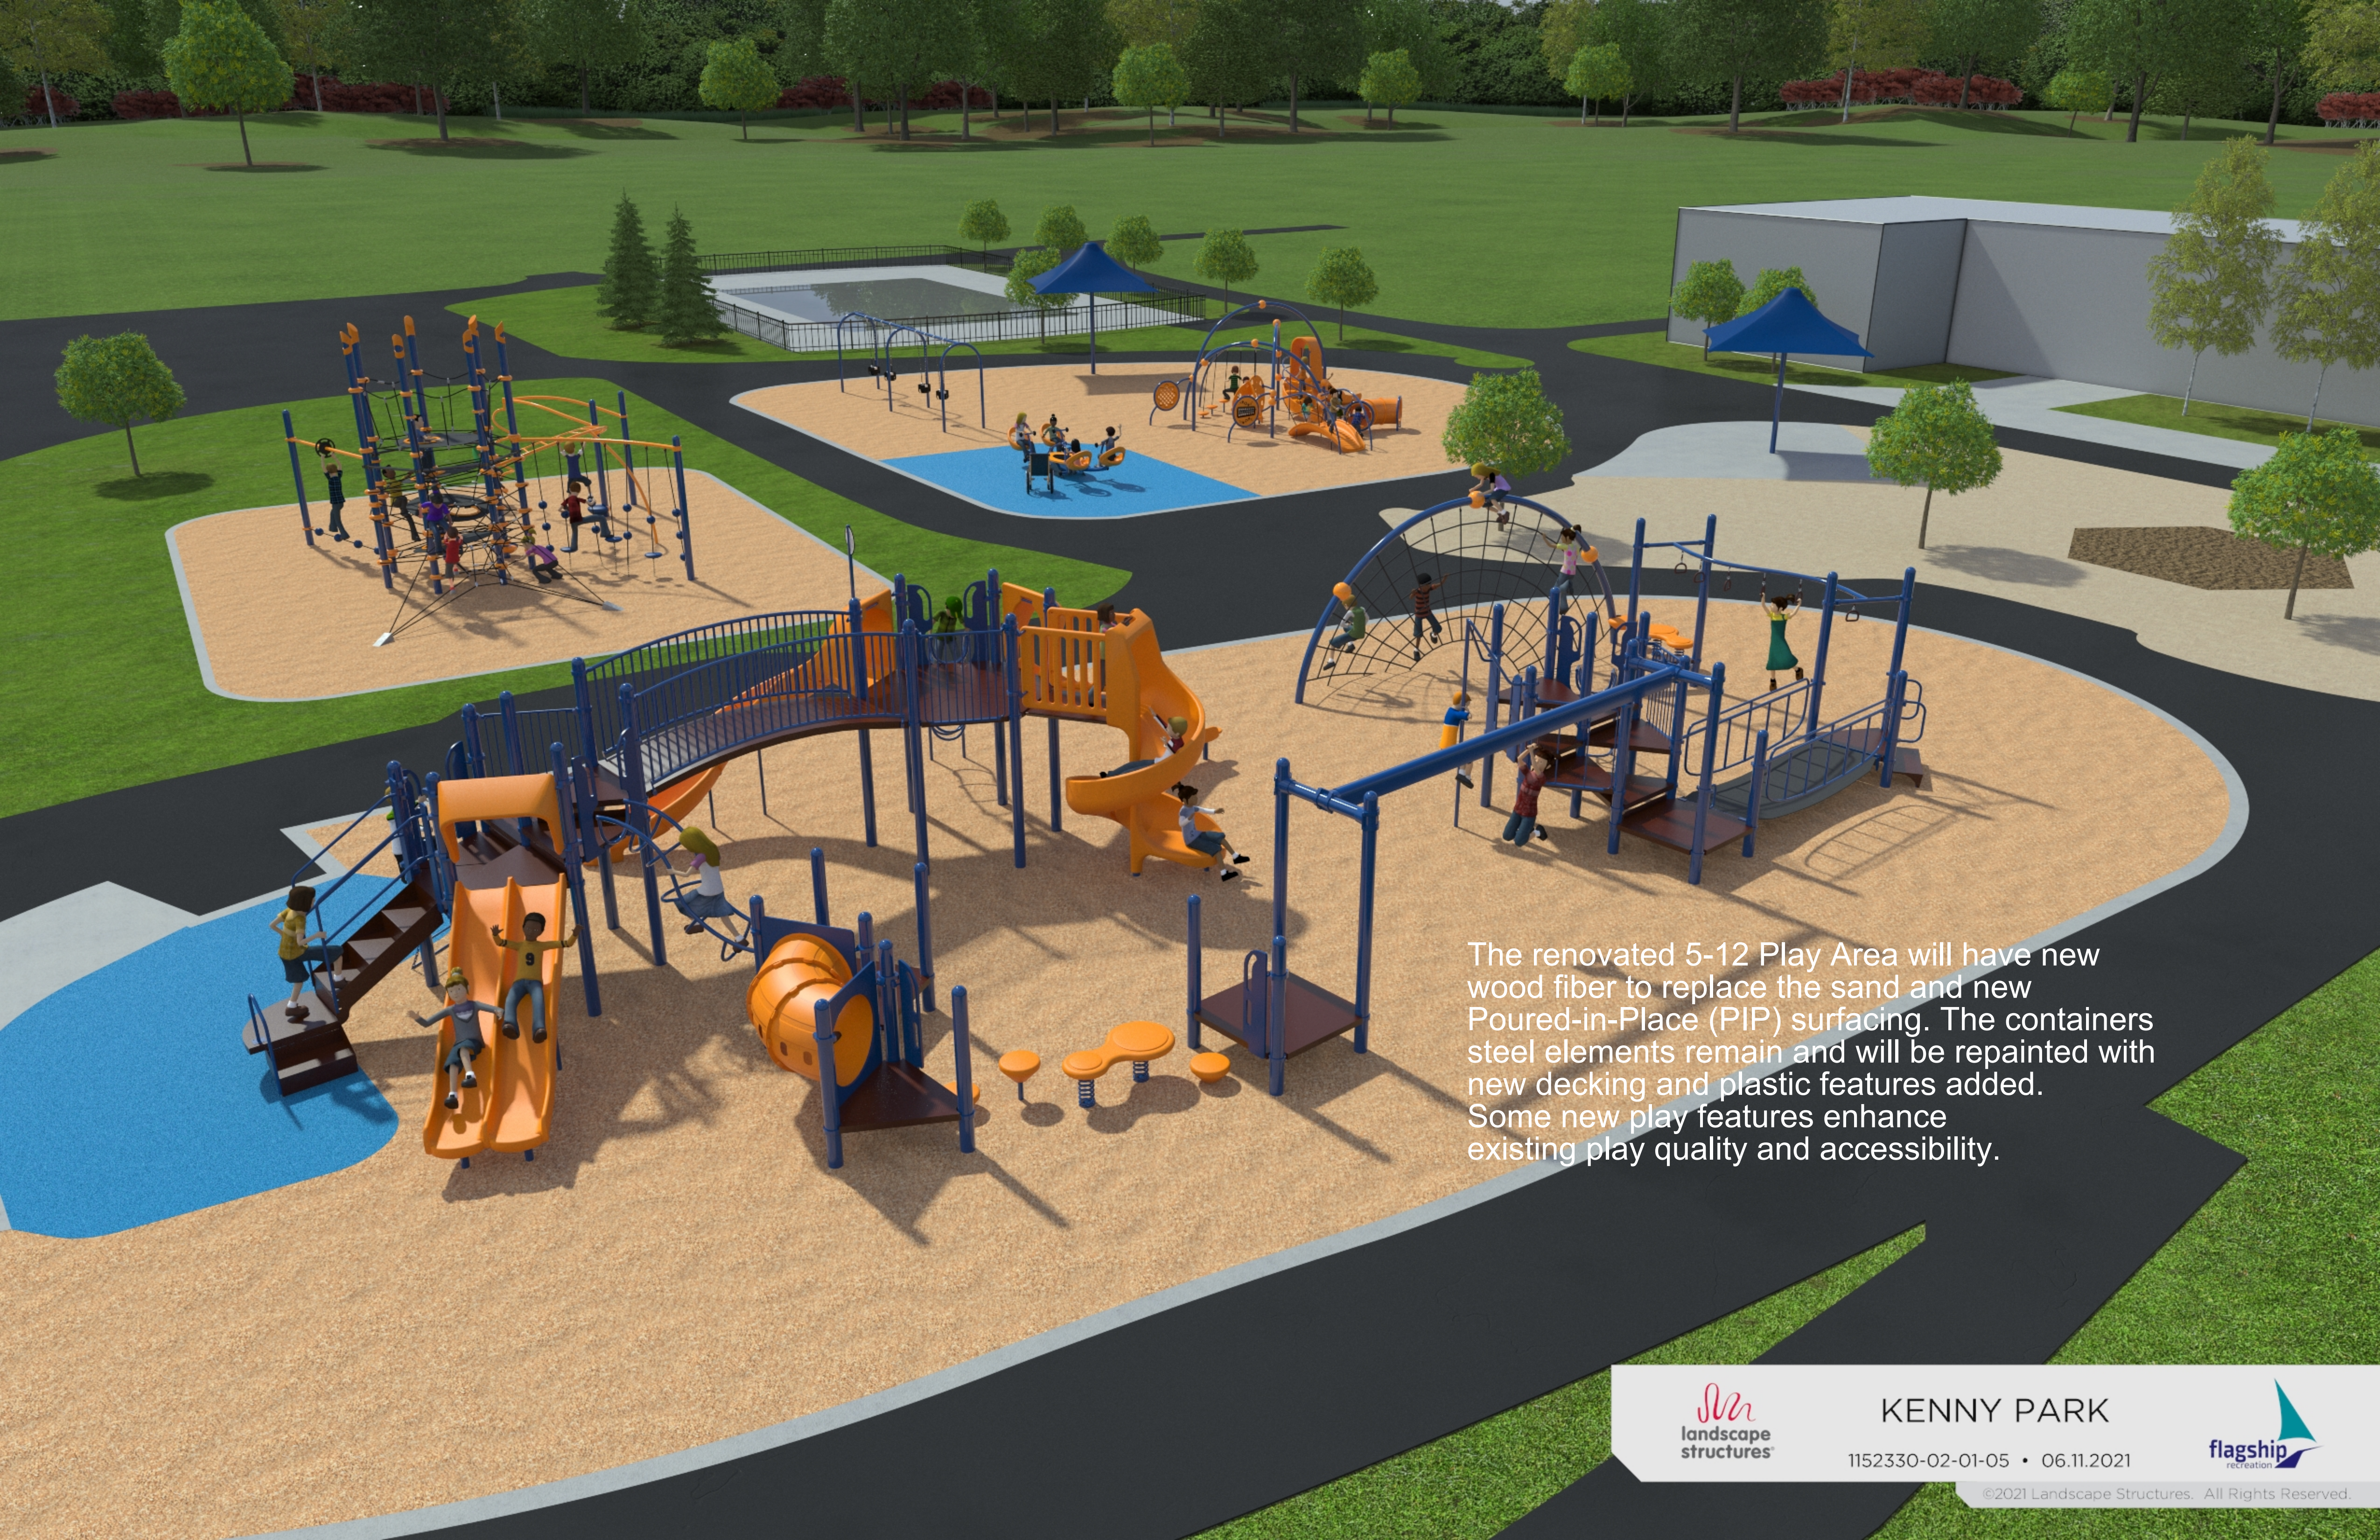
The renovated 5-12 Play Area will have new wood fiber to replace the sand and new Poured-in-Place (PIP) surfacing. The containers steel elements remain and will be repainted with new decking and plastic features added. Some new play features enhance existing play quality and accessibility.

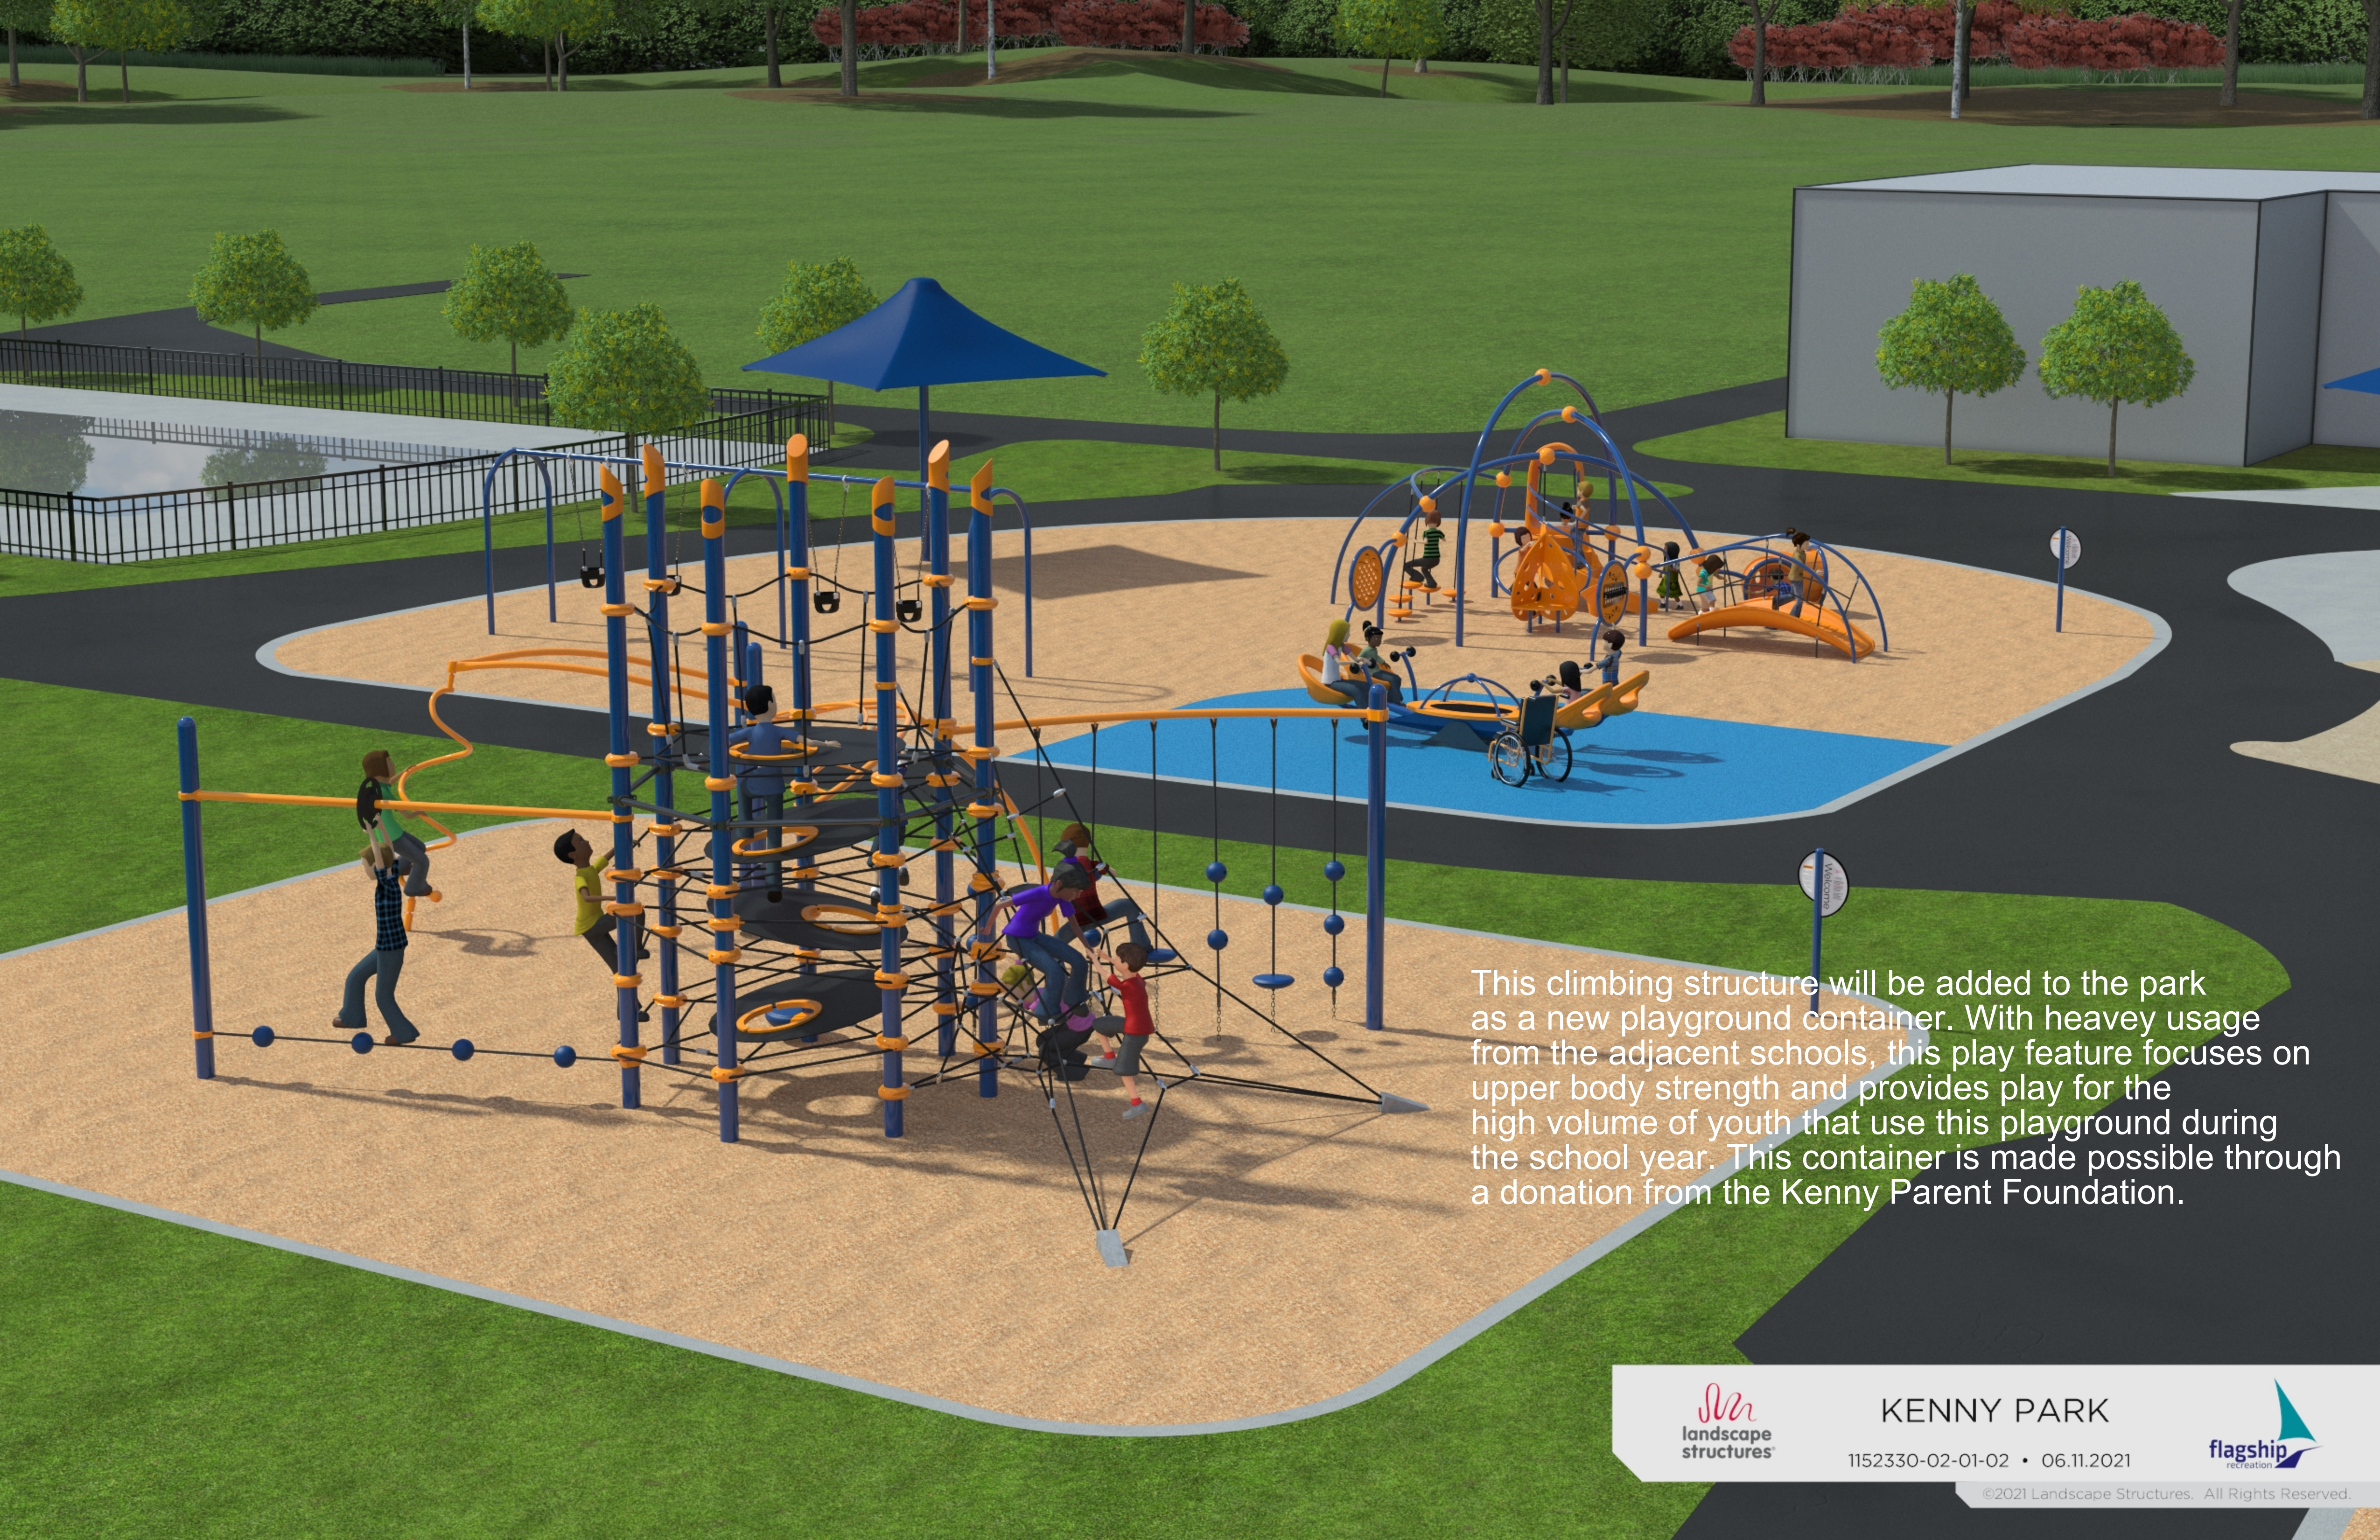
This climbing structure will be added to the park as a new playground container. With heavy usage from the adjacent schools, this play feature focuses on upper body strength and provides play for the high volume of youth that use this playground during the school year. This container is made possible through a donation from the Kenny Parent Foundation.

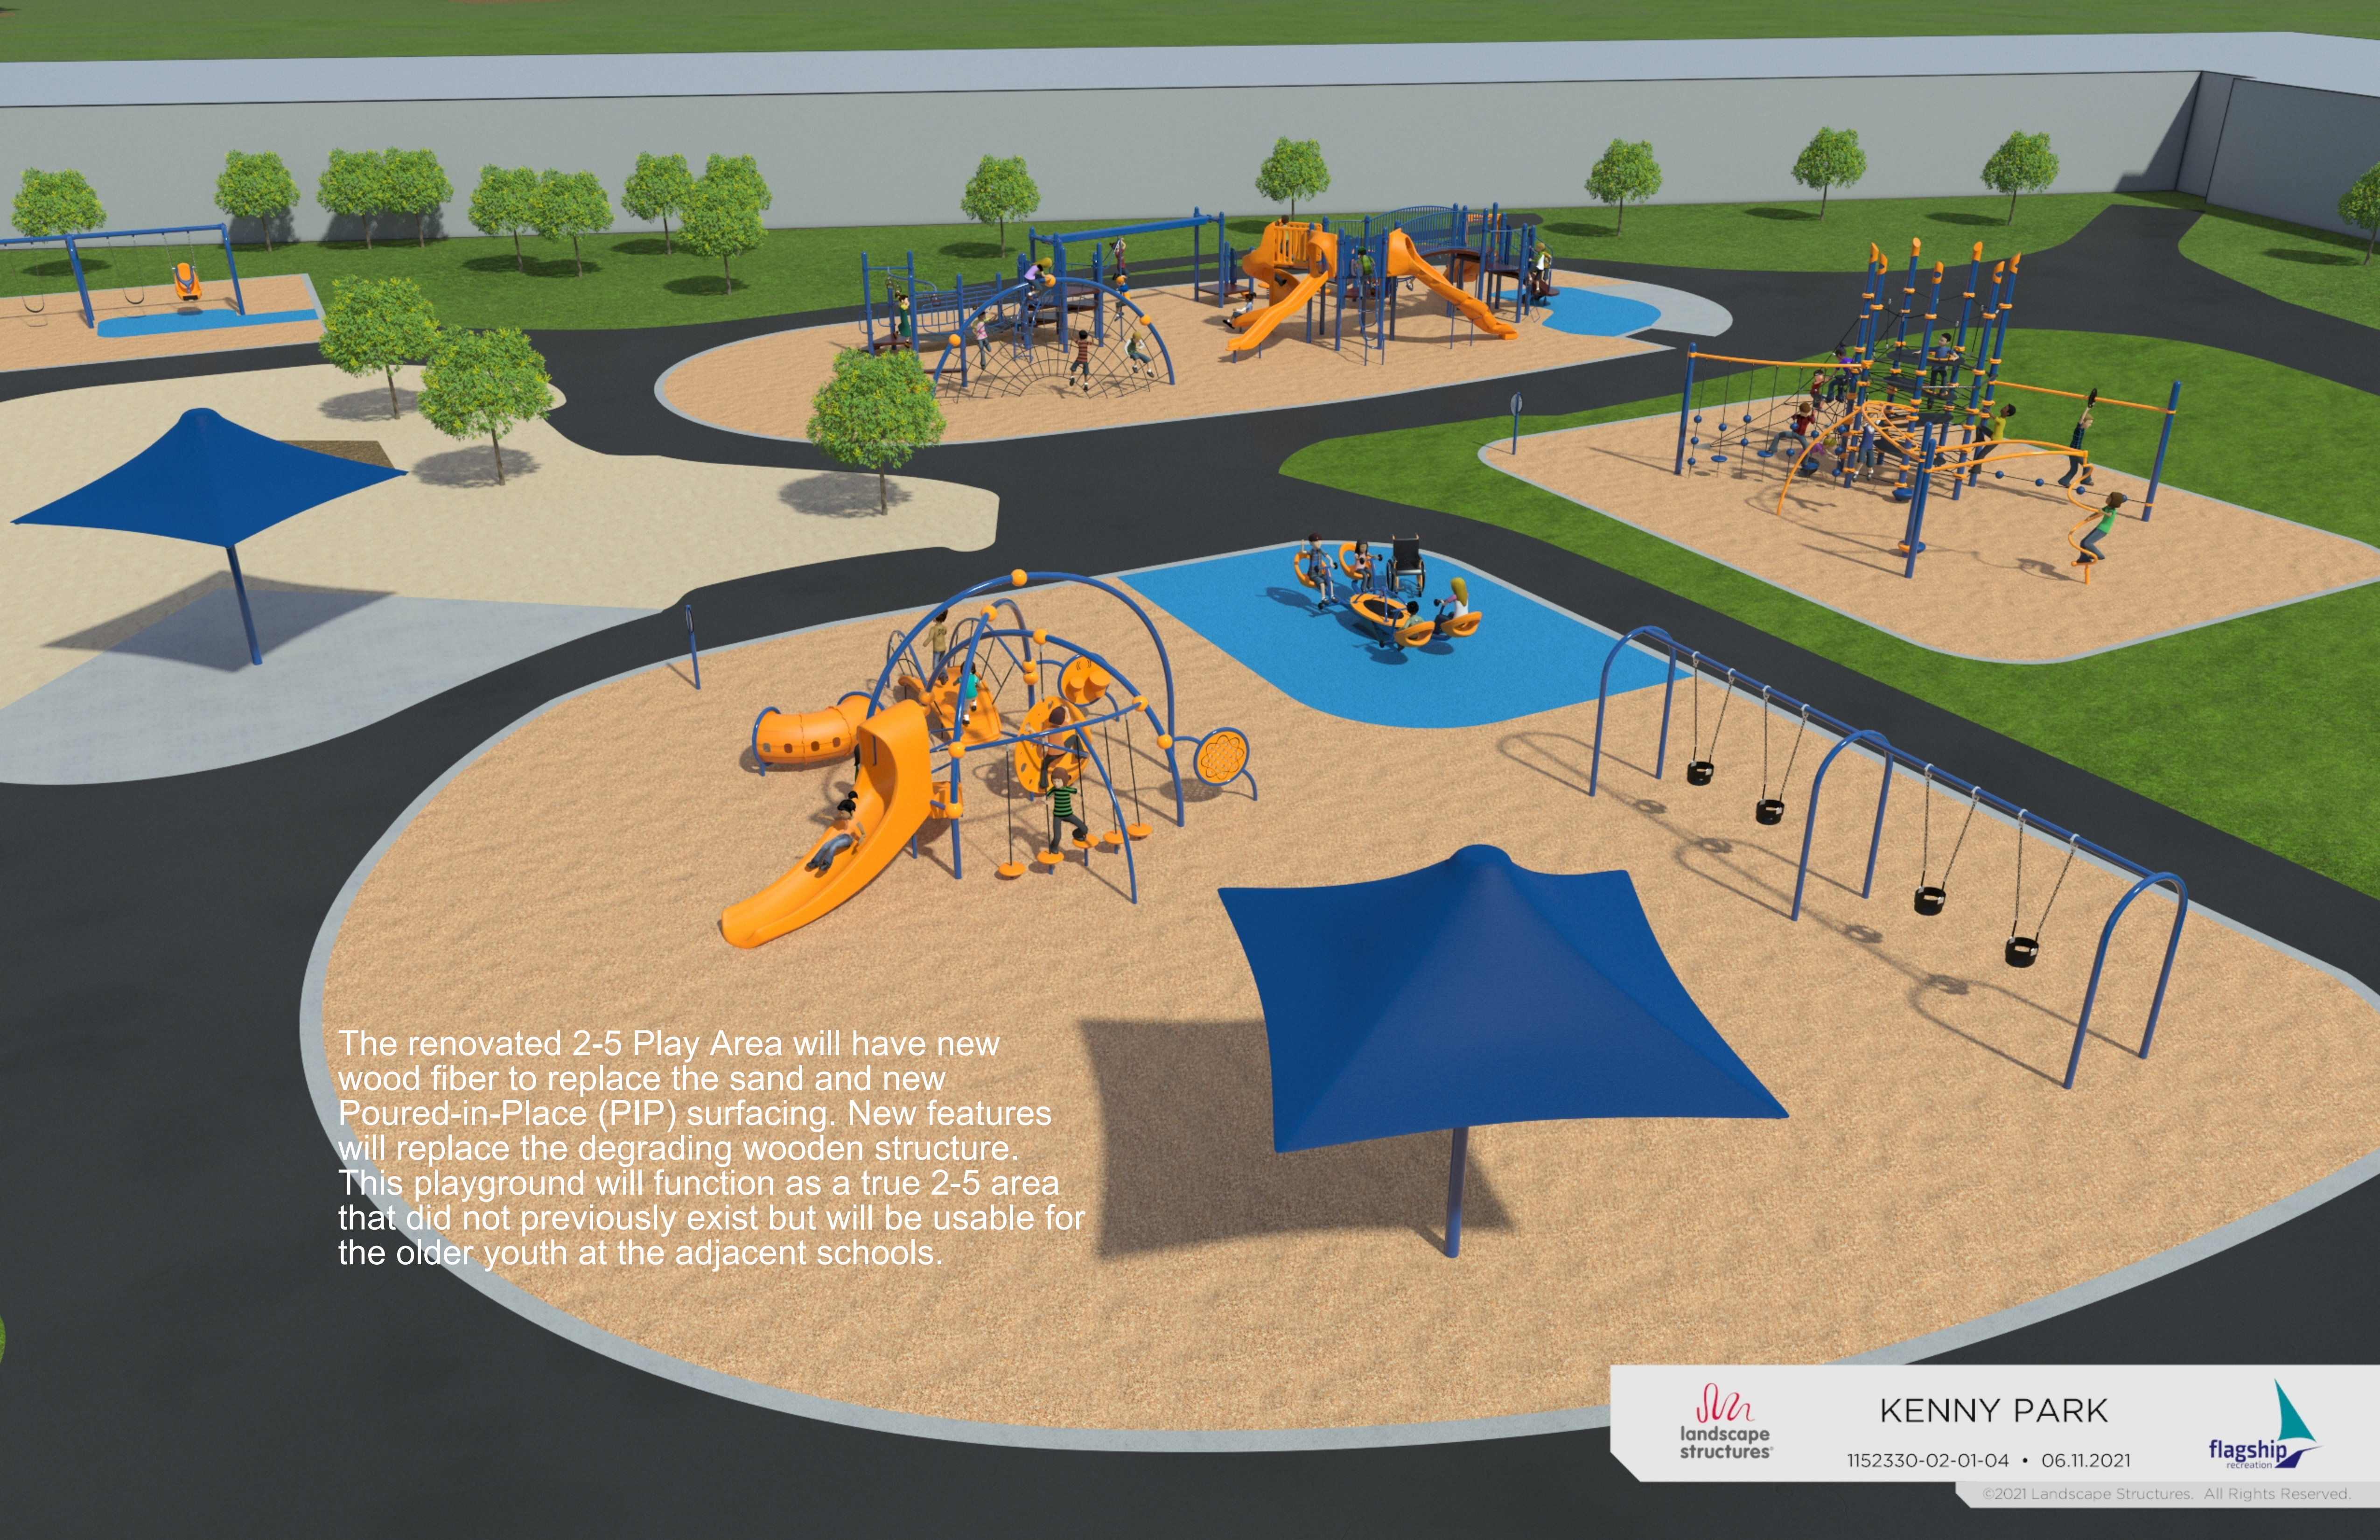
The renovated 2-5 Play Area will have new wood fiber to replace the sand and new Poured-in-Place (PIP) surfacing. New features will replace the degrading wooden structure. This playground will function as a true 2-5 area that did not previously exist but will be usable for the older youth at the adjacent schools.

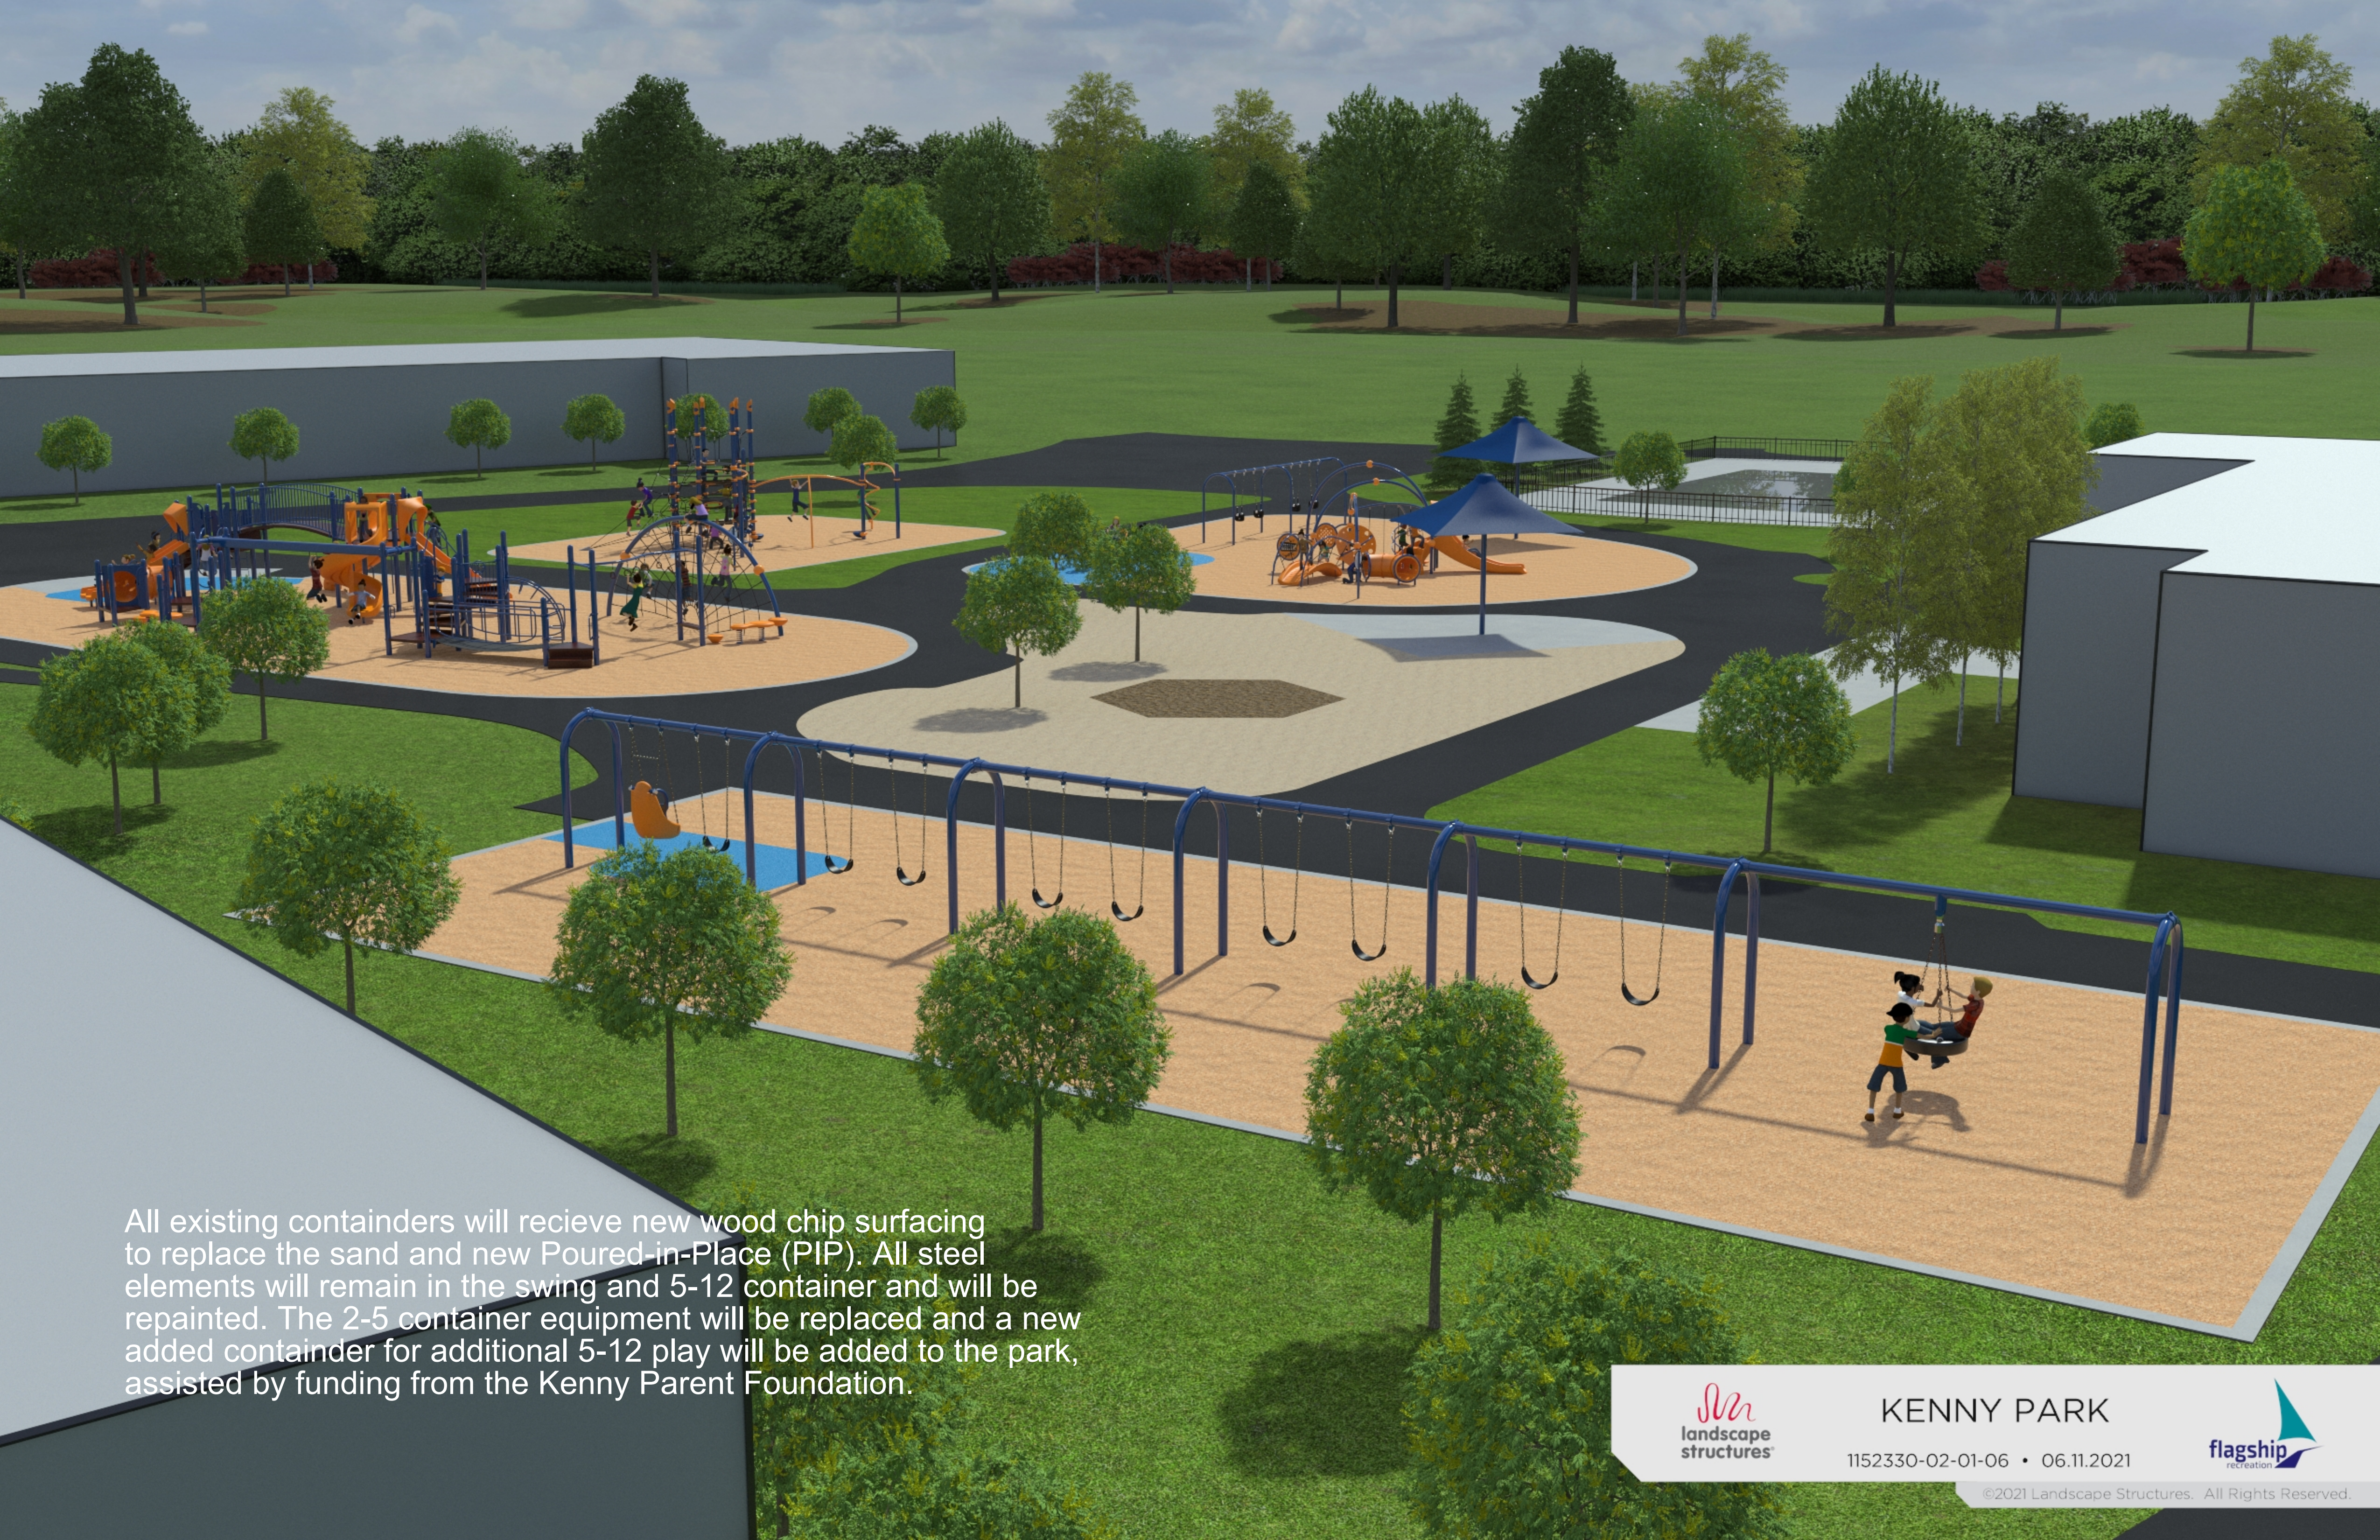
All existing containders will recieve new wood chip surfacing to replace the sand and new Poured-in-Place (PIP). All steel elements will remain in the swing and 5-12 container and will be repainted. The 2-5 container equipment will be replaced and a new added containder for additional 5-12 play will be added to the park, assisted by funding from the Kenny Parent Foundation.
