## Memorandum

Project John H. Stevens House

Regarding Fire Damage Condition Assessment

Re: Condition Assessment and Stabilization Recommendations  
John H. Stevens House, Minnehaha Park  
4901 Minnehaha Avenue So, Minneapolis, MN

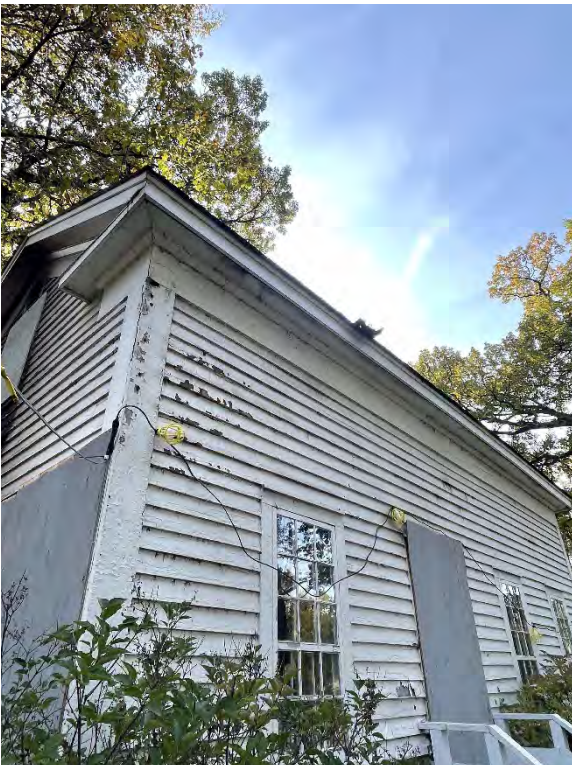
Photo 7 West facade.

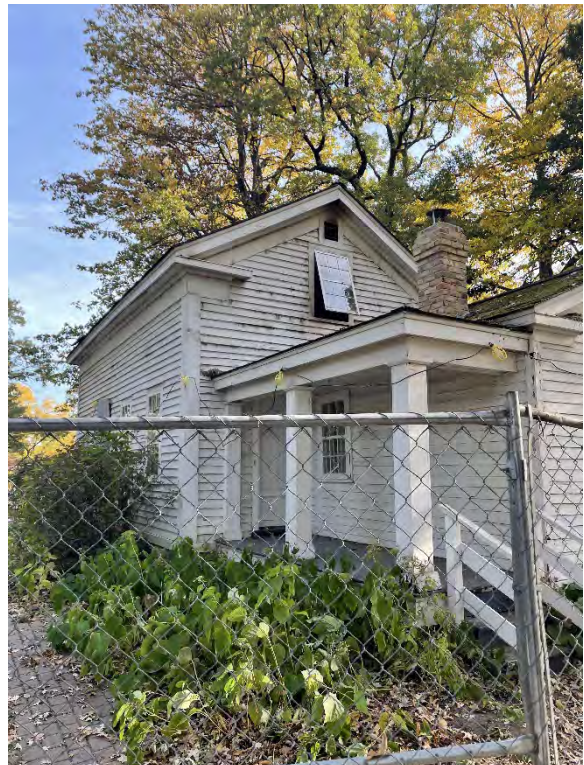
Photo 8 South facade.

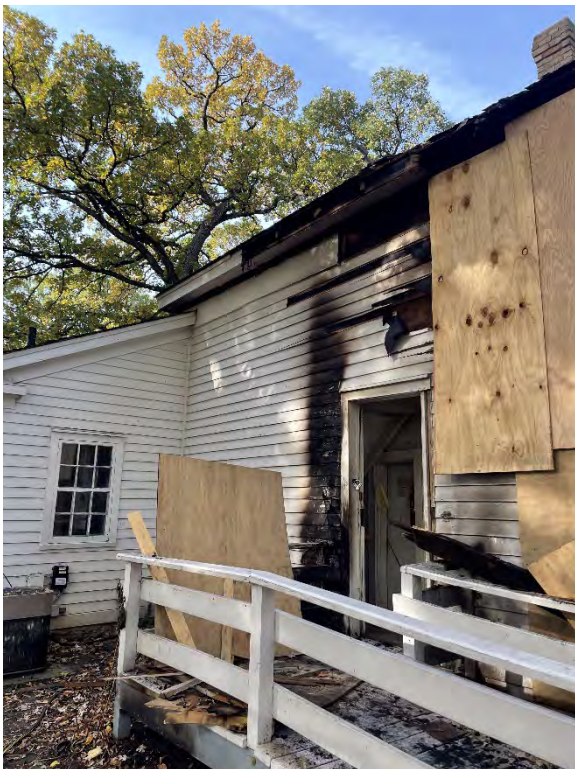
Photo 10 East facade.

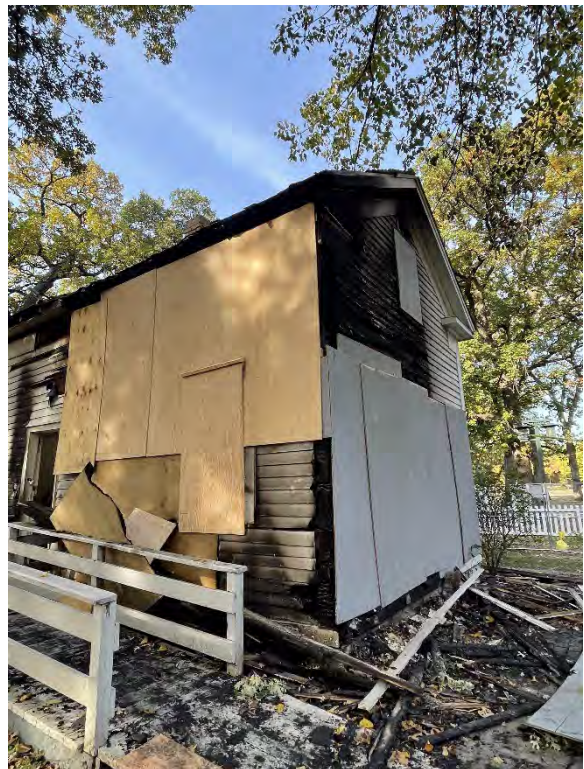
Photo 11 Northeast corner.

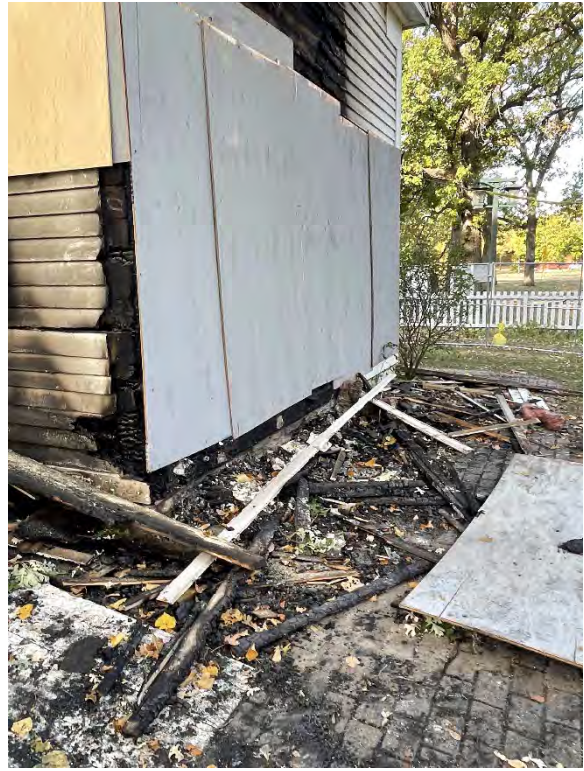
Photo 13 North facade.

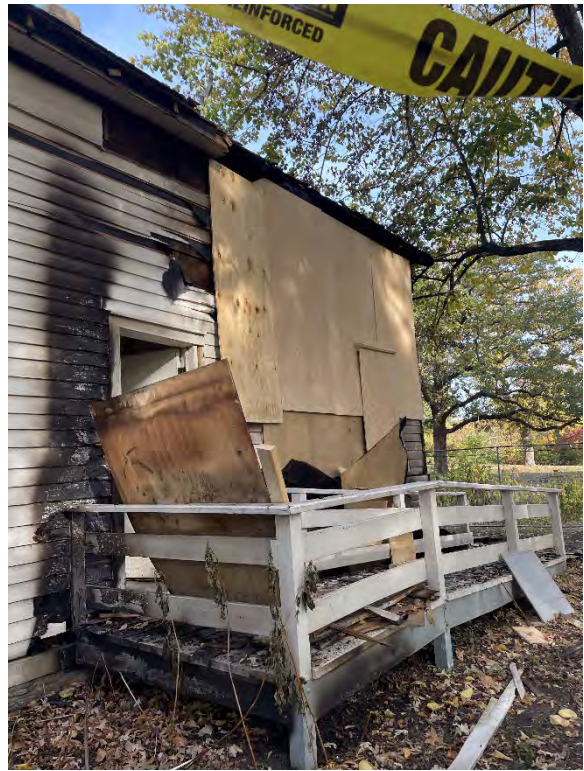
Photo 17 East facade.

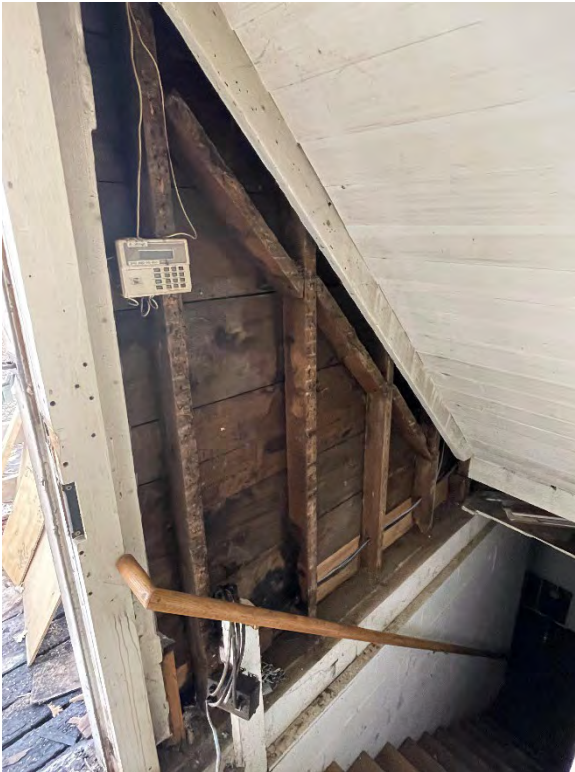
Photo 21 Stairwell wall.

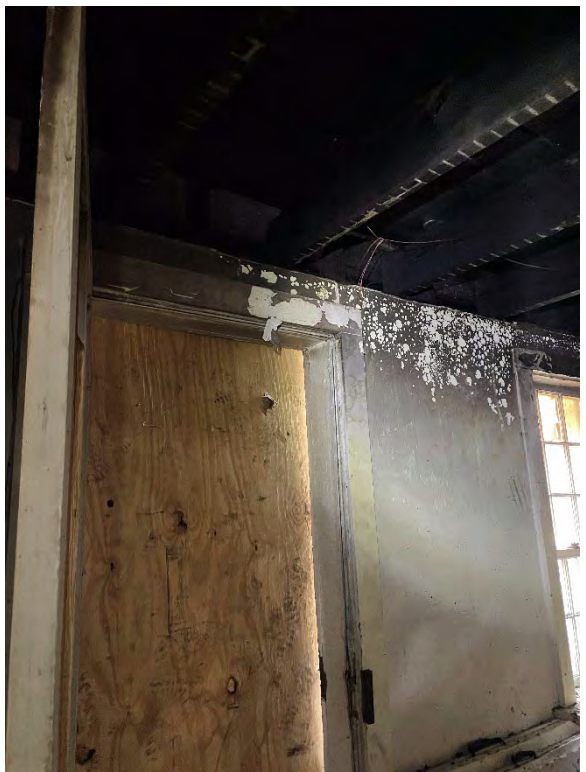
Photo 22 Above west entry door.

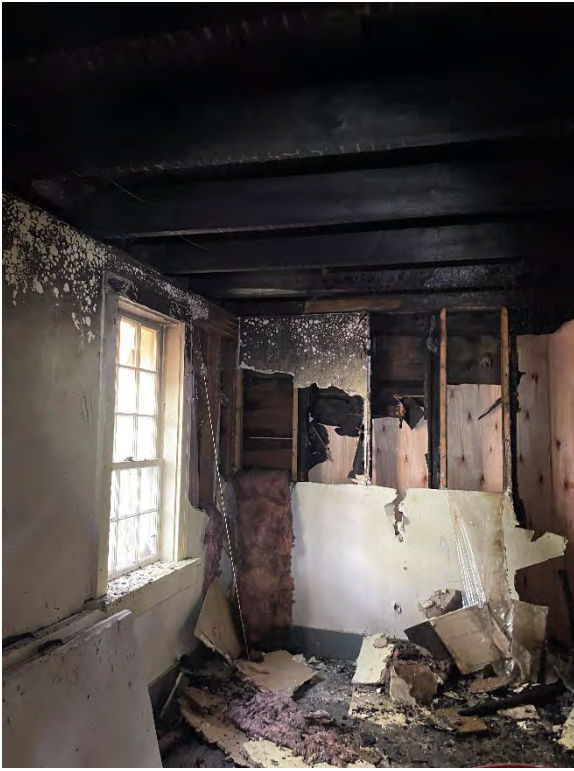
Photo 23 Parlor NW corner.

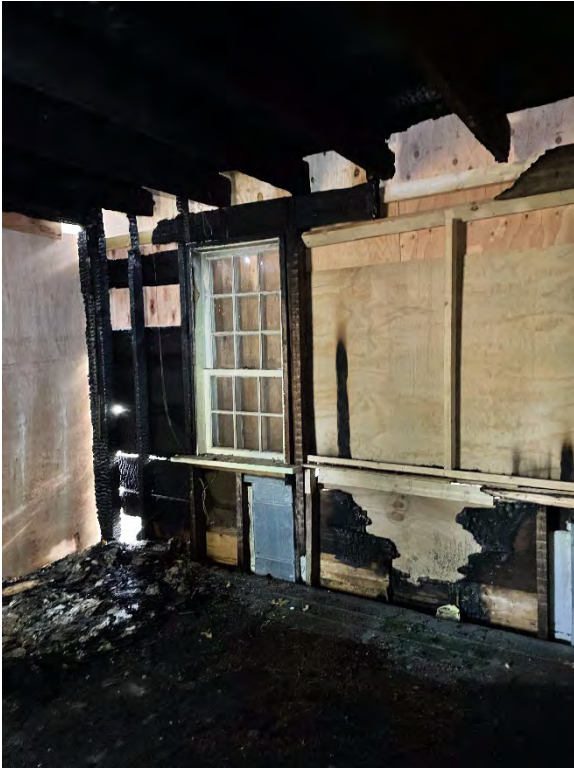
Photo 25 Parlor north elevation.

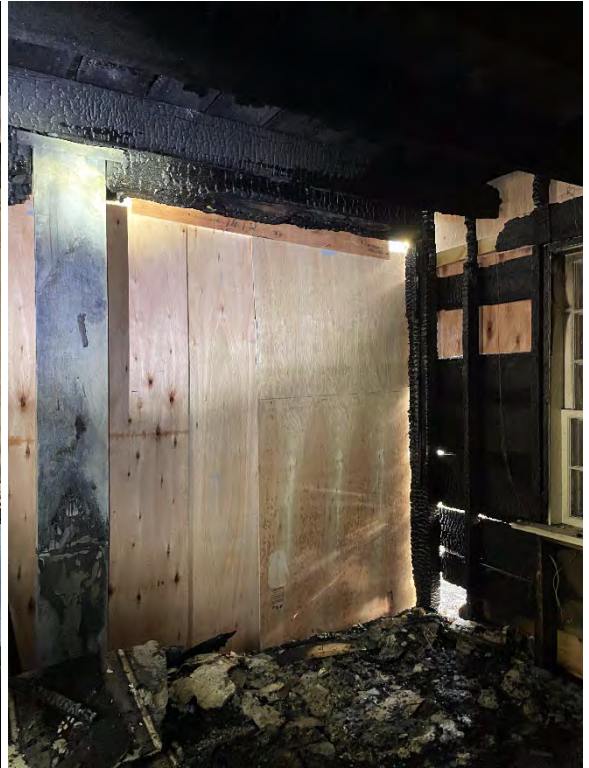
Photo 26 Parlor east elevation.

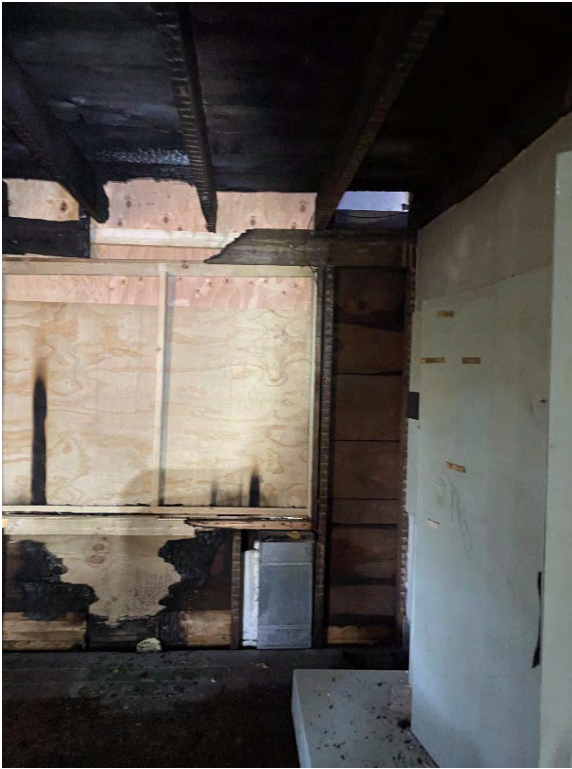
Photo 27 Parlor east elevation.

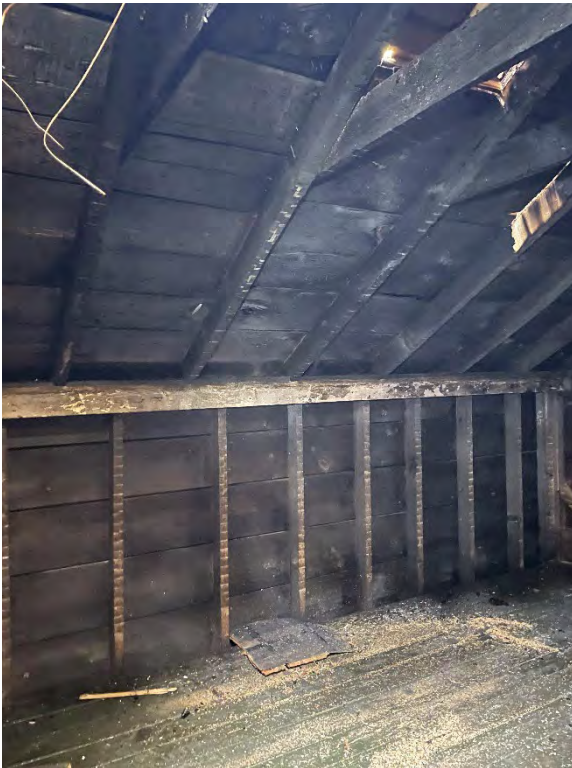
Photo 29 North chamber west elevation.

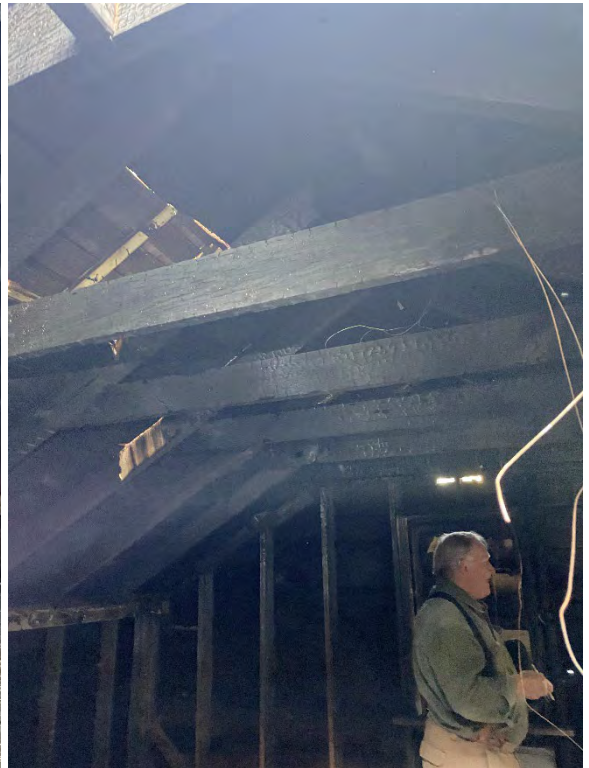
Photo 30 North chamber looking north.
